RAVENSWORTH OPERATIONS

GLENCORE

Heritage Management Plan

Number: RAVCX-307024981-3052

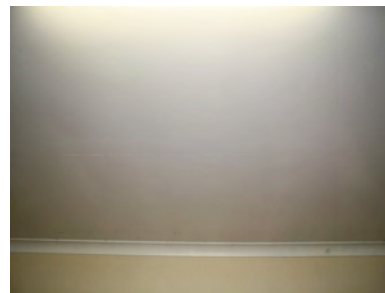
Figure 3462.jpg

Room No.	Room Name	Type / Finish	Comments	photograph
1	Garage Orientation /Element name		Generally good condition with some wall cracking.	
	Floor	concrete	Good condition. Smooth trowel with surface cracks.	3460.jpg
	Wall North	Plasterboard painted Colorbond Roller Doors	3 roller doors. Horizontal crack in NE corner. Horizontal crack along setting of plasterboard.	3463.jpg
	Wall East	As above	Door to exterior is jammed. Hollow Core door required to be replaced by external door.	3460.jpg
	Wall South	As above	Damage to corner of room in lower corner of WC.	3461.jpg
	Ceiling	Plasterboard	Good condition. Cracks on setting Line. Crack in SE corner.	3462.jpg
	Cornice	Plasterboard 90mm Scotia	Good condition. Crack in SE corner.	
	Fixtures	Retractable Clothes Line	Clothes Line located in recess beside laundry and WC.	3461.jpg

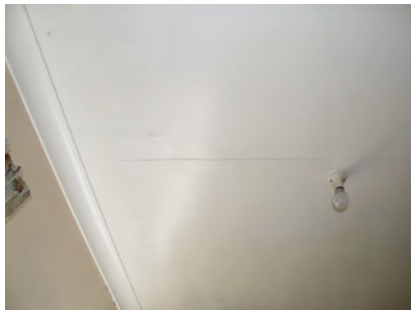
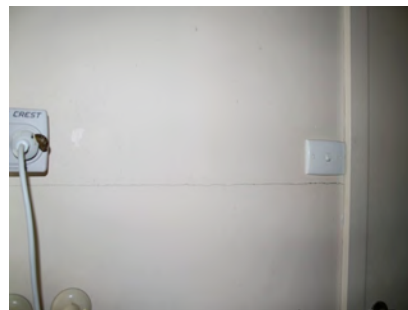
Room No.	Room Name	Type / Finish	Comments	photograph
3	Laundry		Generally satisfactory condition	
	Orientation /Element name			
	Floor	Concrete. Ceramic tiled finish.	Good condition	
	Wall North	Fibre Cement. Ceramic tiled skirting	Built in cupboard.	
	Wall East	As Above	Paper delaminating in wall lining from joint over tub.	3467jpg
	Wall South	As Above.	Crack over door. Setting cracks in fibre cement. External hollow core door showing deterioration. Door should be replaced with new external door.	
	Wall West	As Above		
	Ceiling	Plasterboard. Painted in gloss finish.	Ceiling fan requires new grille	
	Cornice	Scotia 90mm	Crack in SW corner.	3467jpg 3468jpg
	Fixtures	Hot Water Service

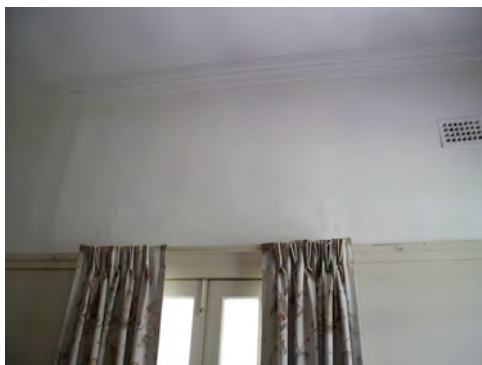
Figure 3501jpg

Cornice	Fibre plaster cornice.	Fluted profile. Crack in western section.	
	Fixtures	Combustion heater AC Register	Partly dislodged AC register.	3499jpg
		Picture wall light	North wall

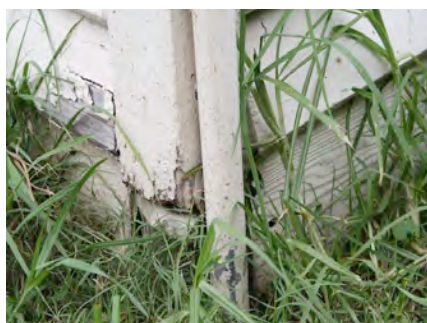
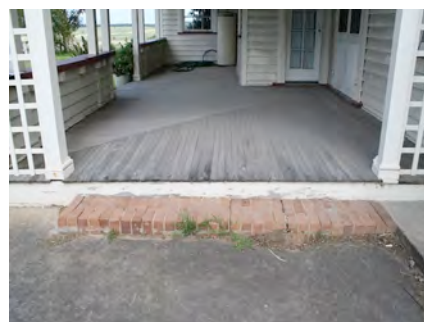
Comment		Requires cleaning, painting, floor sanding and oiling. Repair steps. Timber rotting in north-east corner.

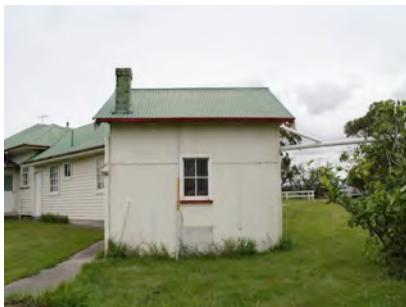
Figure 3438jpg

Gutters	Galvanised Iron. Quad. Painted	Check watertightness and replace if required. Repaint.	3438jpg
	Fixtures	Laundry sinks (number 2)	Cast iron on pedestals. Conserve.	3440jpg
		Cool room		3440jpg
		HWS		3441jpg
		Pump		3443jpg
		Copper	Set in partially rendered brick structure. Conserve copper in situ.	3442jpg 3440jpg

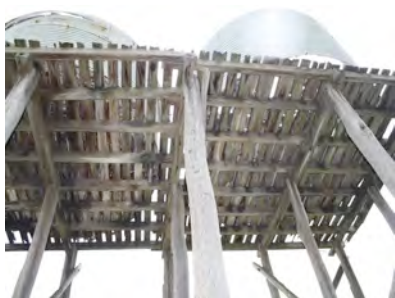
Figure 3409jpg

Item No.	Name	Type / Finish	Comments	photographs
2 and 3	Water Tank			
	Orientation /Element name			
	Support Structure	Timber Logs	Timber logs in ground as supports posts. Machined timber cross bracing bolt fixed to posts. Check and repair joints if required with galvanised wire and new galvanised bolts where required. Retain existing timber members and install new secondary timber structure where required.	3405jpg 3410jpg 3549jpg 3547jpg
	Platform for Water Tanks	Timber	Machined timber bearers and joists. Spaced timber boards showing signs of rot. Remove tanks and repair platform. Replace boards where required.	3409jpg 3407jpg
	Water Tank	Galvanised Iron	Galvanised iron oxidised and deteriorated. Remove loose sections of galvanised iron. Tanks may need to be removed as platform unstable and loose sections of iron. Replace with new Galvanised Steel tanks.	3408jpg 3409jpg
	Plumbing	Galvanised steel pipes	Remove plants from base of tanks. Repair plumbing and do not water around posts.

The Water Tanks are a significance part of the rural complex and should be protected and preserved. The galvanised tanks have deteriorated to such an extent that it may be hard to secure these and they could present a danger in high winds and hence it would be practical to remove the tanks. New galvanized water tanks should be installed if the existing cannot be secured. The tank stands should be protected and preserved. This will require repair work to fix the platforms and fixing of all structural members. New galvanized steel bolt fixings should be used and the original fixings retained. Galvanised wire can also be used to reinforce joints.

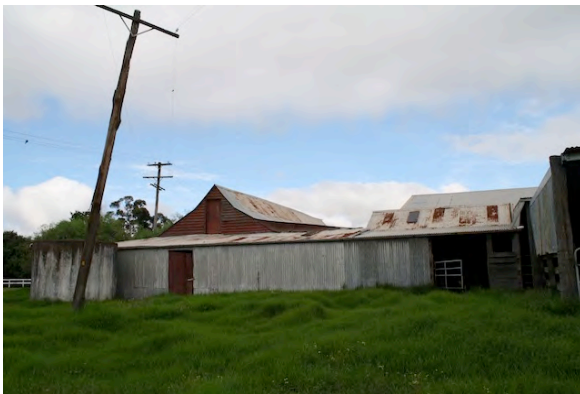
Figure 3730jpg

Room No.	Room Name	Type / Finish	Comments	Photographs
	North Elevation		The skillion roof is an addition as evident by the original external wall (now the internal north wall to Room 3) and the door on the gable end of this same wall projecting above the skillion.	
	Orientation /Element name			
	Wall North	Galvanised Iron	Galvanised Iron painted. Braced and ledged door. Iron strap hinges. Door requires to be squared and rehung.	3730jpg 3731jpg
	Roof		Galvanised iron. Refix all loose iron with galvanised nails. Replace galvanised iron with iron to match if water penetrating. Paint roof with penetrol.	
	Gable end	Lapped timber boards	Timber ledged door. Lapped boards Required to refixed and oiled.	3735jpg
	Gutters	Galvanised Iron	Replace deteriorated gutters if required with galvanised steel half round gutters and check drainage lines and damp to avoid deterioration of timber post and slabs in ground.	3732jpg

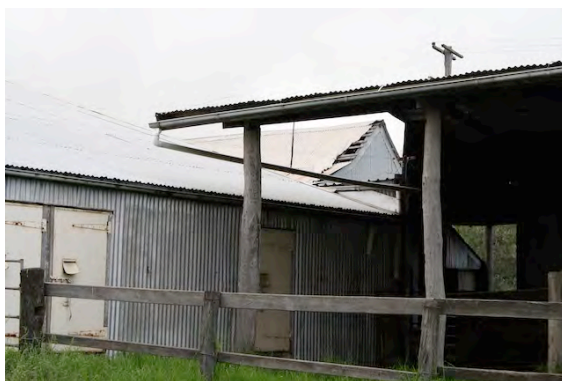
Figure 3719jpg

Room No.	Room Name	Type / Finish	Comments	Photographs
	South Elevation		The elevation has been altered with the addition of the machinery shed that adjoins the subject shed on the south elevation.	
	Orientation /Element name			
	Wall South	Galvanised Steel	Machined slabs to east wall addition to skillion.	3687jpg 3688jpg 3713jpg 3719jpg
	Roof		Galvanised iron. Refix all loose iron with galvanised nails. Replace galvanised iron with iron to match if water penetrating. Paint roof with penetrol.	3713jpg 3719jpg
	Gable end	Galvanised Steel

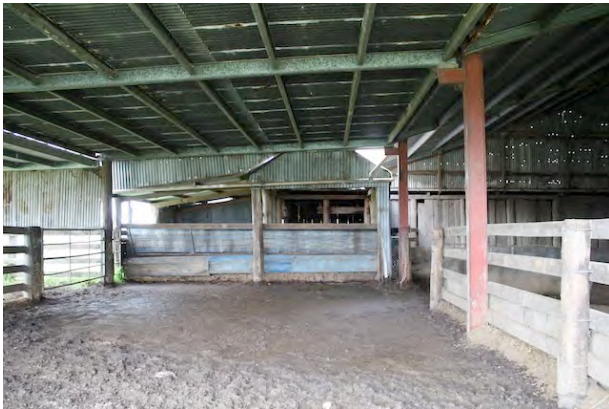
Figure 3725jpg

Room No.	Room Name	Type / Finish	Comments	Photographs
	West Elevation		The elevation has been altered with the addition of the machinery shed and cattle sheds that adjoins the subject shed on the west elevation.	
	Orientation /Element name			
	Wall	Galvanised Steel	Split slabs with adze markings. Fix all slabs with galvanised wire and nails.	3724jpg 3725jpg 3727jpg
	Roof	Galvanised Iron	Galvanised iron. Gaps in roof where iron has been dislodged. Refix all loose iron with galvanised nails. Replace galvanised iron with iron to match if water penetrating. Paint roof with penetrol.	
	Gutters and Downpipes	Galvanised Iron	Replace all gutters and downpipes if required with galvanised steel half round gutters and check drainage lines and damp to avoid deterioration of timber.
