Environmental Impact Statement

BULGA OPTIMISATION PROJECT

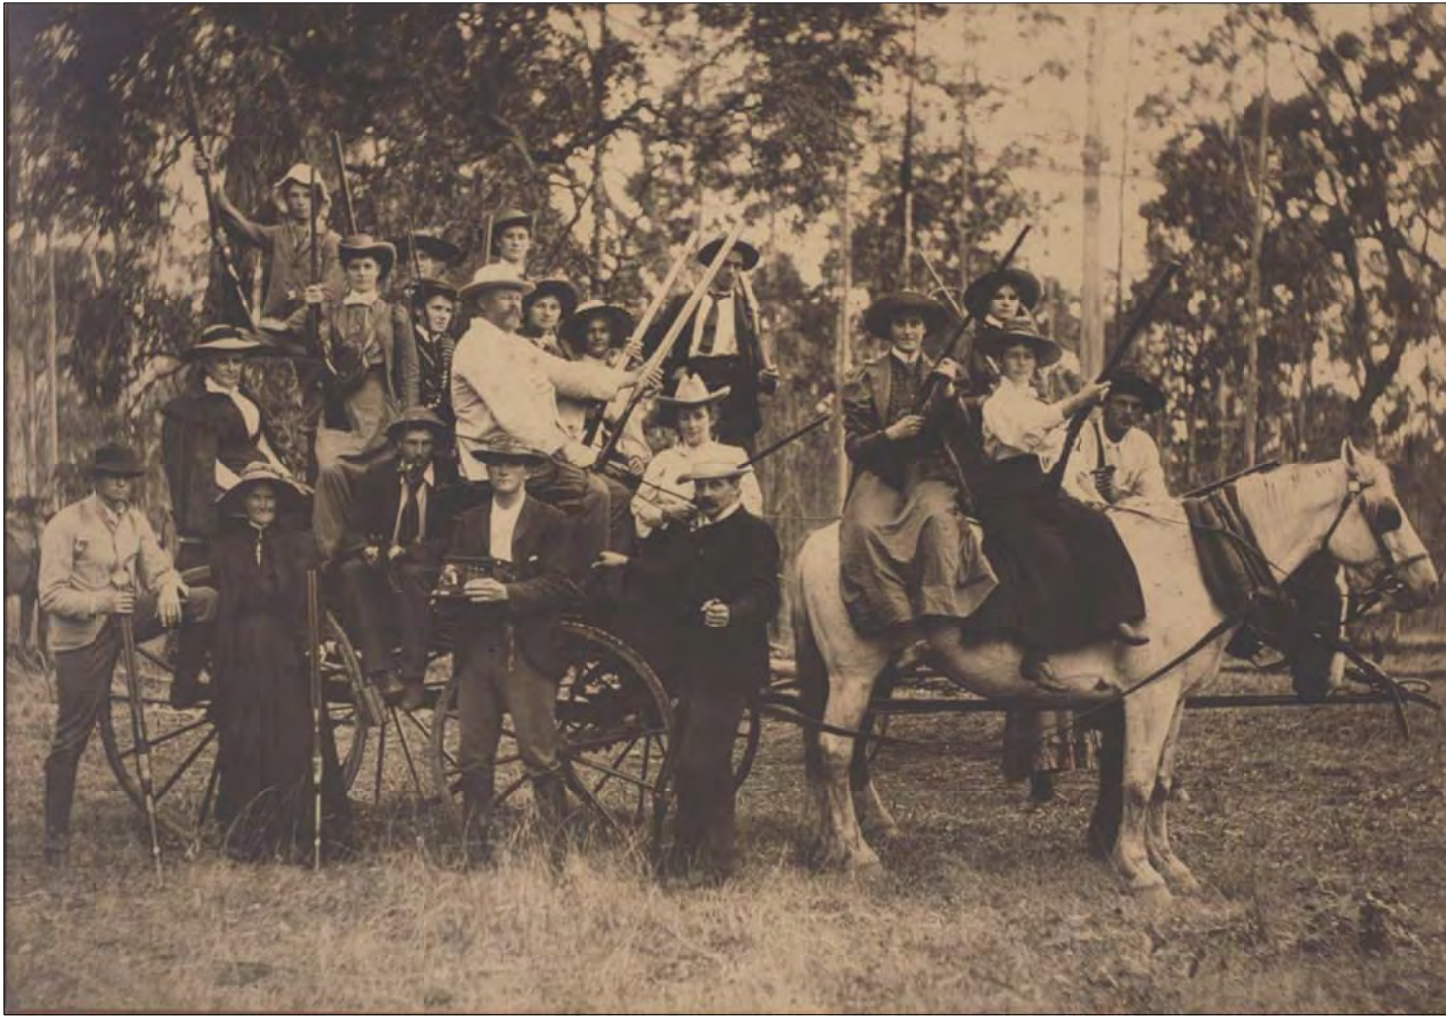
By the early twentieth century the property's outbuildings included a blacksmith's shop, a carpenter's shop, shearing sheds, stables and an engine shed. In 1920 a small creamery was also constructed (Dunne 2012:48-51).

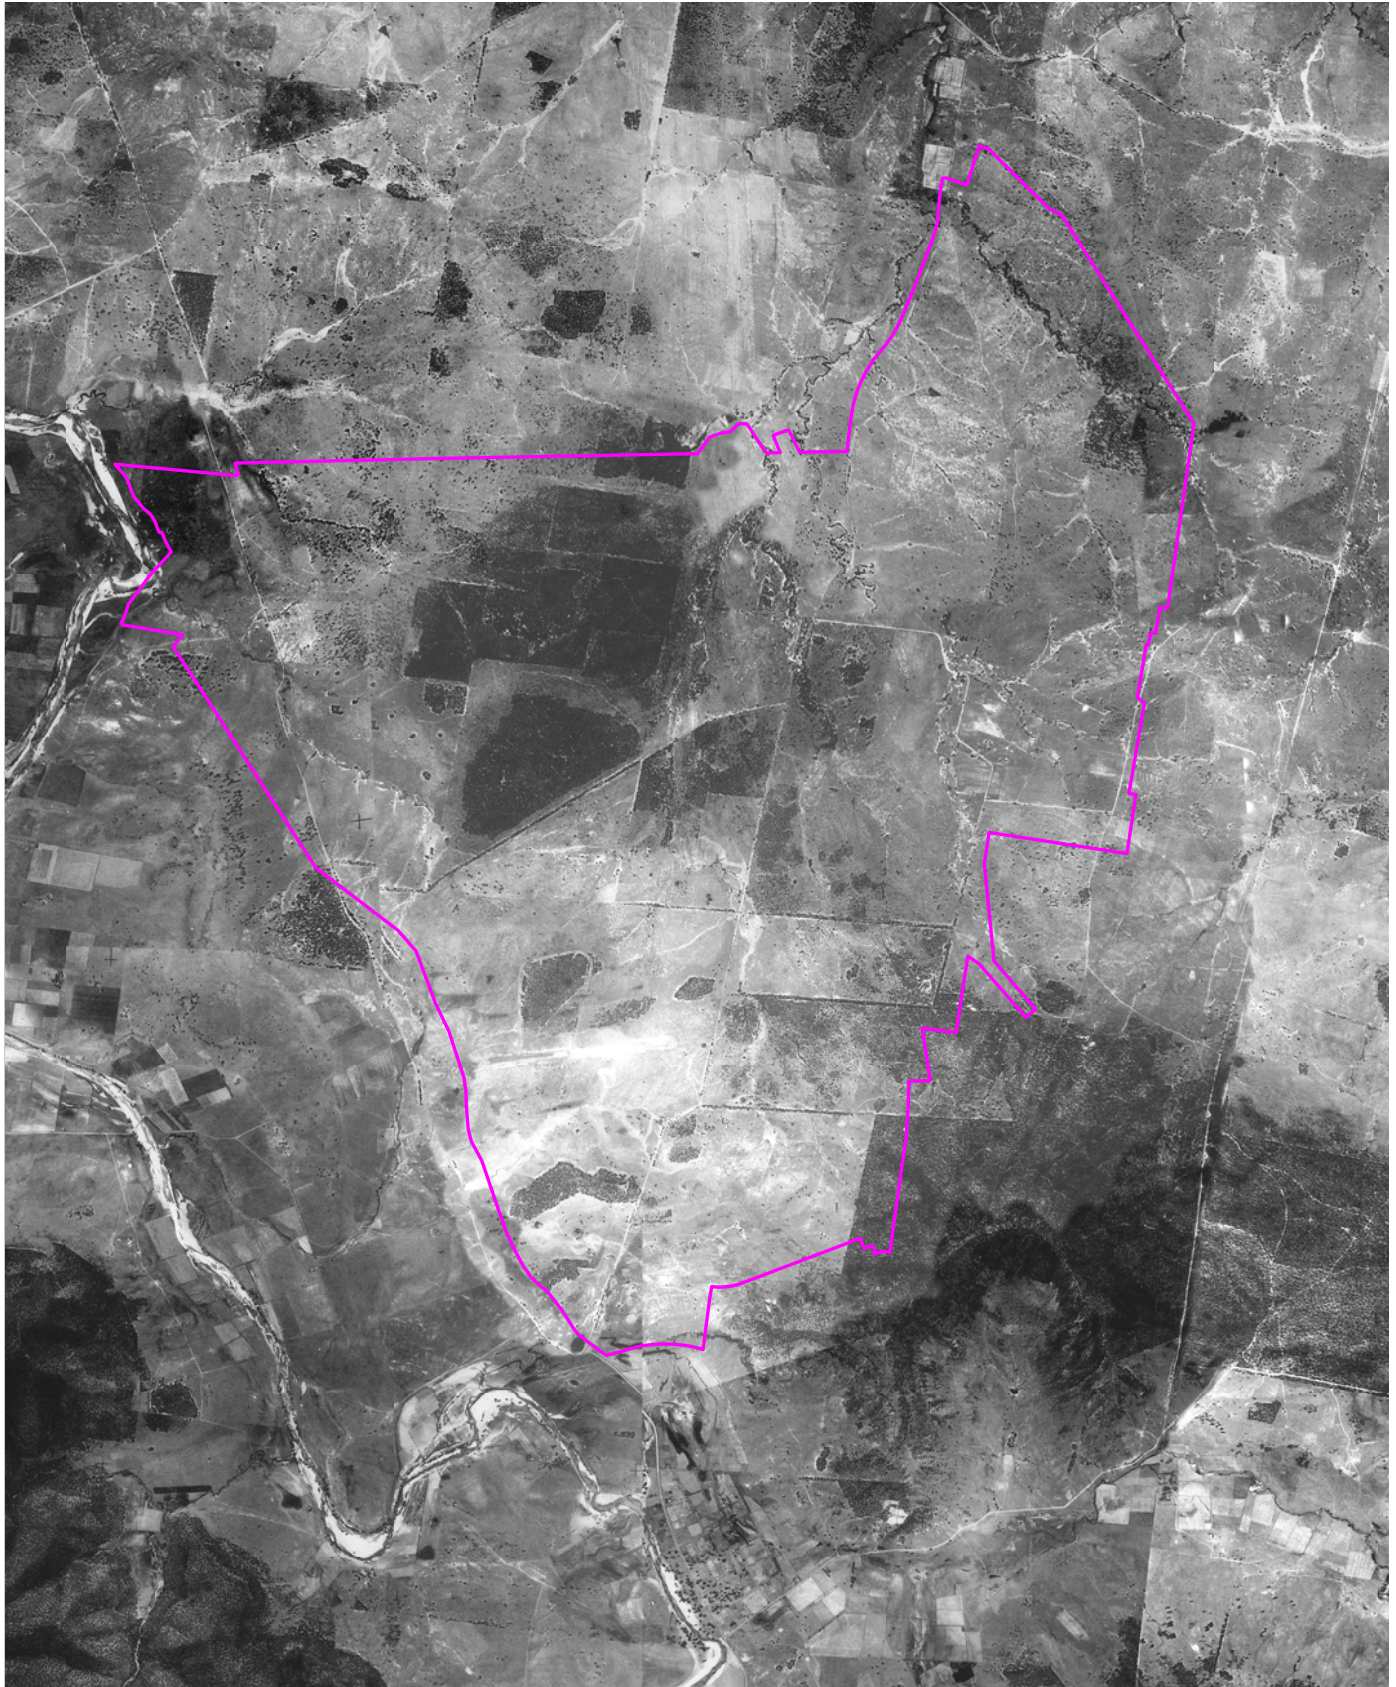
Source: Department of Lands 1952 Aerial Photography

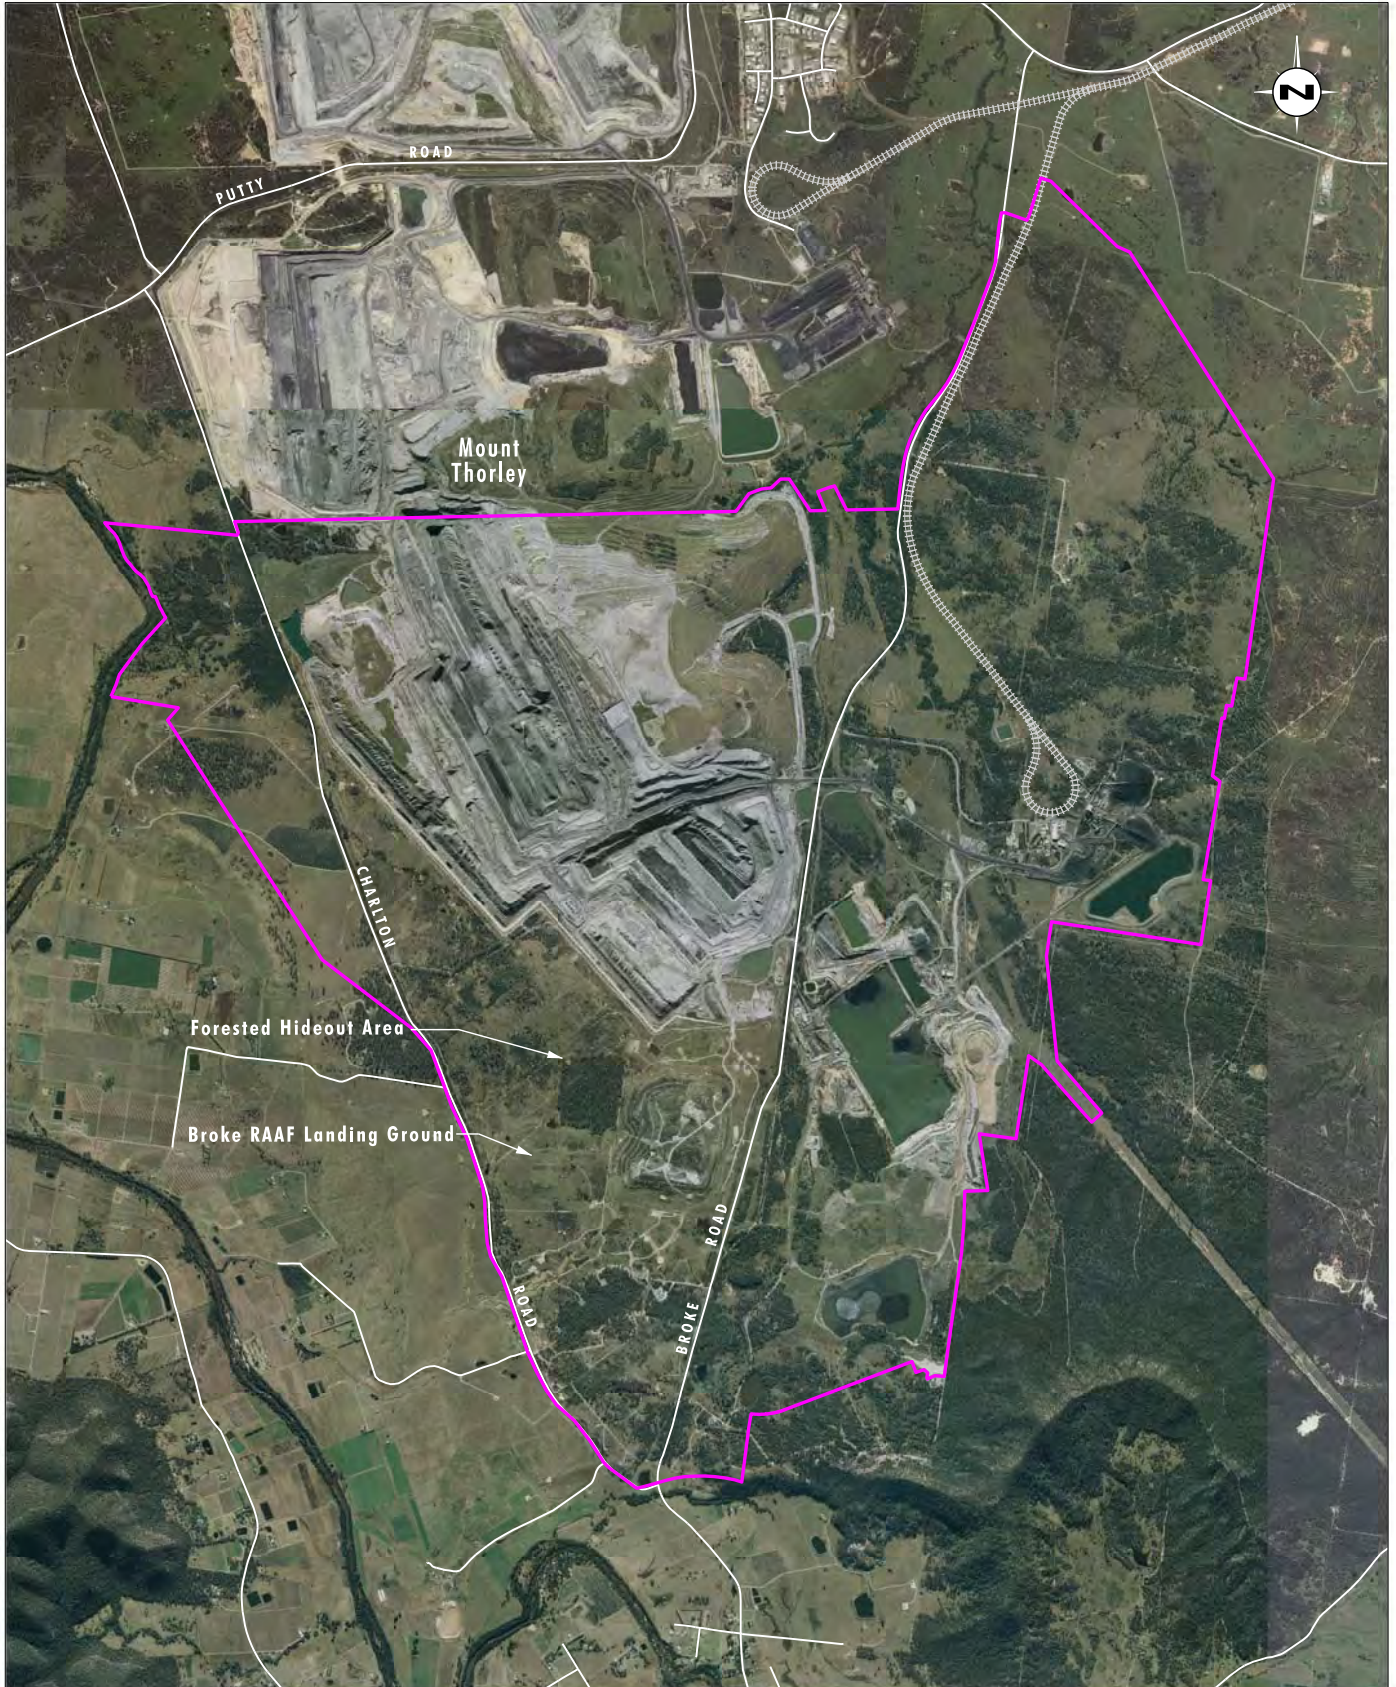
Source: AAM Pty Limited (March 2012), Xstrata Coal (NSW) Pty Ltd

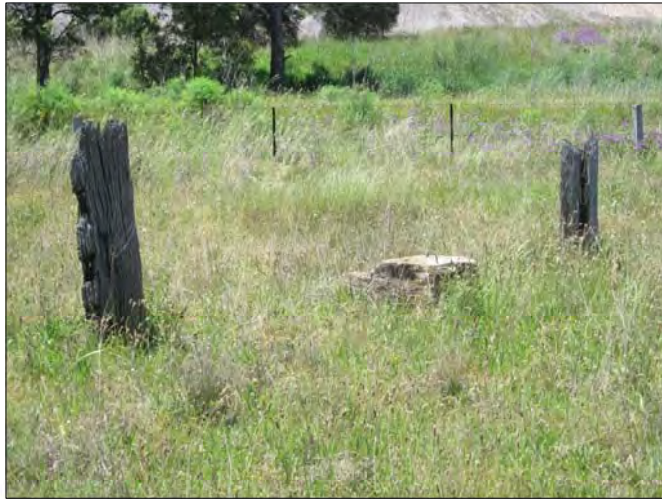
PLATE 4.1
BH1 fence posts, view to East

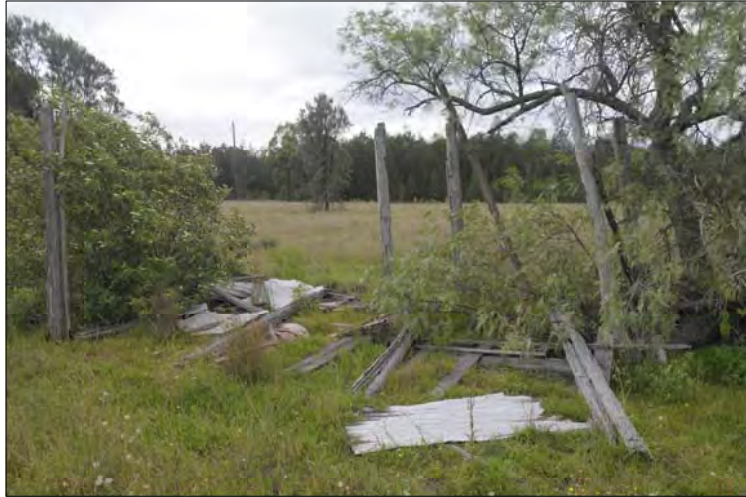
PLATE 4.13
PS2 shed remains, view to North-East

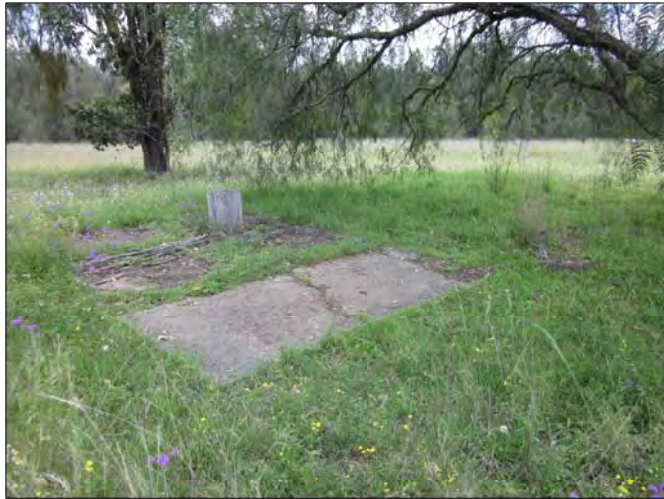
PLATE 4.21
PS8 former dairy or creamery building, view to South-West

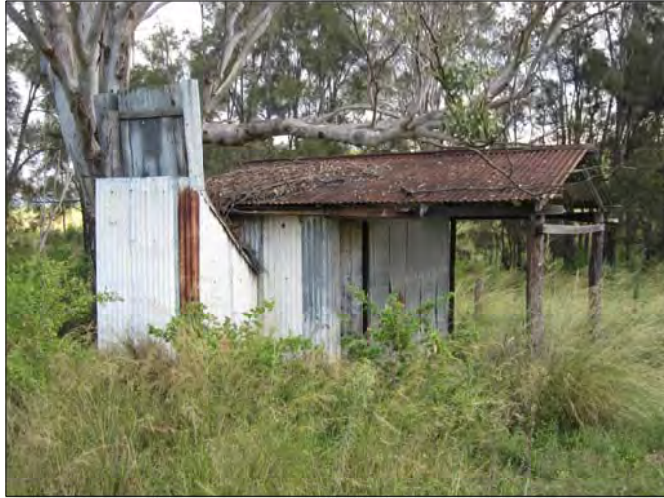
PLATE 4.33
PS17 former hut site, view to South-East

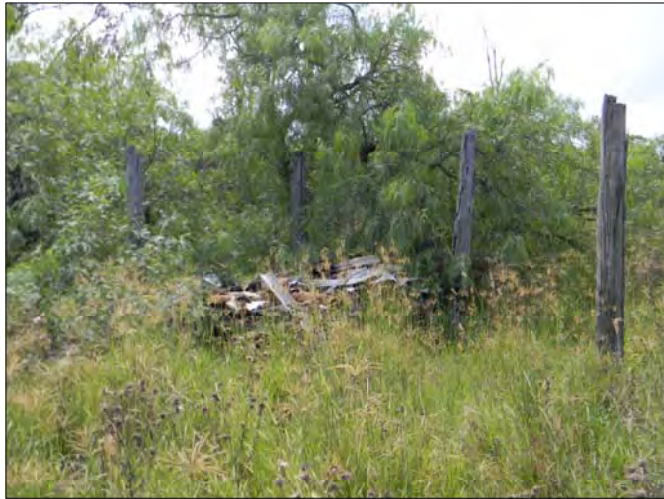
PLATE 4.37
PS19 former shed site

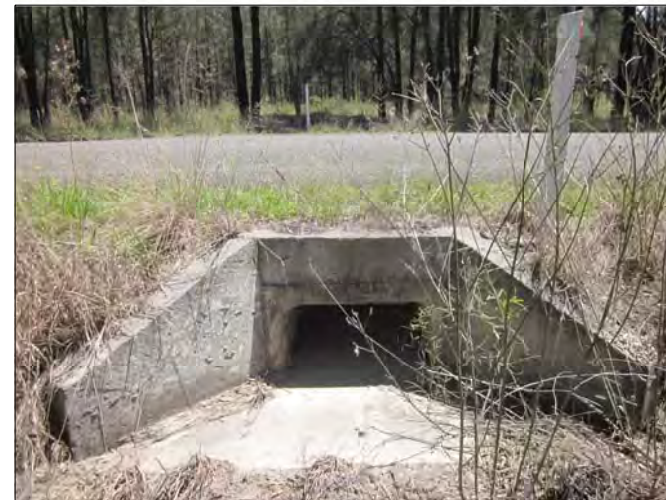
PLATE 4.44
Single rectangular-pipe culvert under Charlton Road,
within realignment area, view to South-West

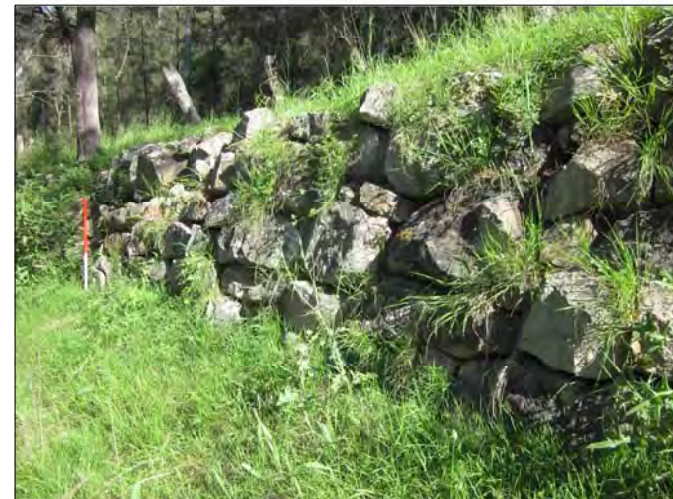
PLATE 4.68
BH13 Stone Wall alongside Monkey Place Creek, view to South
(Scale = 1 metre)

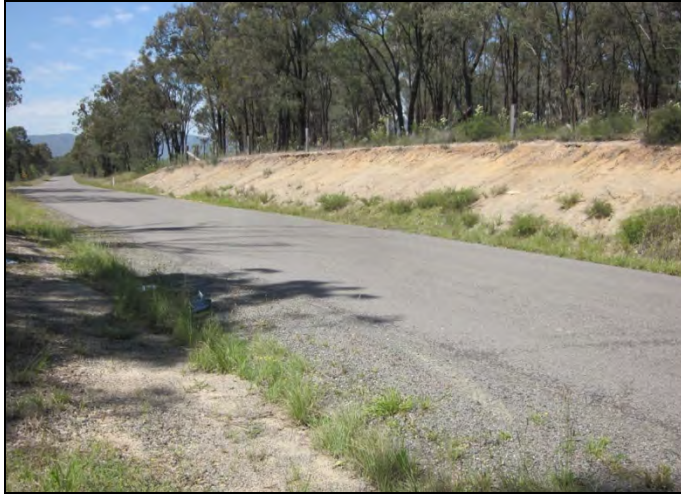
Figure 34:
The cutting, looking south at MGA 319371/6380926 (IMG 1451).

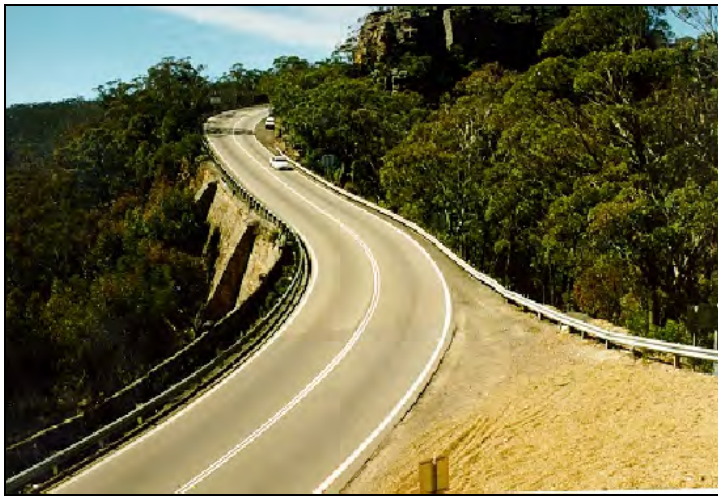
Figure 74: Victoria Pass Causeway.
State Heritage Inventory Sheet.
