MANGOOLA OPEN CUT

Annual Review 2022

1 January to 31 December 2022

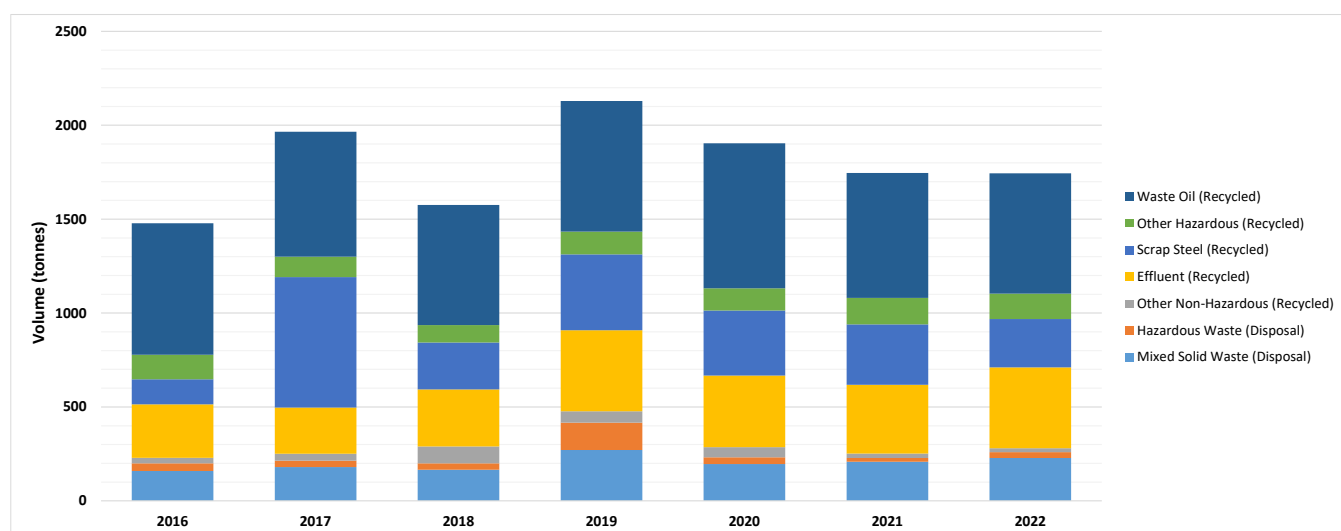
Figure 4-2 2016-2022 Waste Streams Generated

The major waste streams during the reporting period were waste oil (640 tonnes), scrap steel (257 tonnes), mixed solid waste (228 tonnes) and effluent (430 tonnes).

A summary of waste disposal from 2016 to 2022 is presented in **Figure 4-2**.

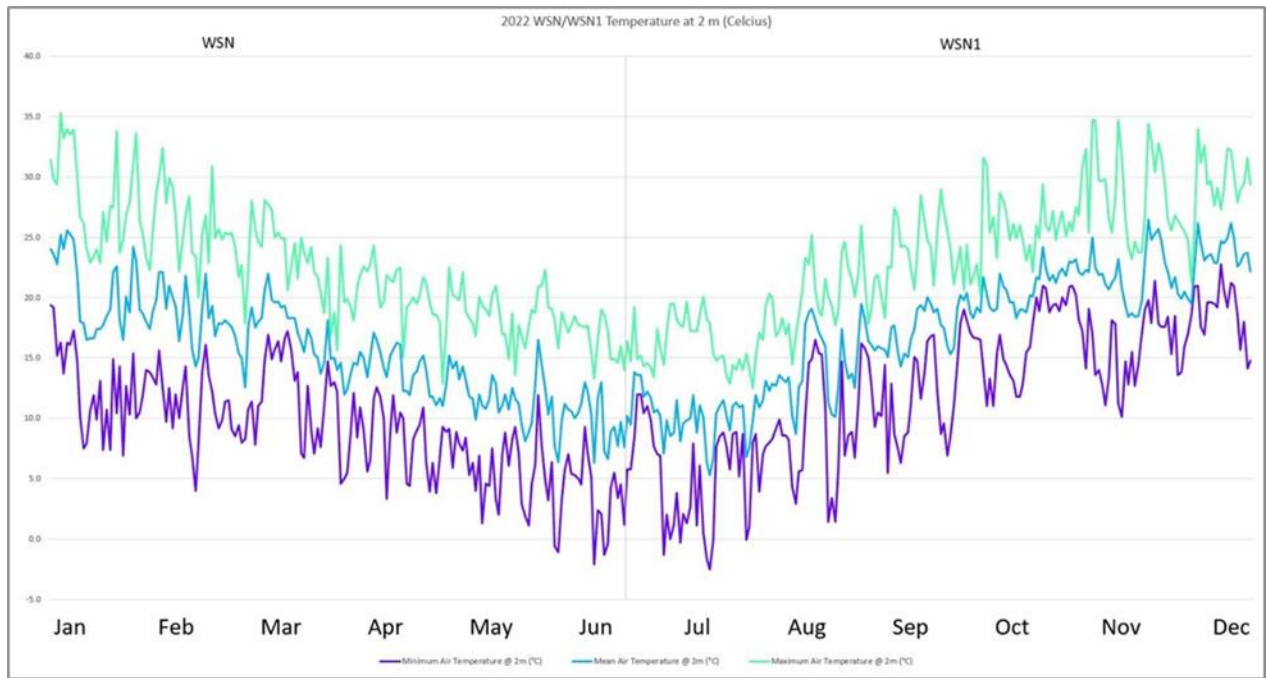
Figure 6-3

As shown in **Figure 6-3**, the daily minimum and maximum 2 metre above surface level temperatures at WSS ranged from 0.0 °C to 35.8°C respectively, with an average daily maximum of 22.5 °C, which is cooler than the 2021 daily average of 23.2 °C. Relative humidity during 2022 ranged from 12.5% to 100%.

WSN/WSN1 2022 2 m Temperature Data

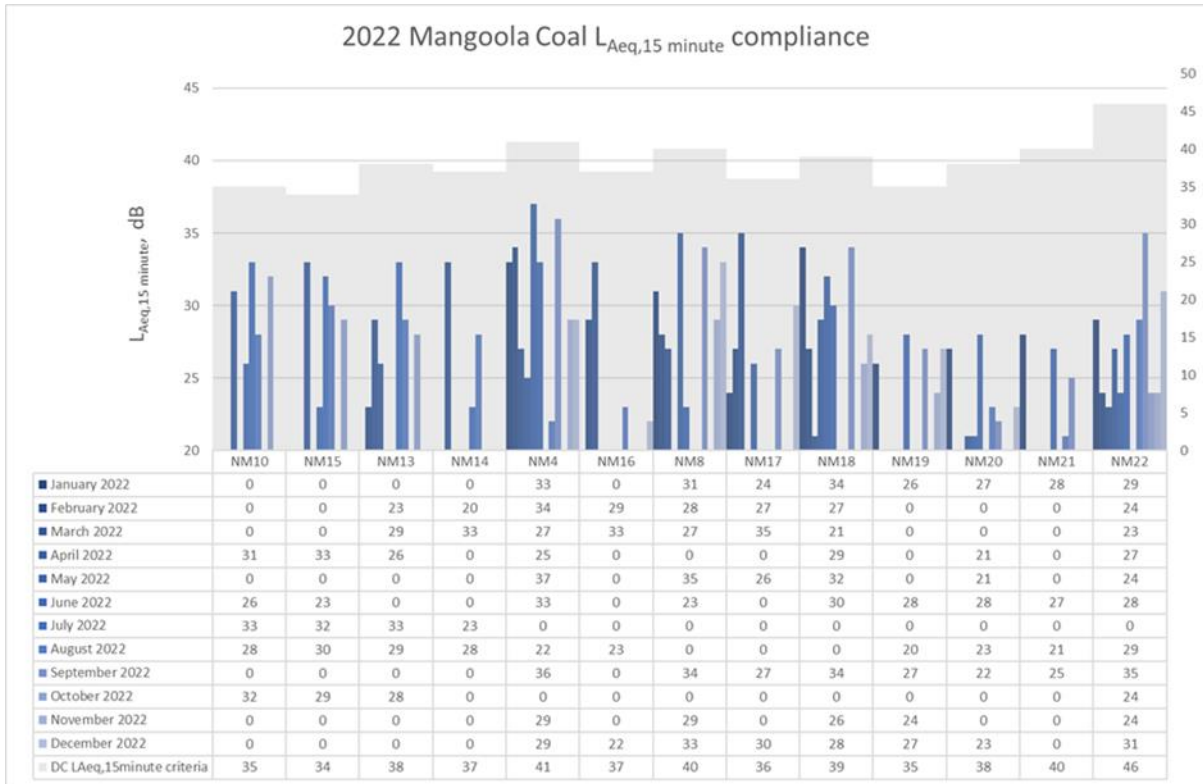
Figure 6-6 Annual Review Attended Noise Monitoring Compliance Results ($L_{Aeq}(15\text{minute})$)

Figure 6-6 and **Figure 6-7** compare the 2022 noise levels recorded at Mangoola with relevant approval criteria. A graph of the December day period levels has not been included as the site was inaudible at all monitoring locations that month.

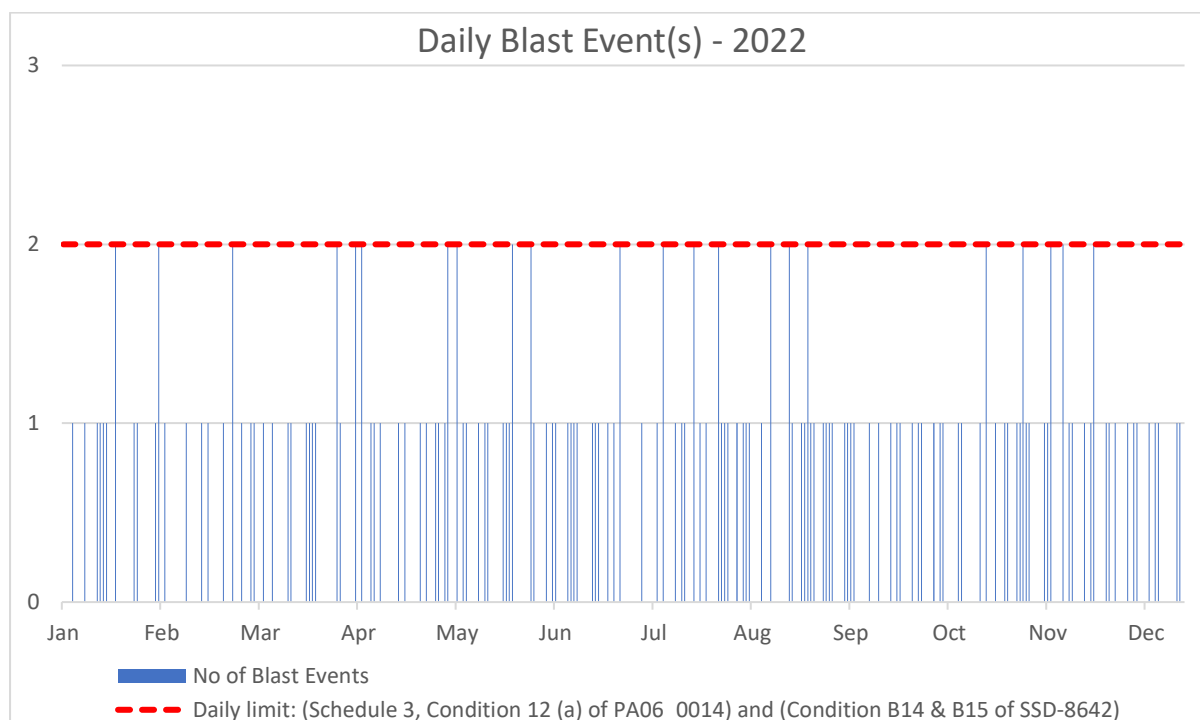
Figure 6-9 Daily Blast Events

During the reporting period there was an average of 3.2 blast events per week, which is compliant with Schedule 3, Condition 12(b) of MP 06_0014 and Condition B14 of SSD-8642, which allow a maximum of 6 blasts per week, averaged over a calendar year. A total of 167 blast events occurred during the reporting period and no more than 2 blast events per day which is compliant with Schedule 3, Condition 12(a) of MP 06_0014 and Condition B14 of SSD-8642, as shown by **Figure 6-9**.

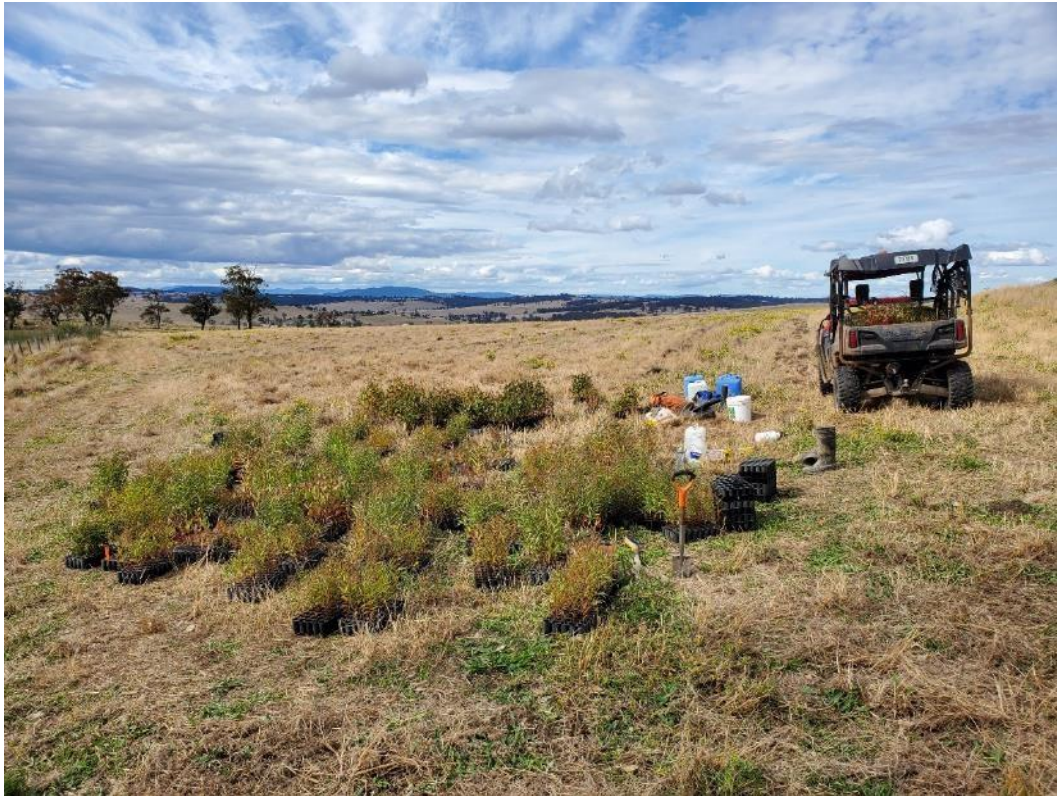
Photo 6-1 Planting NC-05 Offset Area 2022

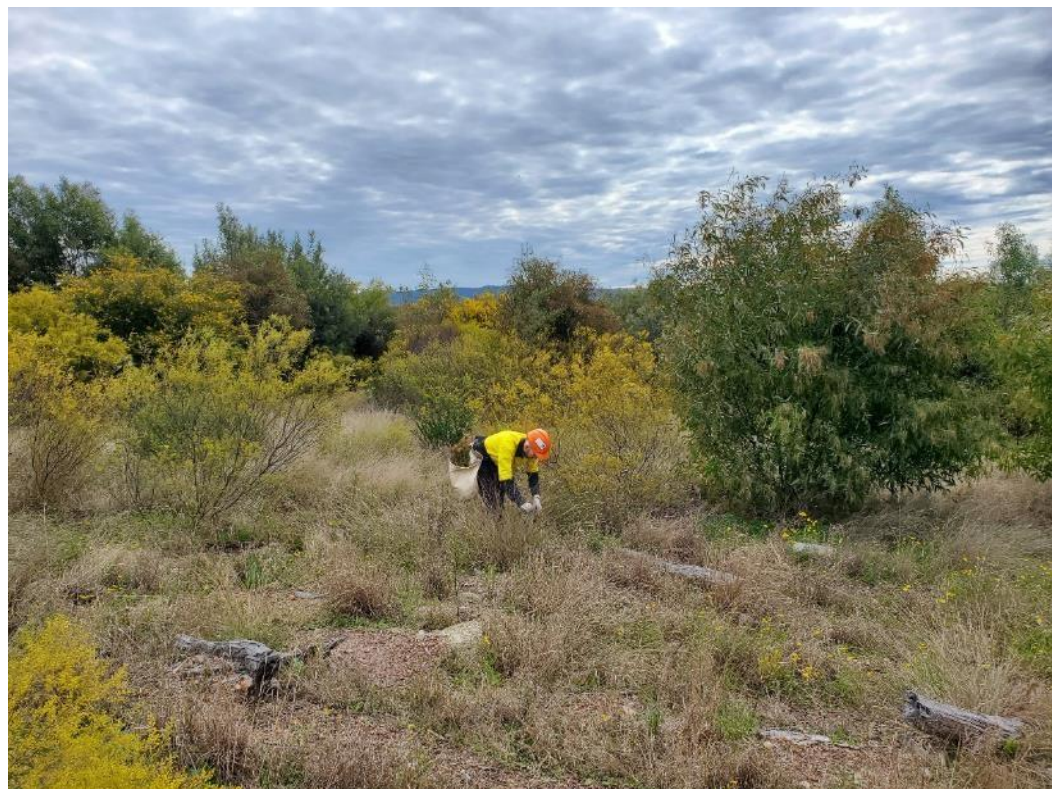
A further 11,000 trees and shrubs were infill planted throughout the rehabilitation areas to improve diversity in accordance with recommendations made in the 2021 walkover inspection report. Areas

planted were in North Pit rehabilitation areas SGL06 and IBW06 and South Pit rehabilitation area IBW11. Infill planting was undertaken in August 2022 to coincide with offset planting works.

Photo 6-2 Infill Planting Throughout the South Pit Rehabilitation Areas 2022

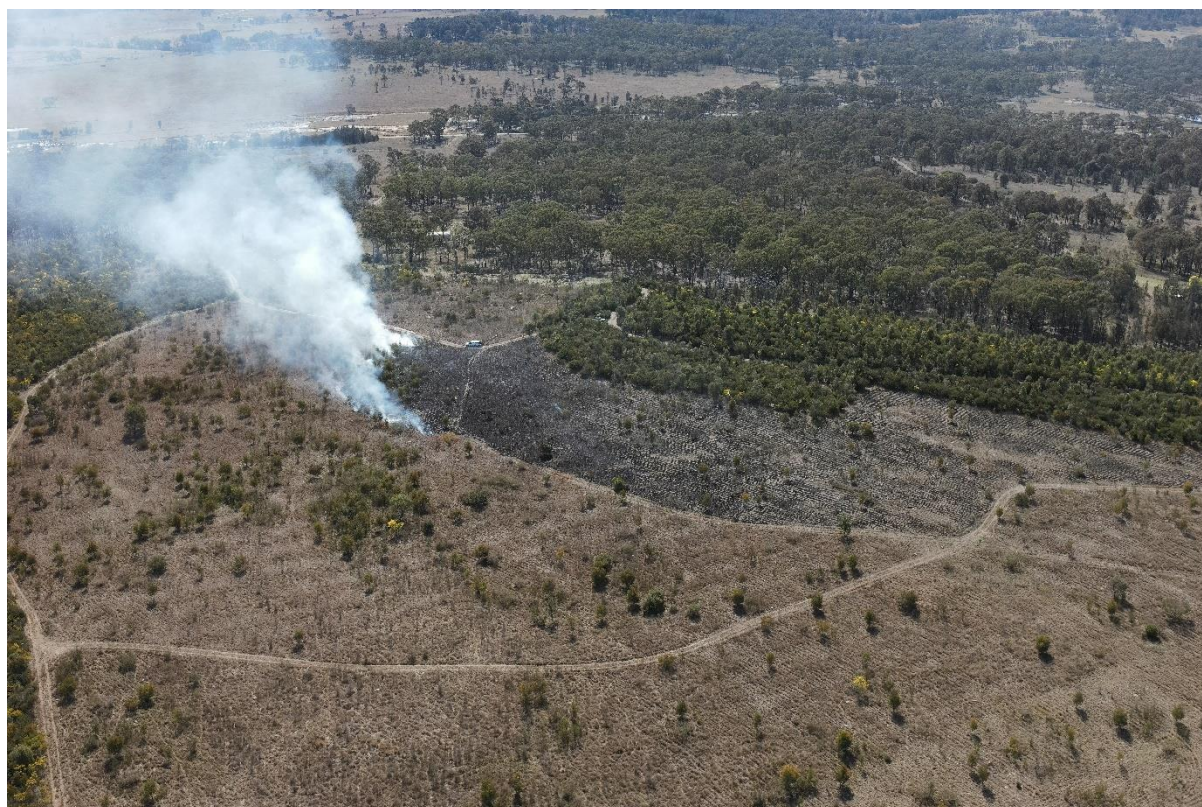
Mangoola has undertaken and is planning to undertake further trial ecological cool burns in areas of rehabilitation. The purpose of the burns is to evaluate the impact of the burns on the flora assemblages, secondary succession, fire resilience, soil chemistry, weed control and hazard reduction potential. Pre-burn ecological monitoring and soil testing has been undertaken and will be followed up with post-burn monitoring to evaluate the impacts. An image from the cool burn undertaken in the North Pit rehabilitation in August 2022 is provided in **Photo 8-1**.

Photo 8-1 Cool burn within the Northern Rehabilitation Area

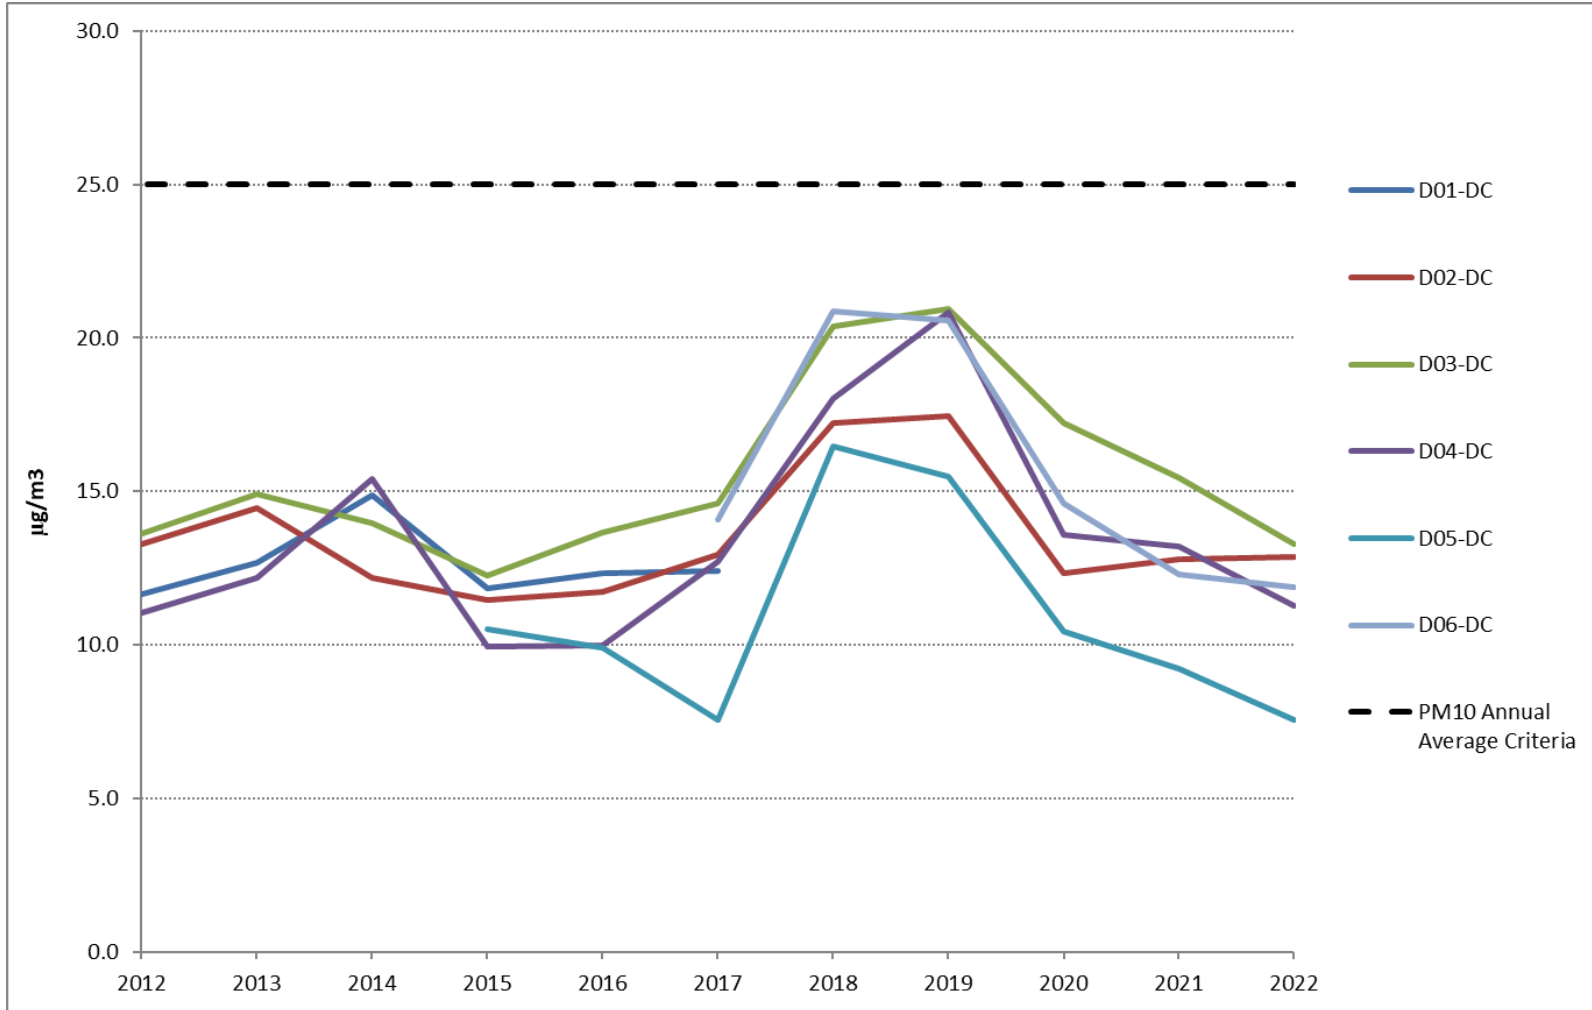
Long Term Annual Average PM10 TEOM Monitoring Results – 2012 to 2022

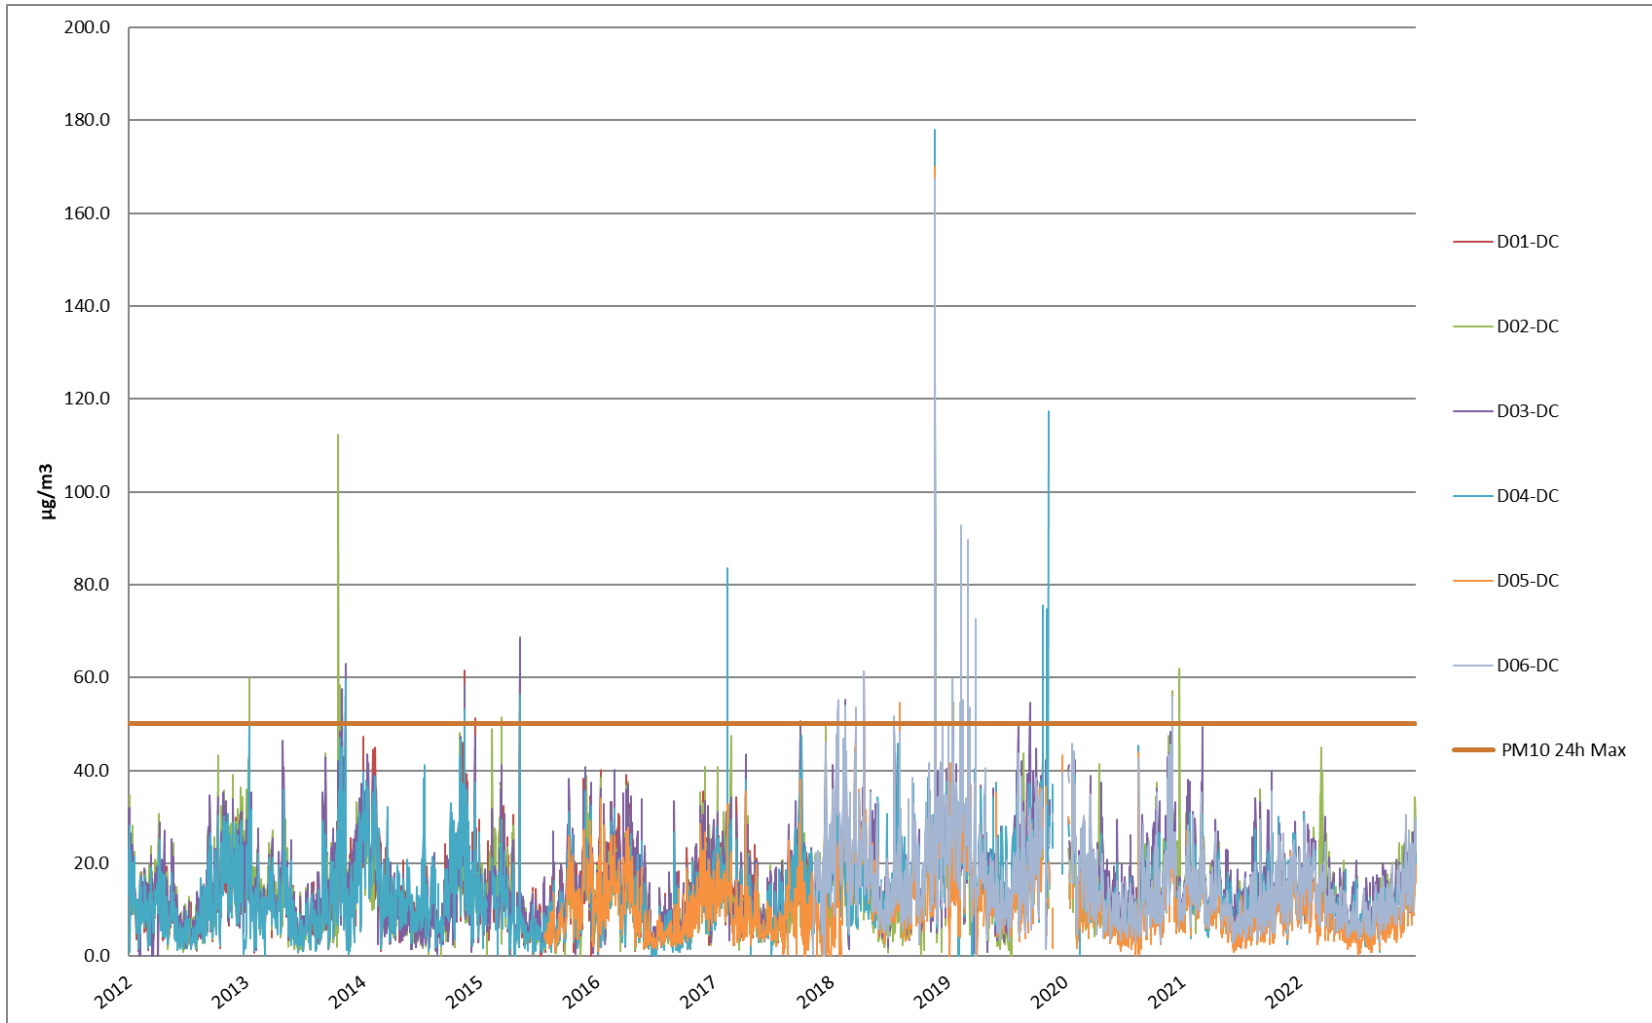
Long Term 24hr PM10 TEOM Monitoring Results – 2012 to 2022

generally increasing during 2018-2019 which correlates with low rainfall and the ongoing drought conditions. Increased rain during 2020 decreased results to be consistent with those from 2015 to 2017. Ongoing rain during 2022 saw 24hr maximum TEOM (averages) remain consistent with those in 2021.

It is noted that a 24-hr average PM₁₀ concentration of 63.0 µg/m³ was recorded at D02-DC on 26 March 2022. An investigation was undertaken on 29 March 2022, which identified a large number of insects within the TEOM unit which were suspected to have spoiled the sample collected during the 24-hr period on 26 March 2022. The sample was deemed contaminated and has therefore been excluded from the annual average and maximum 24-hr results presented in **Table 6-5**. For reference, the maximum PM₁₀ 24-hr average across the Mangoola air quality monitoring network on 26 March 2022 was 9.3 µg/m³, recorded at D06-DC.

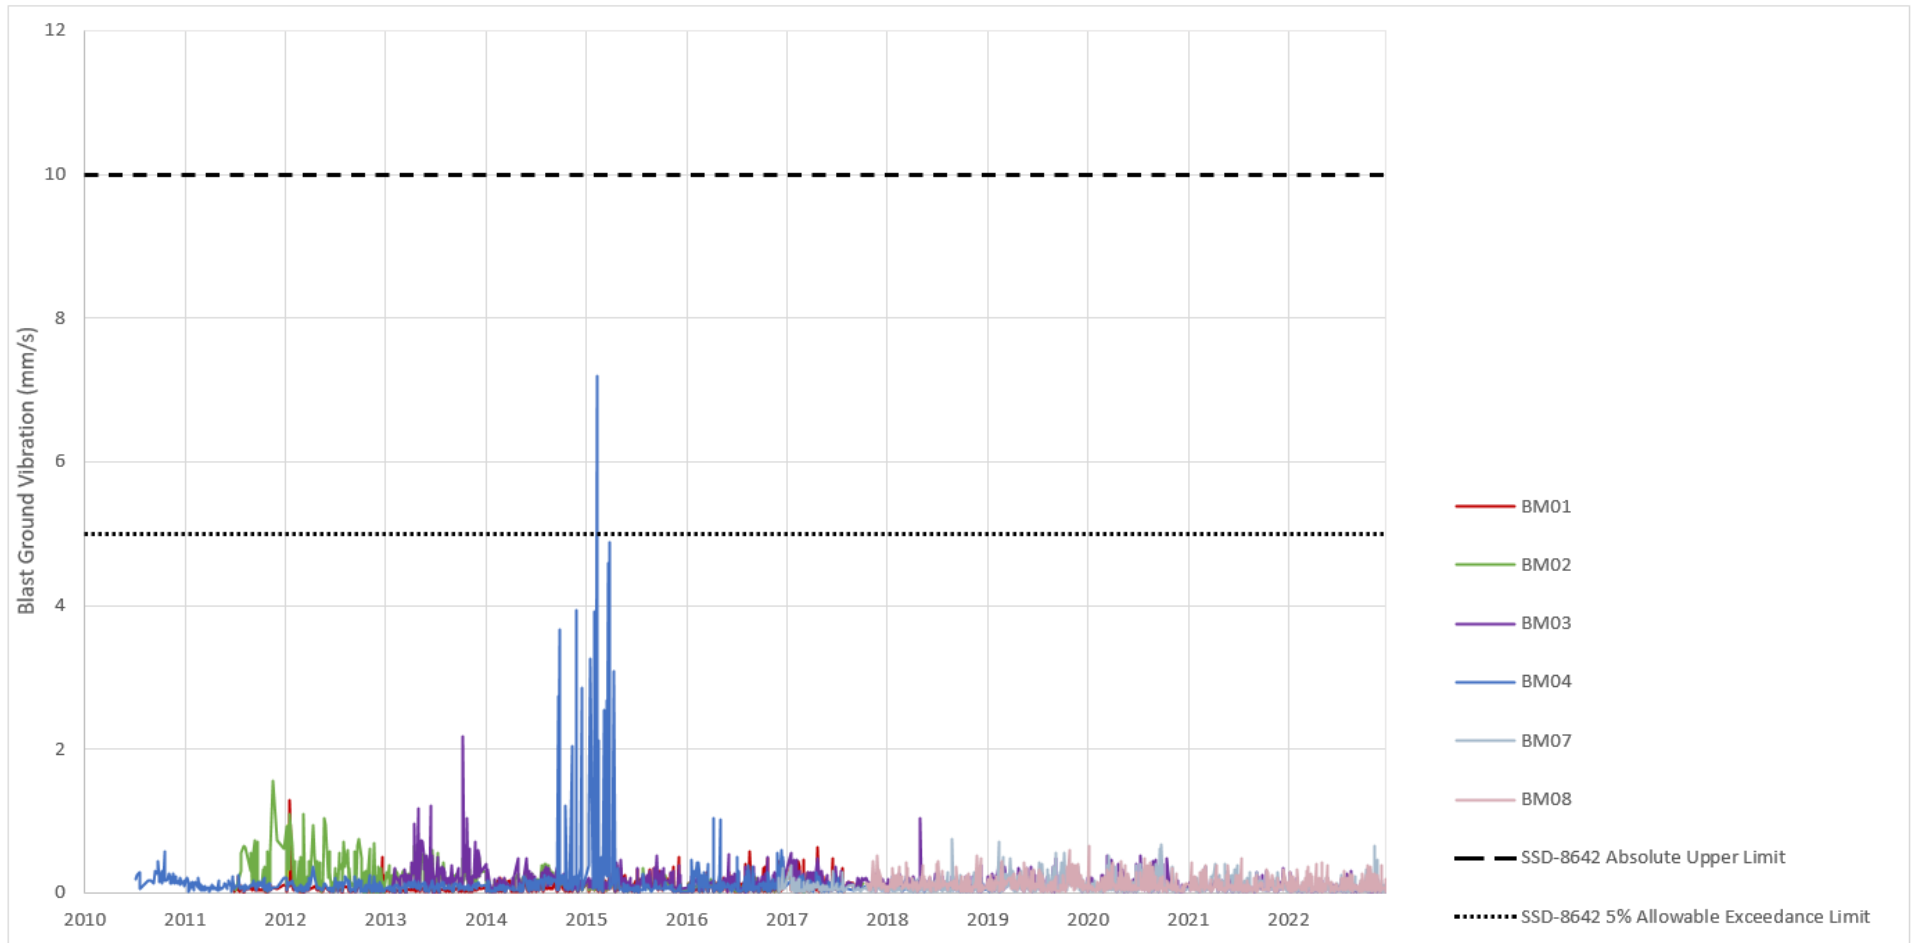
Long Term Blast Vibration Monitoring – 2010 to 2022 at BM01 to BM04, BM07 & BM08

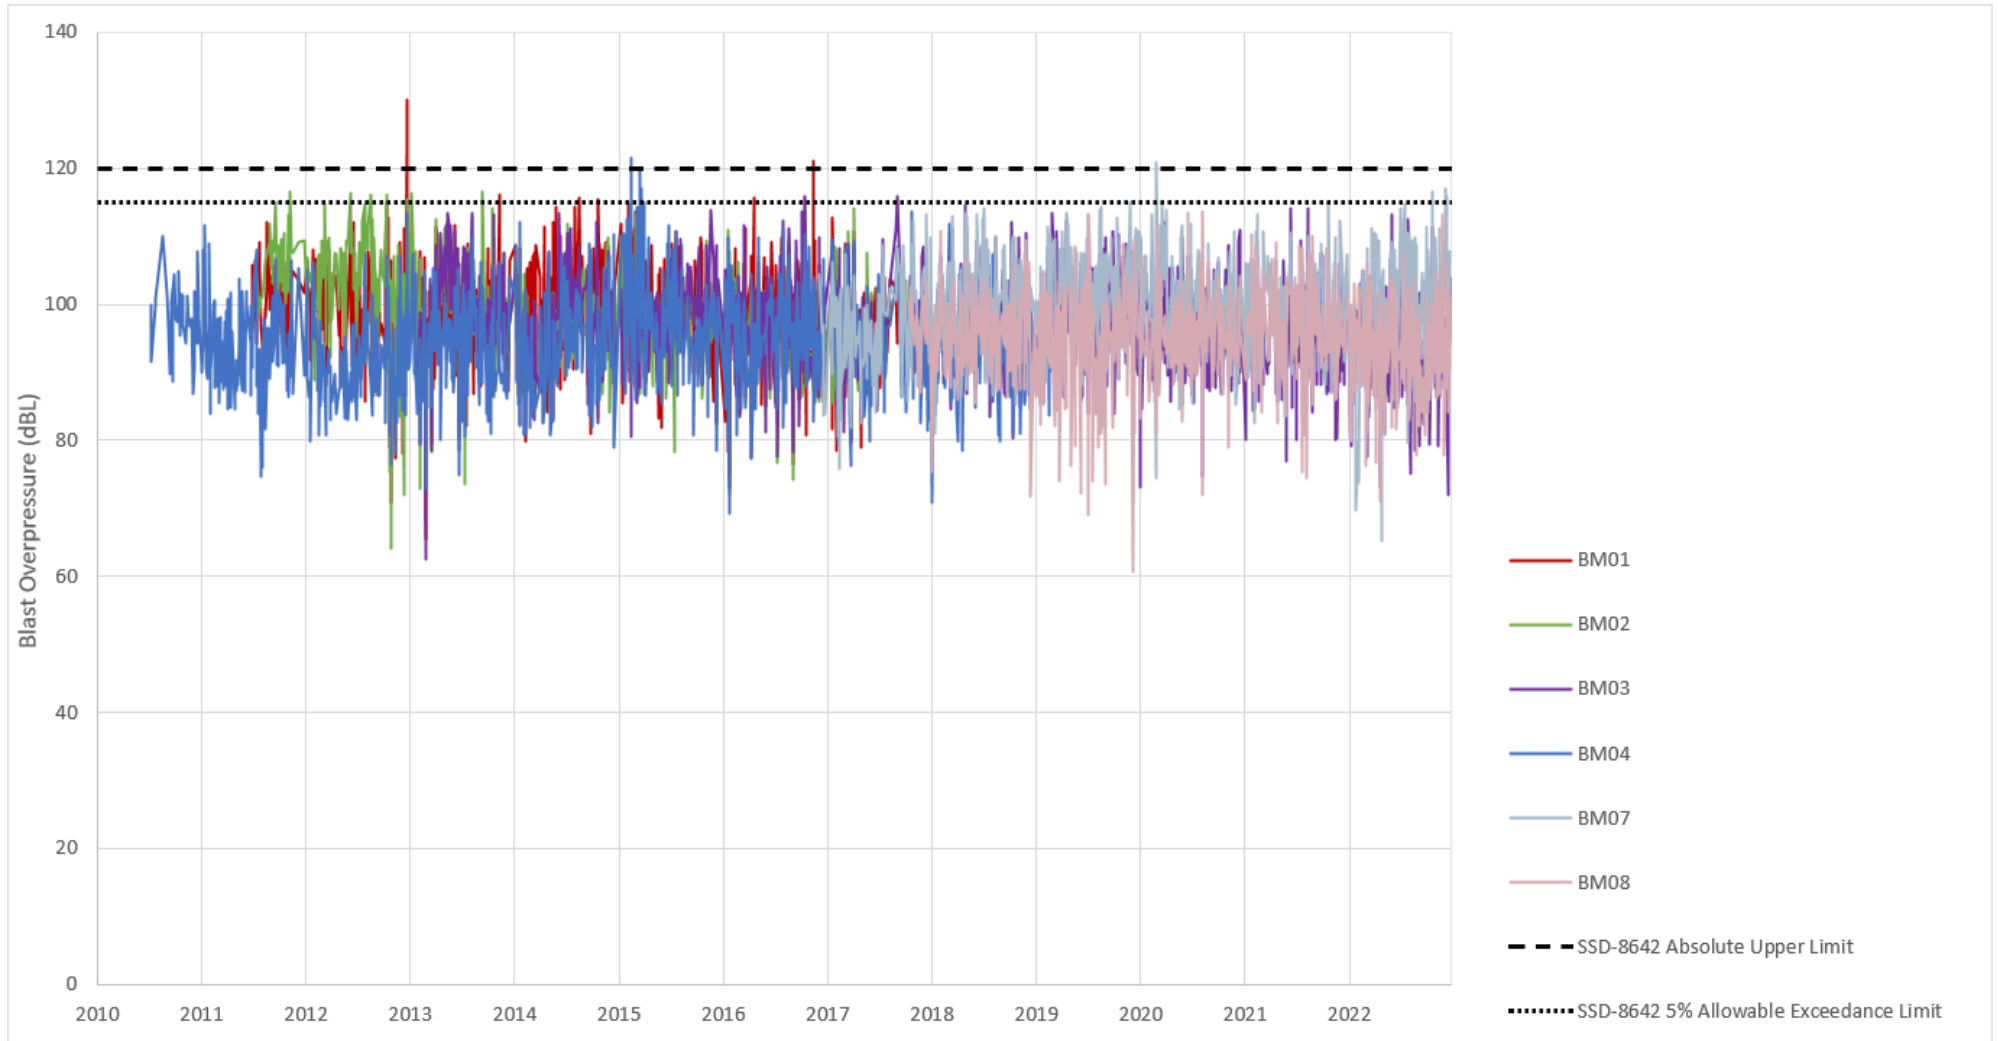
Long Term Blast Overpressure Monitoring – 2010 to 2022 at BM01 to BM04, BM07 & BM08

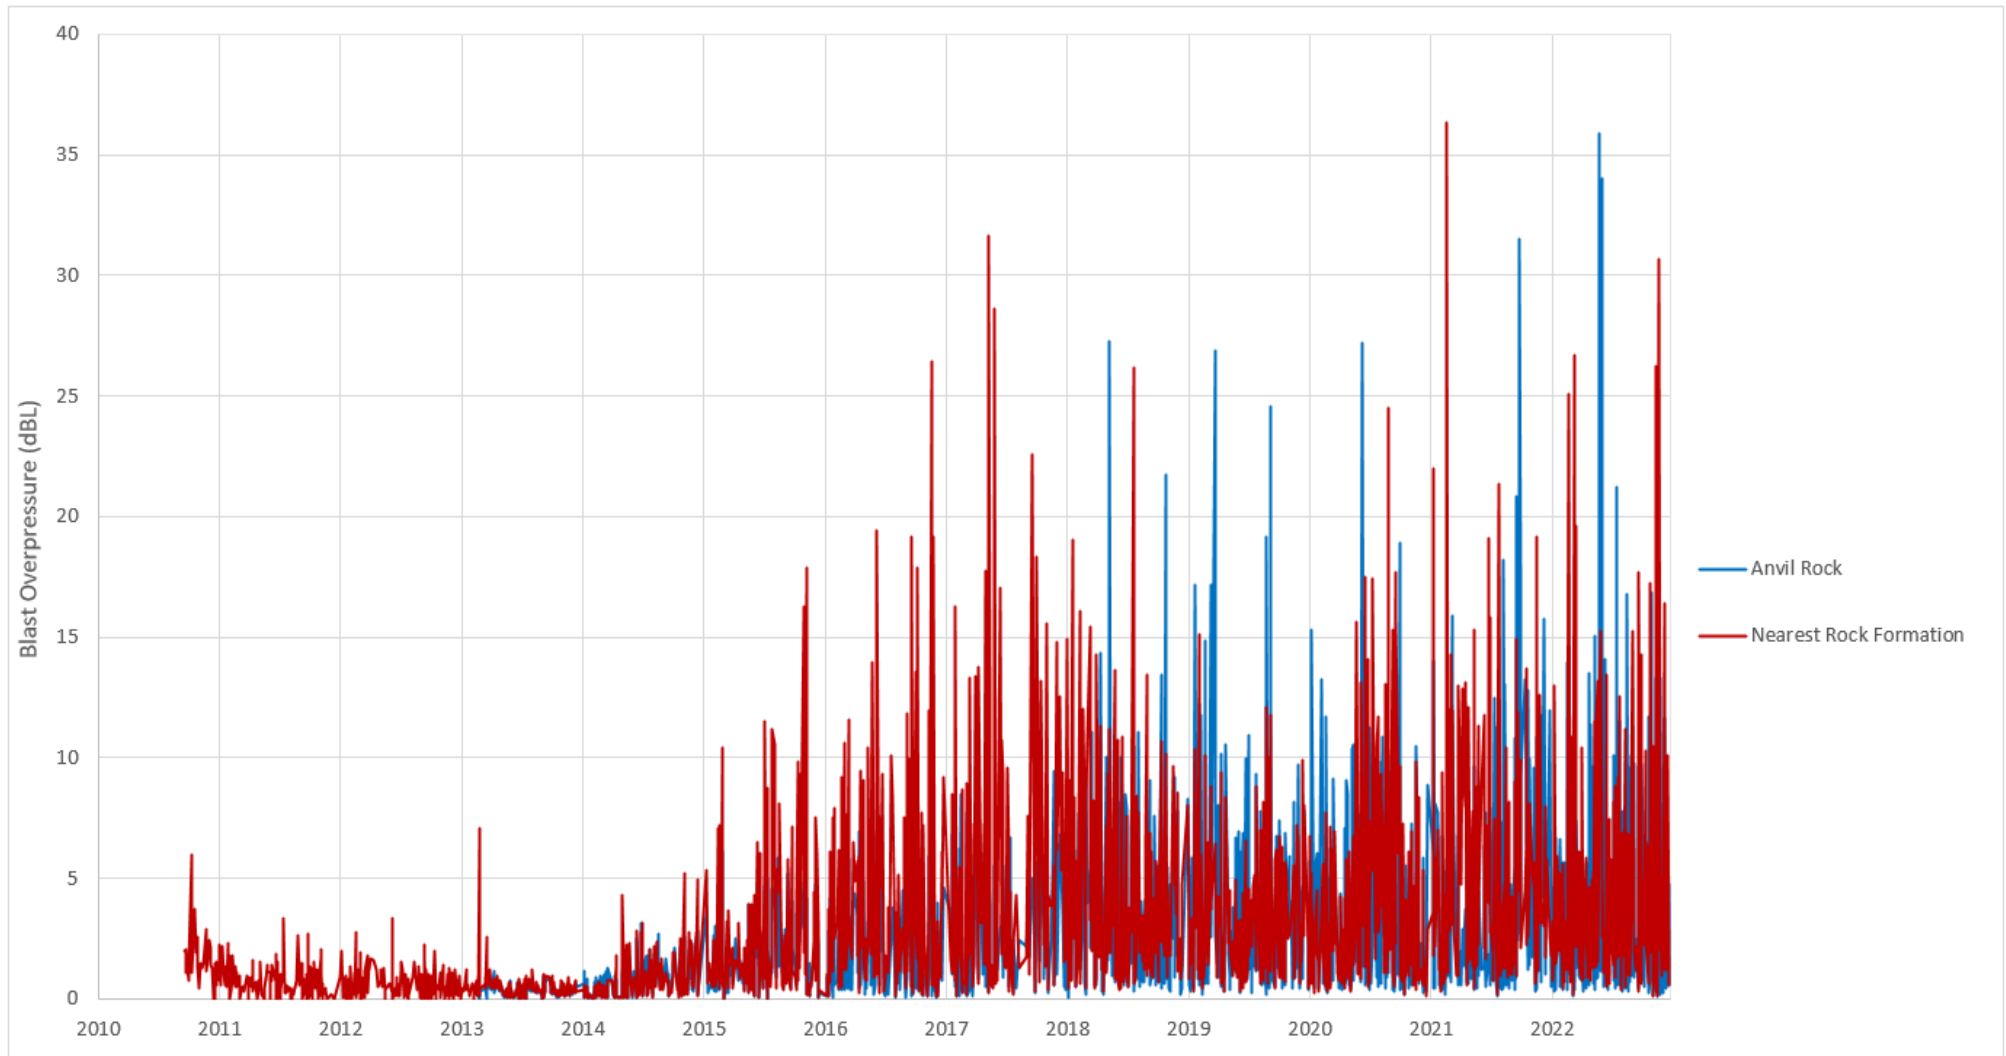
Long Term Blast Vibration Monitoring – 2010 to 2022 at Representative Locations of Anvil Rock and the Nearest Rock Formation
