Annual Review 2022

Name of operation	Mt Owen Glendell Operations
Name of operator	Mt Owen, Ravensworth East and Glendell Mines
Development consent/ project approval	MGO Mining Operations Plan (Mt Owen, Glendell and Ravensworth East), DA SSD-5850 (Mt Owen and Ravensworth East) and DA 80/952 (Glendell).
Name of holder of development consent/ project approval	Mt Owen Pty Limited
Mining lease and exploration lease #	Mt Owen & Rav East – CCL715, CL383, ML1355, ML1415, ML1419, ML1453, ML1475, ML1561, ML1608, ML1629, ML1673, ML1694, ML1741, ML1802, MLA512, MLA513, EL6254, EL5824, A268, A423, A429, AL08 Glendell – ML1629, ML1673
Name of holder of mining lease	Mt Owen Pty Limited
Mining lease and Exploration Lease #	Glendell – CL358, MPL343, ML1410, ML1476, EL6594, EL8184
Name of holder of mining lease	Glendell Tenements Pty Ltd
Water licence #	Refer list provided in Table 31
Name of holder of water licences	Mt Owen Pty Limited

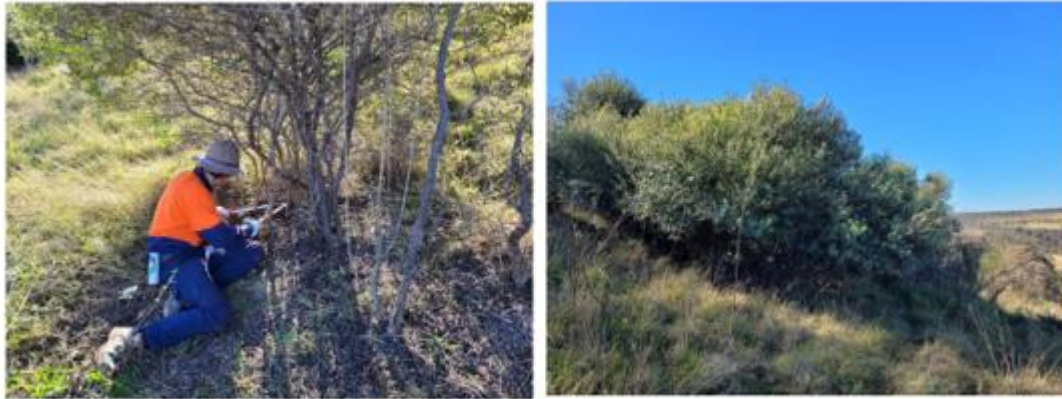
Figure 13: African Olive control

A summary of weed management works undertaken in MGO BOAs during the reporting period is included in *Table 32*. During 2022, successful campaigns were carried out on abundant high threat weeds African Olive and Coolatai grass within MGO's BOAs. Before and after images can be viewed below in *Figure 13* and *Figure 14*.

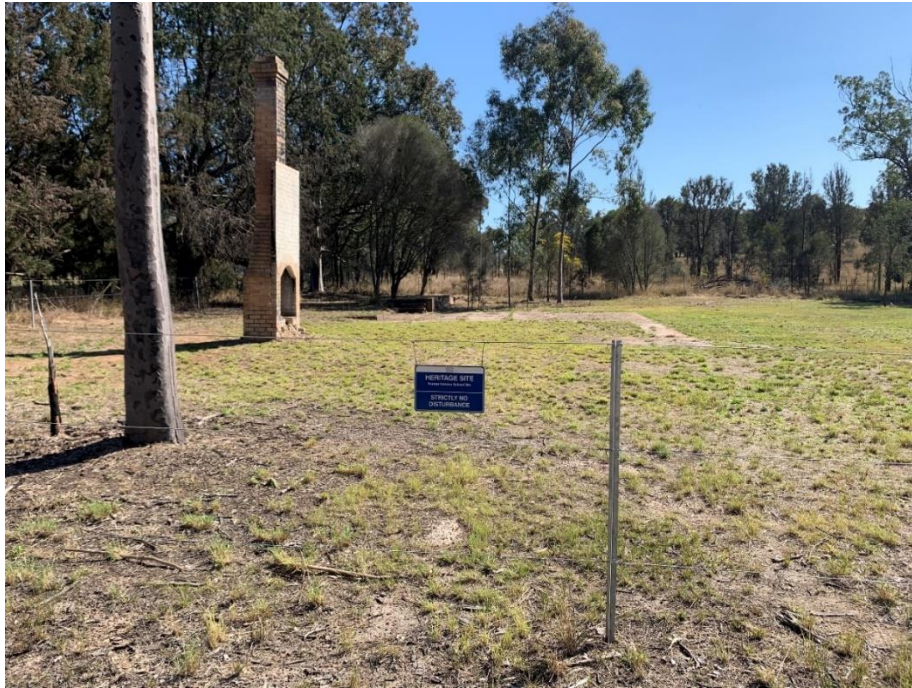
Figure 16: Hebden Public School Remains.

Monitoring during the reporting period found that sites are well-preserved with minimal management recommendations required, such as the Hebden and Ravensworth Public School managed ruin sites pictured in *Figure 16* and *Figure 17*.

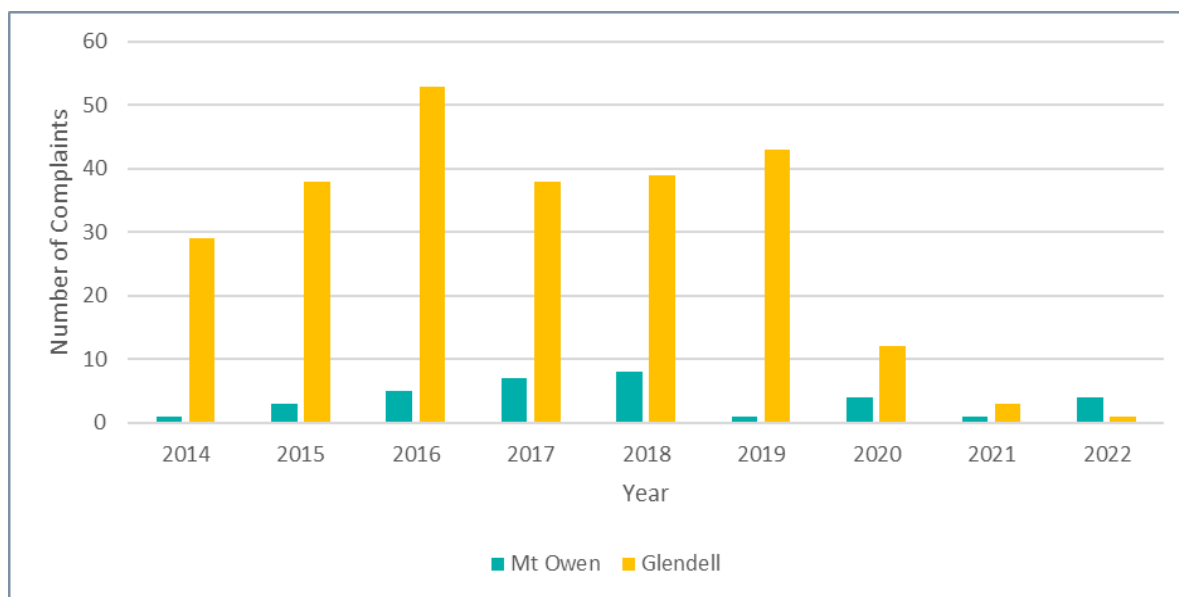
Figure 24: Comparison of Complaints Received at MTO and Glendell from 2014 to 2022

During 2022, noise and air quality related complaints made up the majority. However, complaints often aligned with unsuitable meteorological conditions such as temperature inversions. Temperature inversions are monitored across MGO daily to reduce these impacts. Furthermore, MGO operates a real time noise monitoring system (with alarms) to assist mining Supervisors in adjusting operations, which ultimately reduces noise during periods of increased risk.
