## 4. Existing environment

NC Coal Company Pty Limited  
Newlands Closure Project - Cerito Creek Permanent  
Diversion System

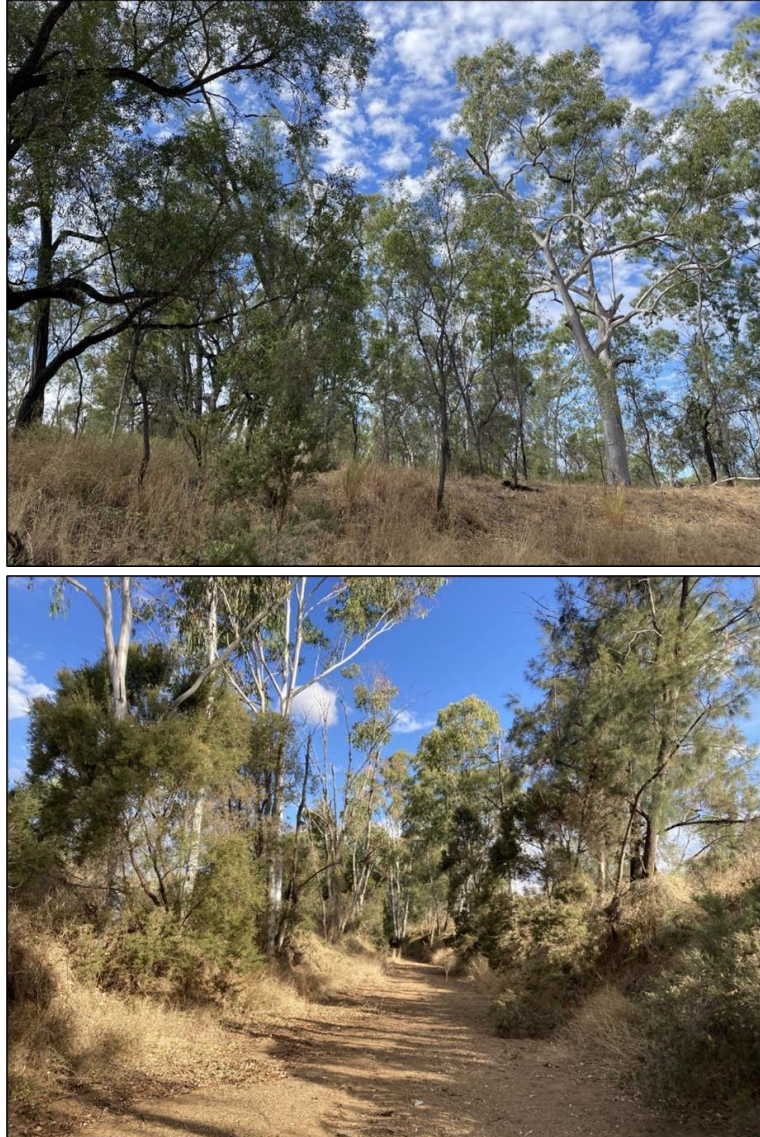
| Habitat type | Description | Representative photograph |
|---|---|---|
| Eucalypt woodlands along main creeks | <ul style="list-style-type: none"> <li>– Regrowth and remnant woodlands of Queensland blue gum along creek edges and/or floodplains. Other canopy and sub-canopy species included Moreton Bay ash, <i>Casuarina cunninghamiana</i> (river sheoak), swamp box and black tea tree.</li> <li>– The shrub layer within this habitat type is generally sparse but, where present, included black tea tree, <i>Cassia brewsteri</i> (Leichhardt bean) and <i>Ficus coronata</i> (sandpaper fig). The ground layer is typically dominated by <i>Megathyrsus maximus</i> (Guinea grass).</li> <li>– Associated with RE 11.3.4, 11.3.4a and 11.3.25.</li> <li>– Shelter habitat in the form of large hollow-bearing trees containing small and large hollows, leaf litter and logs, creek banks, dense grass cover. The hollows provide roosting and breeding habitat for a diverse range of bird and arboreal mammals as well as micro-bat species.</li> <li>– Large hollow-bearing trees appeared to be most prevalent within this habitat through the northern Project Area (RE 11.3.4 and 11.3.25).</li> <li>– Refuge habitat and riparian corridors that provide connectivity within the landscape for arboreal mammals, such as koala, which has potential to utilise these areas, and greater glider, which was observed.</li> <li>– Logs, leaf litter and grass cover provide refuge and foraging habitat for amphibians, reptiles and ground-dwelling mammals.</li> <li>– Moderate to high levels of erosion were observed in some sections along the streams. Several invasive species were observed within this habitat type, including introduced parthenium (<i>Parthenium hysterophorus</i>) and rubber vine (<i>Cryptostegia grandiflora</i>).</li> </ul> | |

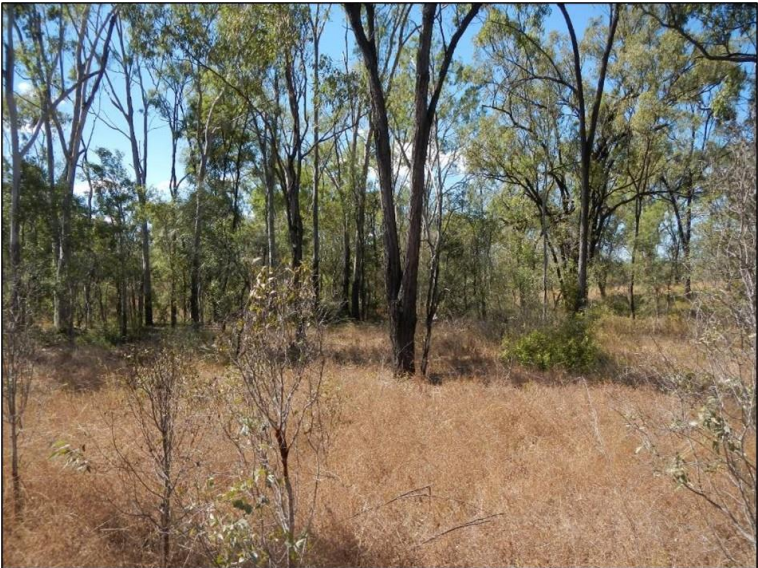
| Habitat type | Description | Representative photograph |
|---|---|---|
| Eucalypt dry woodlands | <ul style="list-style-type: none"> <li>– Regrowth and remnant woodlands generally dominated by narrow-leaved ironbark or mountain coolibah with <i>Corymbia erythrophloia</i> (red bloodwood) and/or <i>Blakella dallachiana</i> (Dallachy's gum) as a sub-canopy or associated canopy species.</li> <li>– The shrub layer within this habitat was generally sparse, but often included <i>Santalum lanceolatum</i> (native olive), <i>Lysiphyllum carronii</i> (ebony tree), Leichhardt bean and <i>Carissa ovata</i> (currant bush). The groundcover was generally dense and included a mix of native and exotic pasture grasses but was often dominated by <i>Bothriochloa pertusa</i> (Indian bluegrass).</li> <li>– Associated with RE 11.8.5 and 11.9.9.</li> <li>– Variety of shelter, including tree hollows, logs, leaf litter and dense grass cover, providing different degrees of habitat for the koala and the greater glider, containing a wide variety of food and shelter tree species.</li> <li>– Suitable shelter and foraging habitat for a range of amphibians, reptiles, woodland bird species, ground-dwelling mammals, and arboreal mammals.</li> </ul> | |

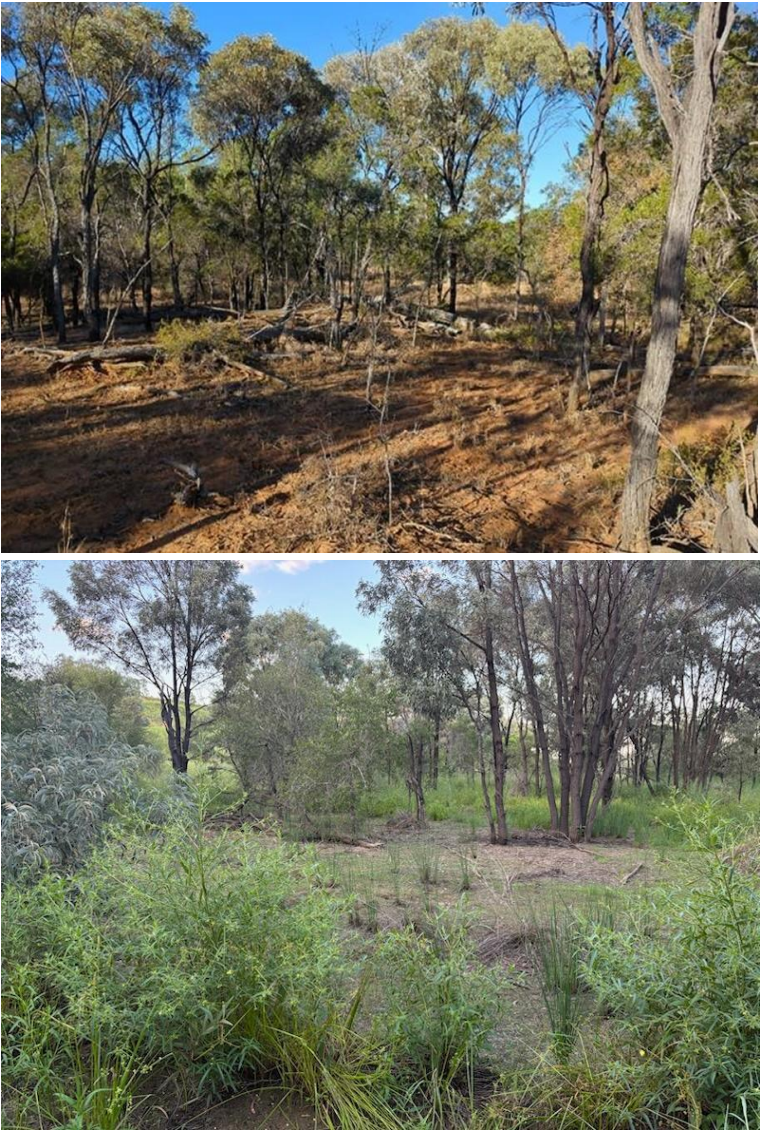
| Habitat type | Description | Representative photograph |
|---|---|---|
| Acacia woodland to open forest | <ul style="list-style-type: none"> <li>– Brigalow woodland.</li> <li>– <i>Terminalia oblongata</i> (yellowwood), <i>Geijera parviflora</i> (wilga) and <i>Eremophila mitchellii</i> (false sandalwood) were sometimes present as low tree layer or tall shrub layer. Currant bush was common as a short shrub. Live groundcover ranged from being dense, often dominated by <i>Cenchrus ciliaris</i> (buffel grass), to very open in patches.</li> <li>– Associated with RE 11.9.1 and 11.9.5.</li> <li>– Large amounts of coarse woody debris from fallen trees, providing shelter for amphibians, small reptiles and ground-dwelling mammals.</li> <li>– Suitable foraging and nesting habitat for a range of woodland birds but generally lack hollow-bearing trees and koala foraging trees.</li> <li>– Occasional gilgai and cracking clay soil was observed during surveys (limited to two areas, of which one is shown in the below photo, including some with standing water at the time of survey), indicating that some habitat would be favourable for the threatened species ornamental snake. These areas generally provide shelter habitat as woody debris, however, the presence of the ornamental snake depends on the availability of its diet, which is comprised almost exclusively of frogs, indicating that majority of this habitat type is less likely to be of high quality habitat for this species.</li> <li>– Contains open areas that are potential foraging and/or breeding habitat for squatter pigeon.</li> </ul> | |

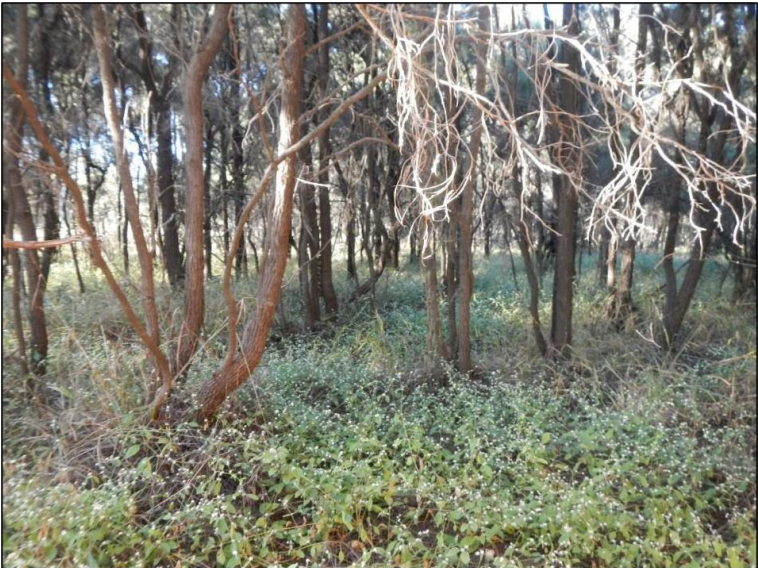
| Habitat type | Description | Representative photograph |
|---|---|---|
| Melaleuca woodlands on alluvial plains | <ul style="list-style-type: none"> <li>– Associated with RE 11.3.3a – restricted to one area west of the Project Area.</li> <li>– Low, dense canopy of black tea-tree, as well as a dense groundcover of <i>Alternanthera denticulata</i> (joyweed).</li> <li>– Lacked habitat features such as woody debris, hollows and decorticated bark.</li> <li>– The dense canopy and groundcover provide a high degree of shade and shelter that is likely to be utilised by a variety of small mammals, reptiles and amphibians for shelter, as well as large mammals such as eastern grey kangaroo during warm periods.</li> <li>– No suitable habitat for any of the threatened species with potential to occur.</li> </ul> | |

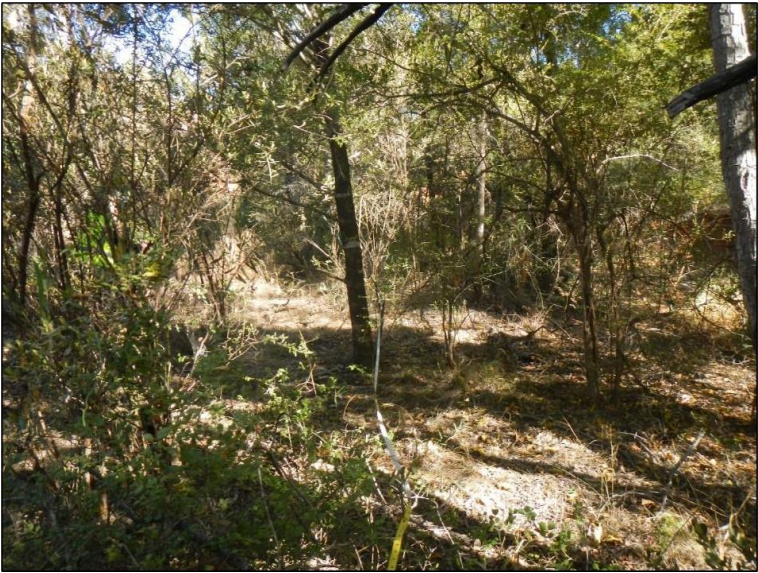
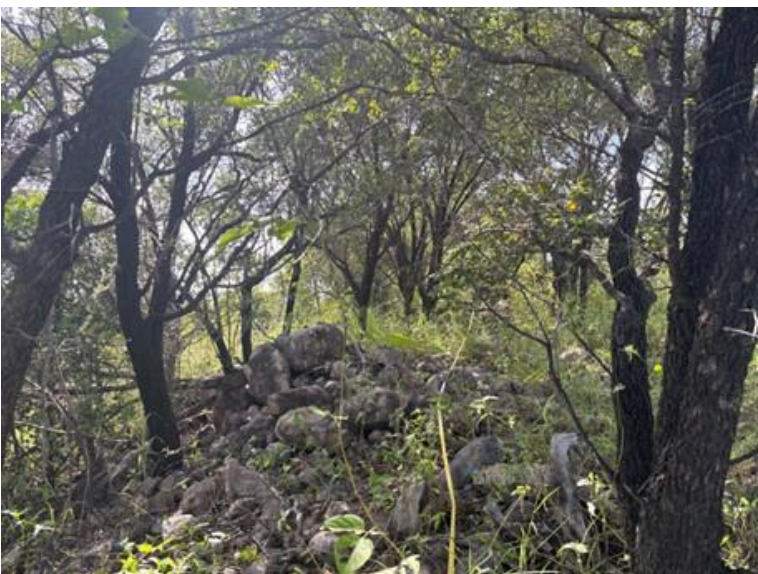
| Habitat type | Description | Representative photograph |
|---|---|---|
| Semi-evergreen vine thicket | <ul style="list-style-type: none"> <li>– Restricted to the edge of one creek in northern Project Area and one hillside in central Project Area: <ul style="list-style-type: none"> <li>• Dense canopy and subcanopy along the creek with a variety of species consistent with RE 11.3.11 (top photograph).</li> <li>• Dense continuous shrub cover on a hillside with a variety of canopy and shrub species consistent with RE 11.12.7 (below photograph).</li> </ul> </li> <li>– Diverse range of flora provided a variety of potential food sources for birds and other wildlife.</li> <li>– The creek line escarpments and large rocks on the hill provided small crevices that can be utilised as potential shelter and open sunning positions for small mammals and reptiles.</li> <li>– Patches of dense low shrub cover as well as open groundcover with more leaf litter along the creek compared to most areas of other major habitat types. Dense low shrubs, such as currant bush, provided shelter habitat for small mammals, reptiles and amphibians.</li> <li>– The dense canopy and shelter from the escarpments also created a potential cooler microclimate effect that may be utilised by fauna in the area during warm periods.</li> </ul> | |

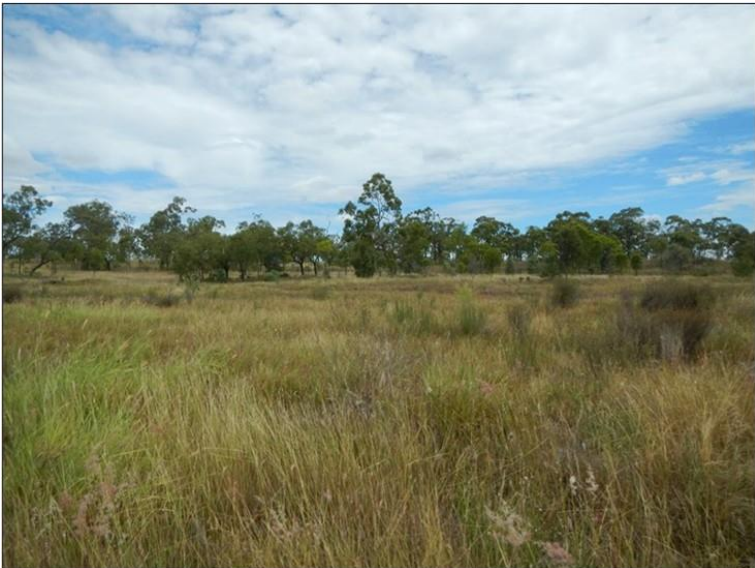
| Habitat type | Description | Representative photograph |
|---|---|---|
| Pasture grassland | <ul style="list-style-type: none"> <li>– Non-remnant vegetation characterised by pastureland, either cleared or containing returning vegetation which generally borders patches of remnant vegetation.</li> <li>– Trees were typically absent or sparse within this habitat type, with only isolated <i>Acacia</i> spp. or <i>Eucalyptus</i> spp. saplings occurring throughout the cleared areas.</li> <li>– Habitat value is limited compared to the other major habitat types.</li> <li>– Open areas provide hunting habitat for birds of prey and foraging habitat for ground-dwelling mammals.</li> <li>– Dense grasses provide shelter habitat for small mammals, reptiles and amphibians.</li> </ul> | |
