# MANGOOLA OPEN CUT

## Mangoola Open Cut

### 2021 Annual Review

1 January 2021 to 31 December 2021

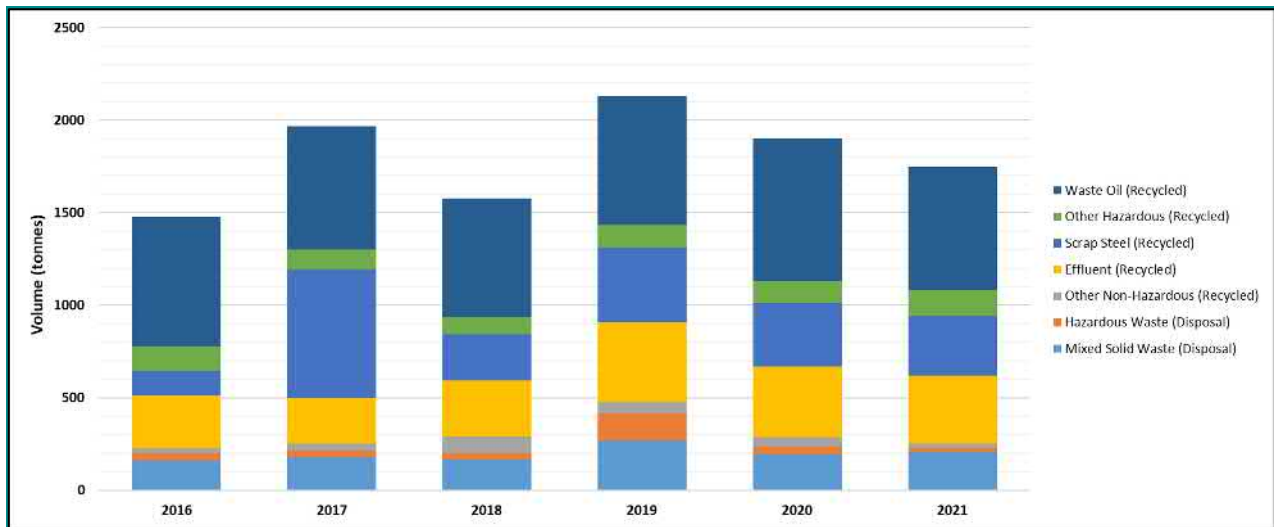
Figure 3 2016-2021 Waste Streams Generated

The major waste streams during the reporting period were waste oil (665 tonnes), scrap steel (321 tonnes), mixed solid waste (208 tonnes) and effluent (366 tonnes).

A summary of waste disposal from 2016 to 2021 is presented in **Figure 3**.

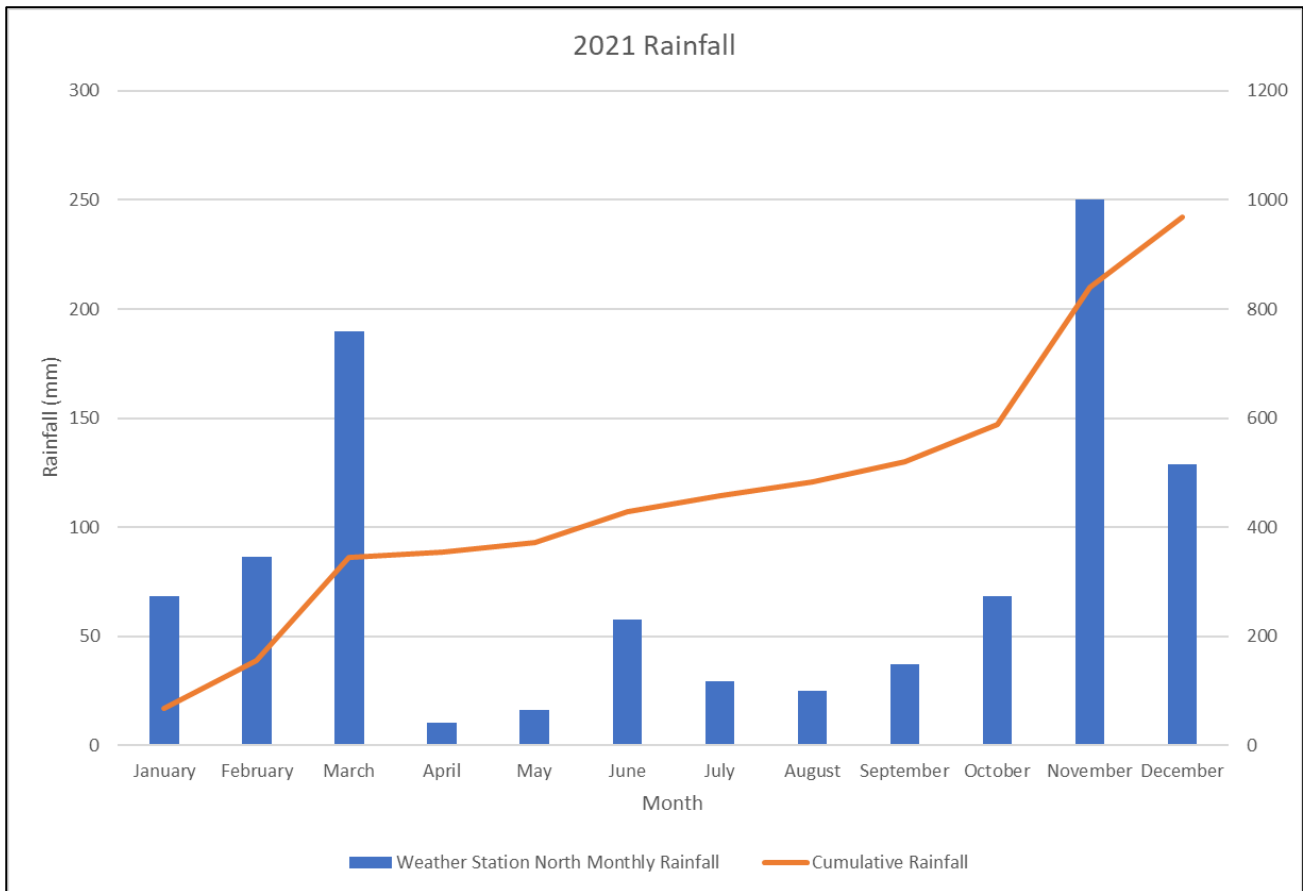
**Figure 5 WSN 2021 Rainfall Data**

2021 was another wet year. Total annual rainfall for 2021 was 967.8 mm, which was consistent with the rainfall in 2020 (941 mm) (**Figure 5**). As shown in **Figure 5**, annual rainfall at WSN was lowest in April and highest in November 2021. Long term rainfall data is presented in **Appendix B**, which shows that rainfall at the site was higher than most years since reporting began in 2010 but lower than 2020.

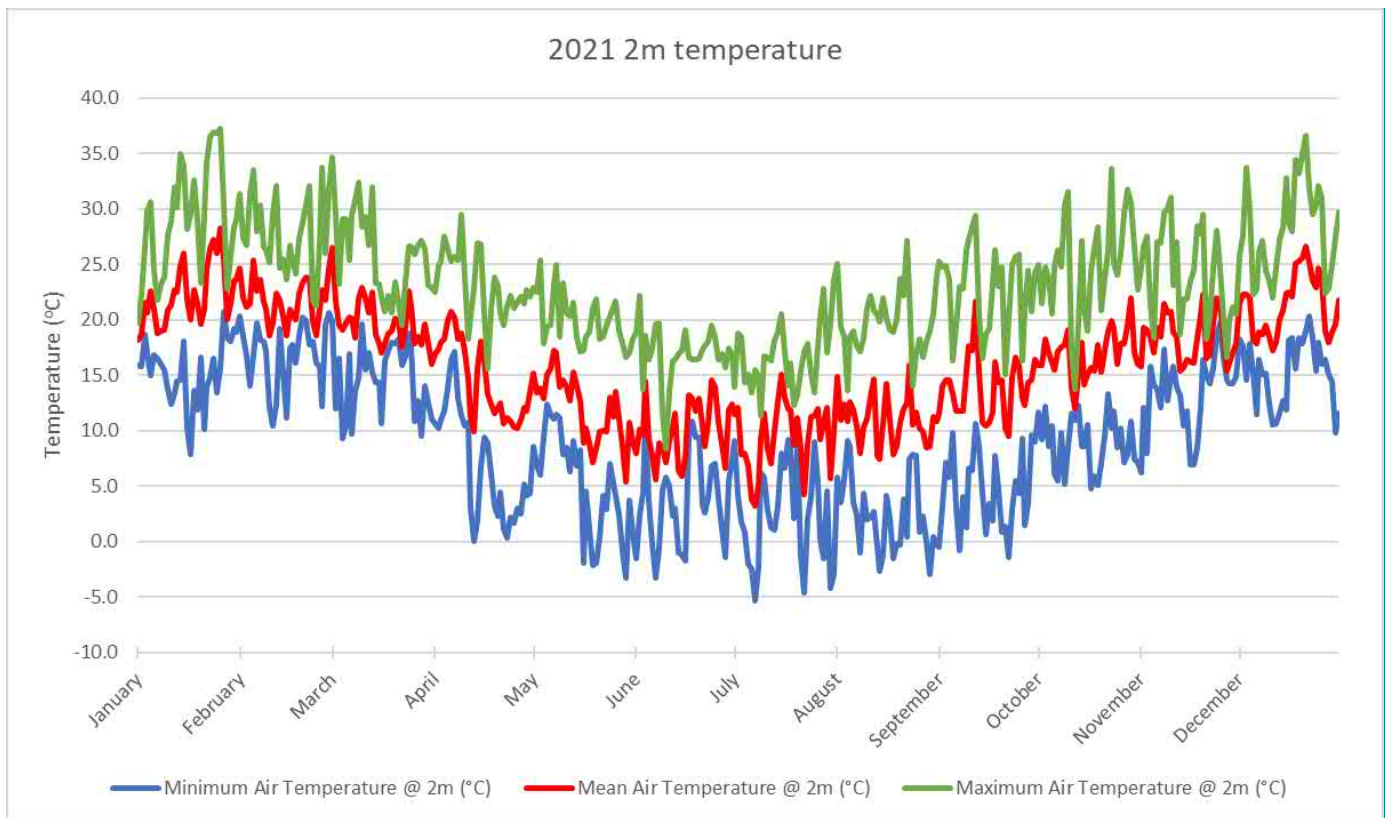
Figure 6 WSN 2021 2m Temperature Data

As shown in **Figure 6**, the daily minimum and maximum 2 metre (m) above surface level temperatures ranged from -5.3°C to 37.2°C respectively, with an average daily maximum of 23.2°C, which is cooler than the 2020 daily average of 24.0°C. Humidity during 2021 ranged from 9.0% to 97.5%.

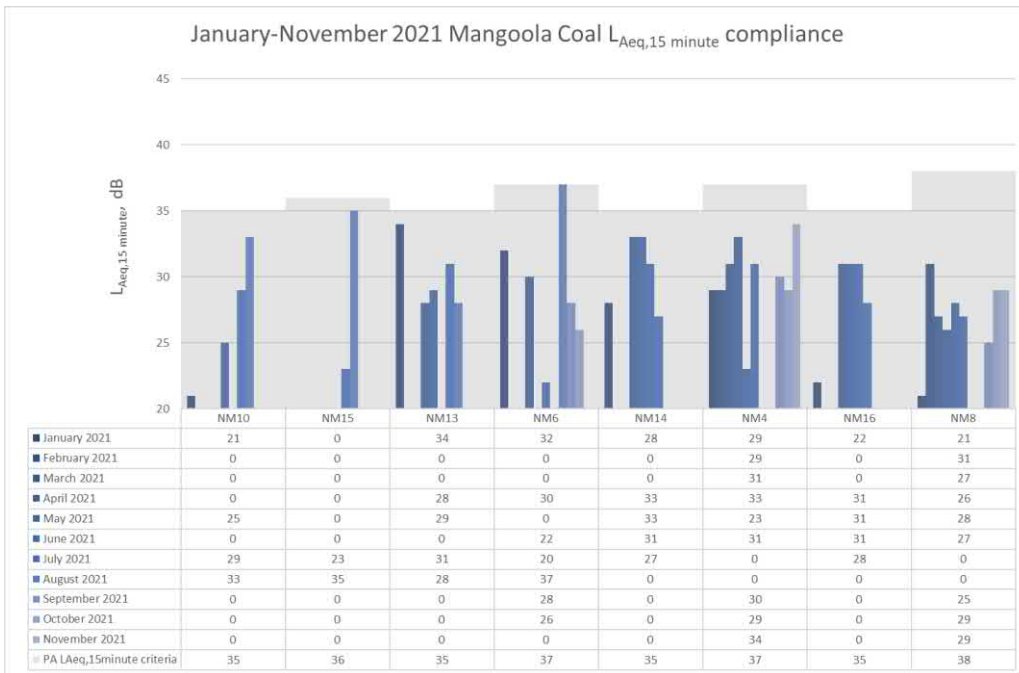
**Figure 9 Annual Review Attended Noise Monitoring Compliance Results ( $L_{Aeq(15\text{ minute})}$ ) – January to November**

**Figures 9, 10, 11 and 12** compare the 2021 noise levels recorded at Mangoola with the relevant approval criteria. A figure of the December daytime noise levels has not been included, as site noise was determined to be inaudible at all noise monitoring locations.

'0' indicates that the Mangoola Coal noise contribution was determined to be 20 dB or less.

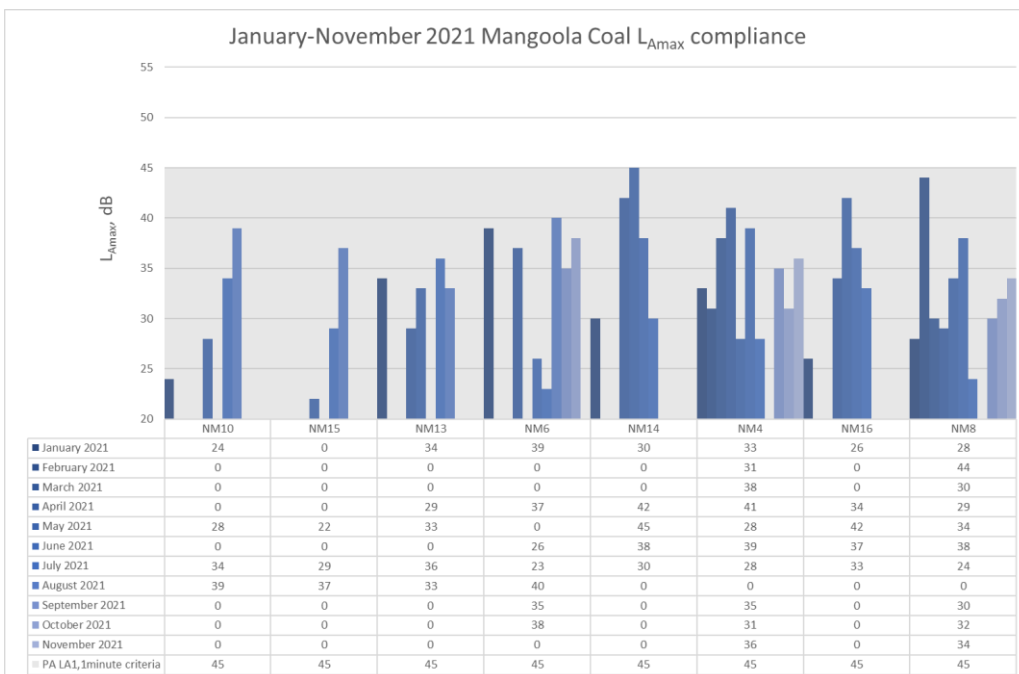
**Figure 10 Annual Review Attended Noise Monitoring Compliance Results ( $L_{Amax}$ ) – January to November**

'0' indicates that the Mangoola Coal noise contribution was determined to be 20 dB or less.

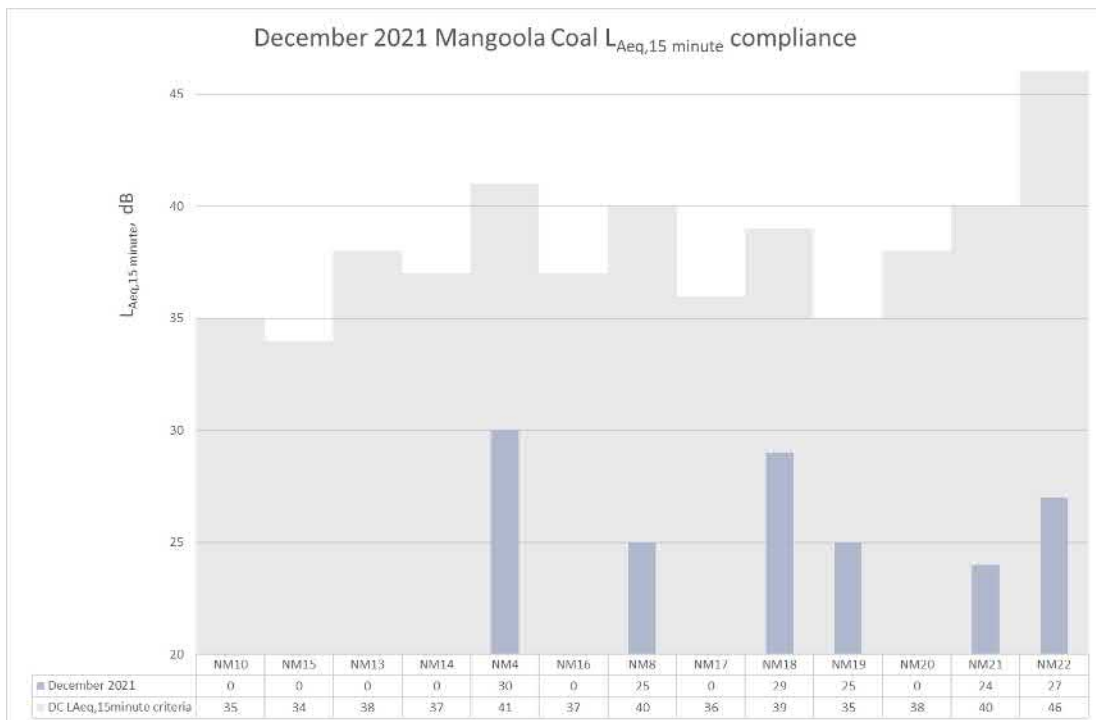
**Figure 11 Annual Review Attended Noise Monitoring Compliance Results (L<sub>Aeq(15minute)</sub>) – December**

'0' indicates that the Mangoola Coal noise contribution was determined to be 20 dB or less.

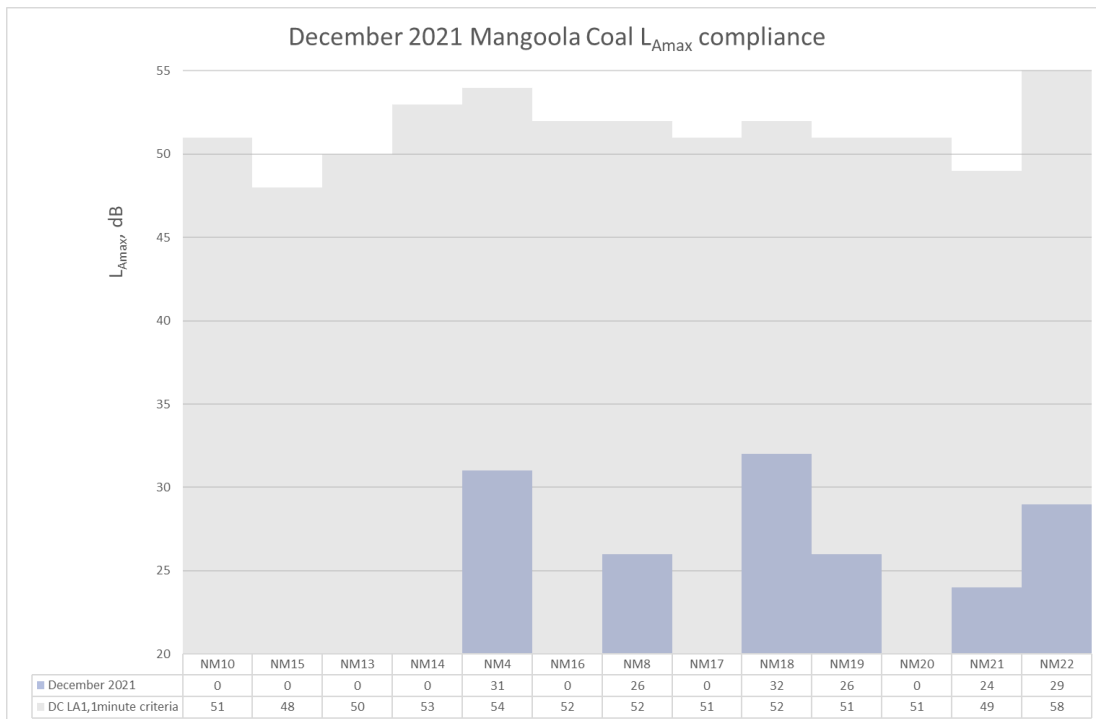
**Figure 12 Annual Review Attended Noise Monitoring Compliance Results (L<sub>Amax</sub>) – December**

'0' indicates that the Mangoola Coal noise contribution was determined to be 20 dB or less.

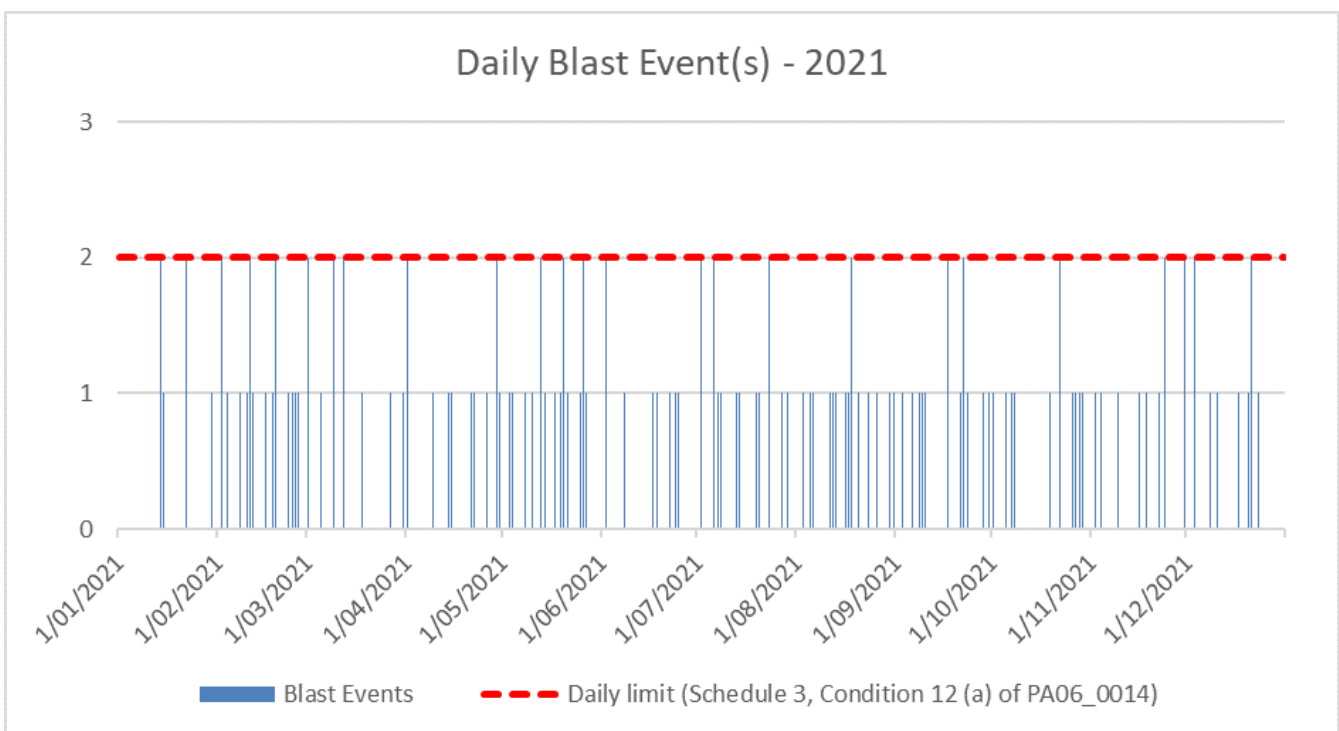
Figure 13 Daily Blast Event(s) 2021

During the reporting period there was an average of 2.2 blast events per week, which is compliant with Schedule 3, Condition 12(b) of PA 06\_0014 and Condition B14 of SSD 8642, which allows a maximum of 6 blasts per week, averaged over a calendar year. A total of 114 blast events occurred during the reporting period and no more than 2 blast events per day which is compliant with Schedule 3, Condition 12(a) of PA 06\_0014 and Condition B 14 of SSD 8642.

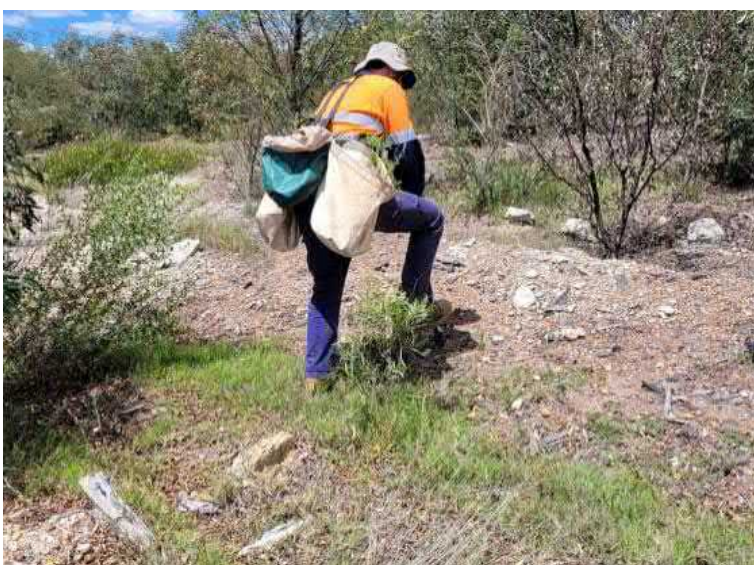
Infill planting was conducted throughout indicated areas in North and South Rehabilitation areas.

Photo 1 Planting throughout rehabilitation areas.

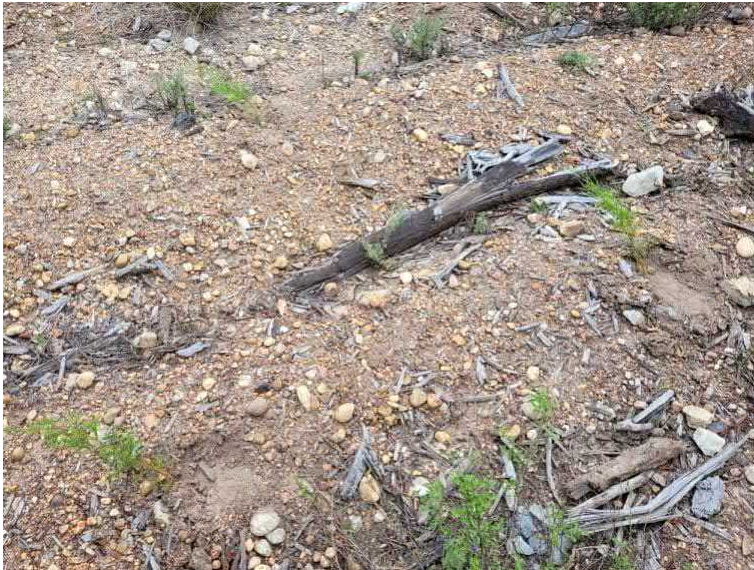
**Photo 2 Tubestock established throughout the rehabilitation areas**

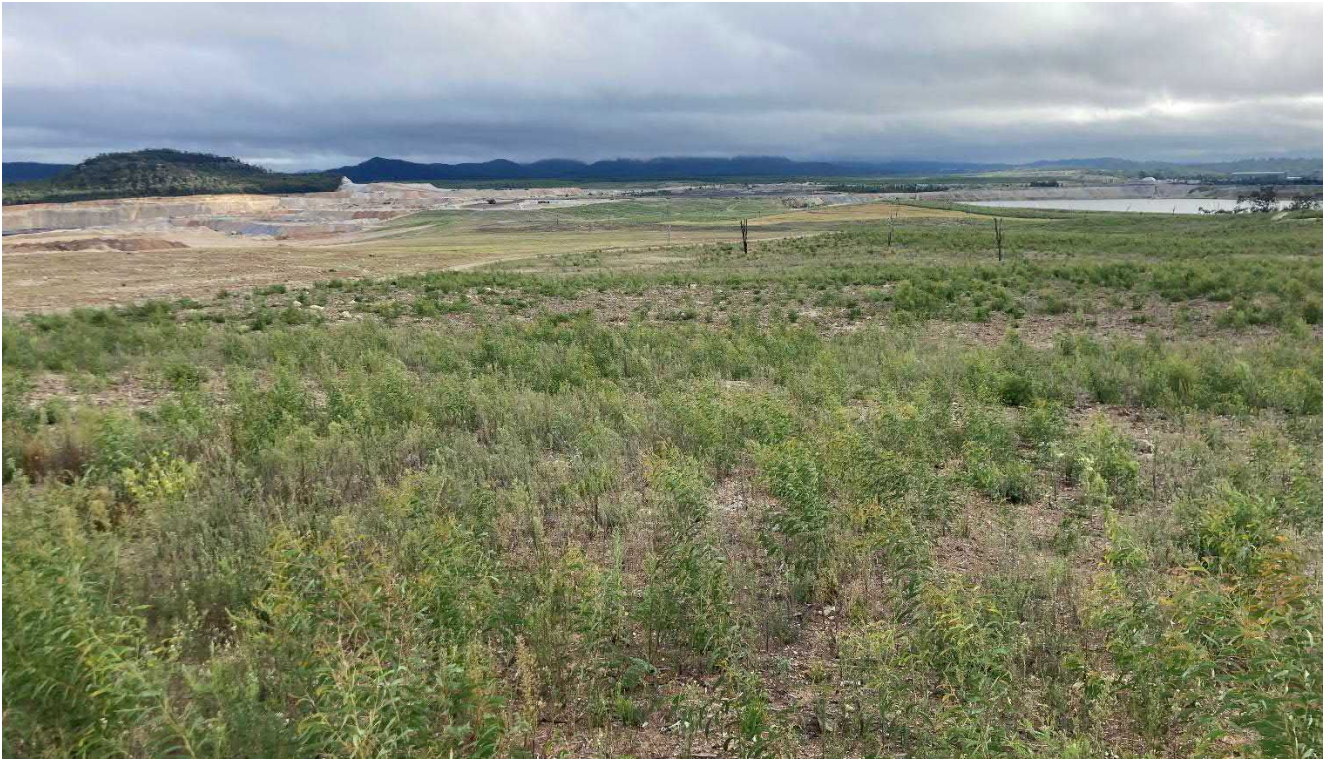
**Photo 3** 2020 and 2021 South Pit Progressive Rehabilitation looking North

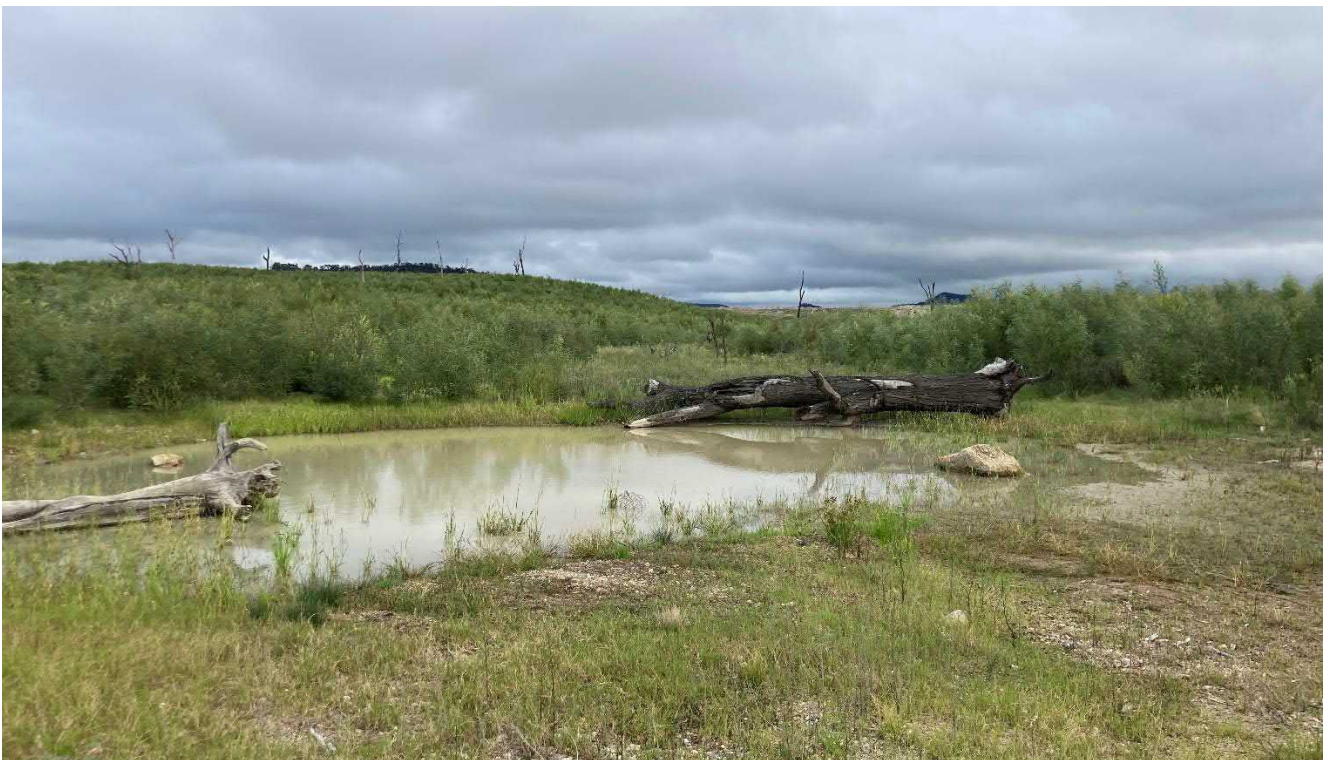
**Photo 4** South Pit Rehabilitation Frog Ponds Constructed 2019

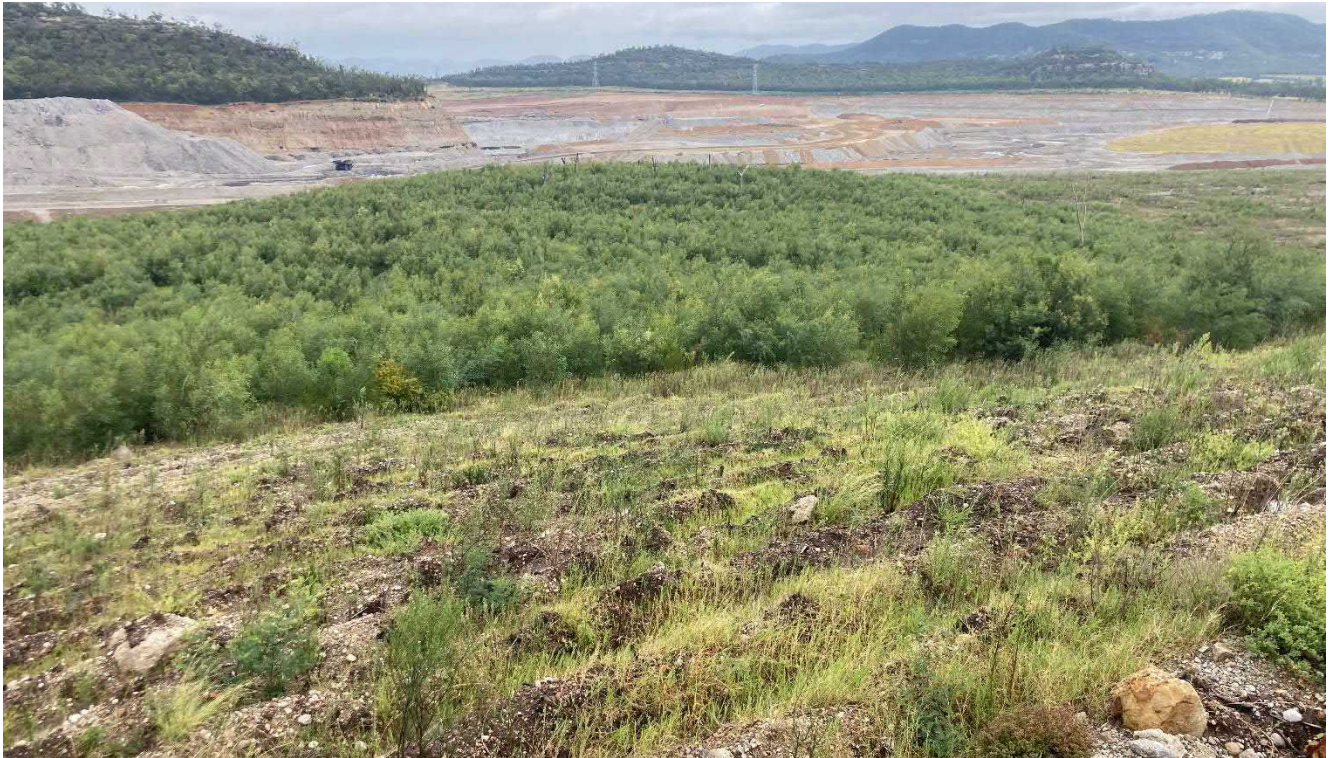
**Photo 5** View from Main Pit Central towards 2019-2021 Progressive Rehabilitation

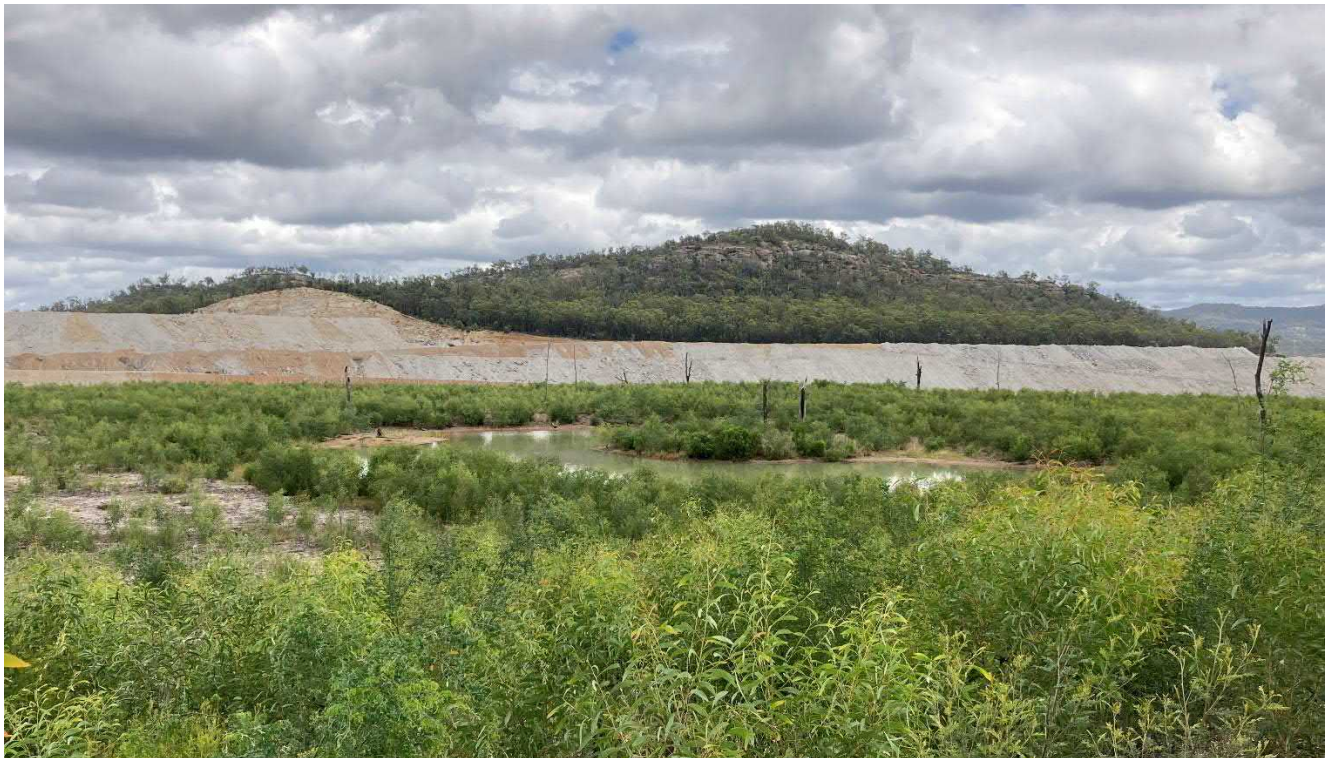
**Photo 6** Frog Pond and Progressive Rehabilitation in Main Pit Central 2019 Area

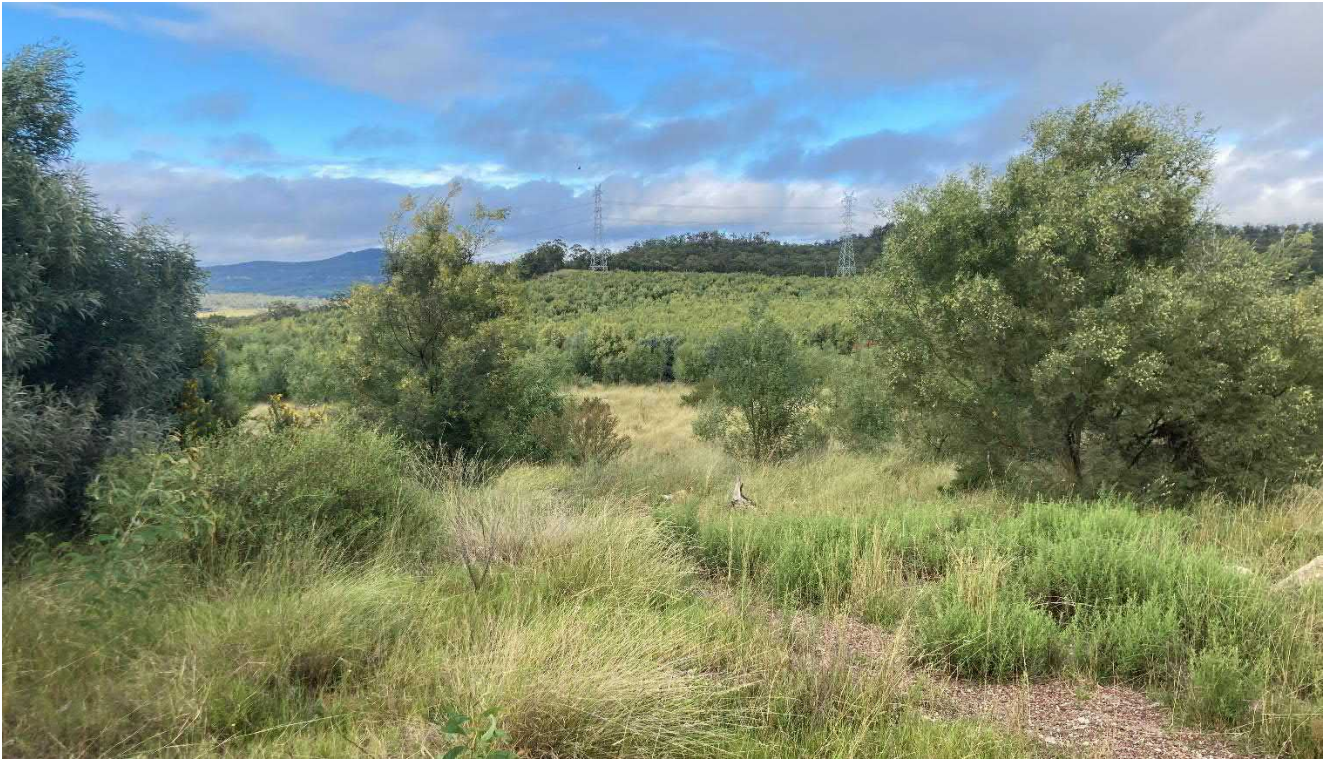
**Photo 7** 2017 South Pit Rehabilitation looking toward Offset Area and 500kV Powerline

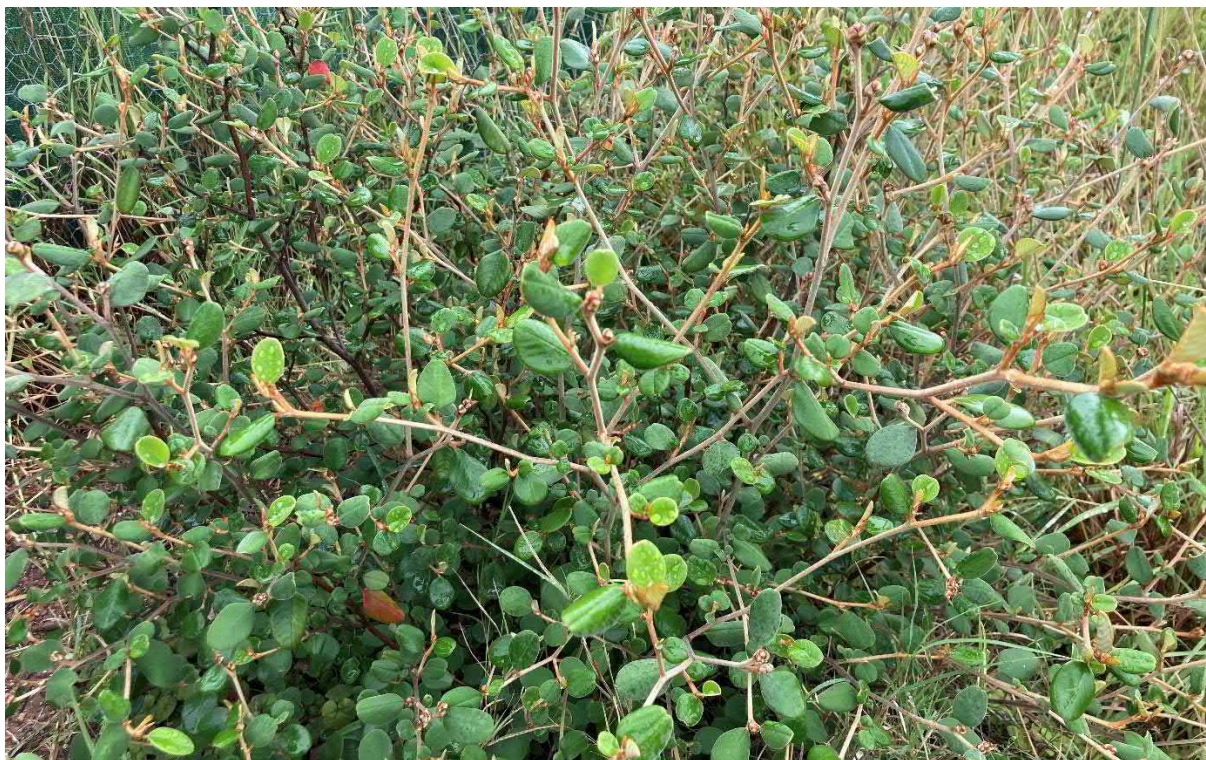
**Photo 8** Translocated *Pomaderris reperta* in rehabilitation area

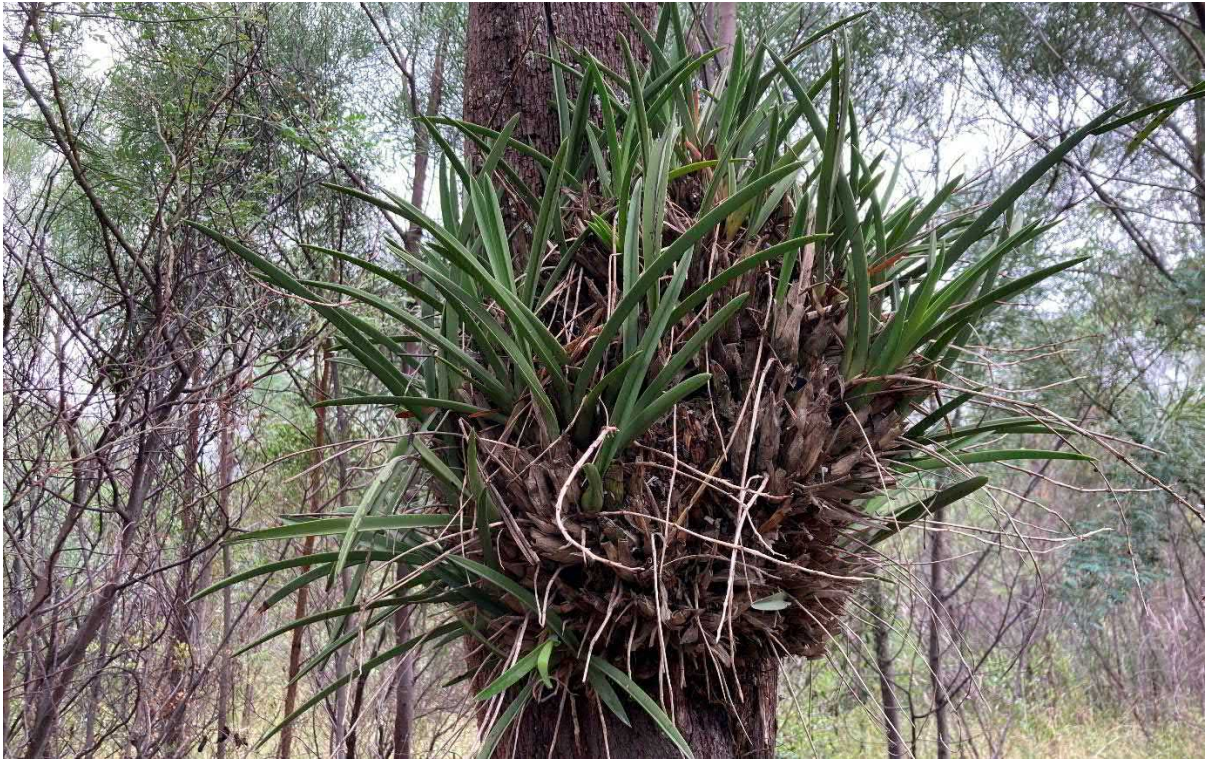
**Photo 9** Translocated *Cymbidium canaliculatum* within rehabilitation area

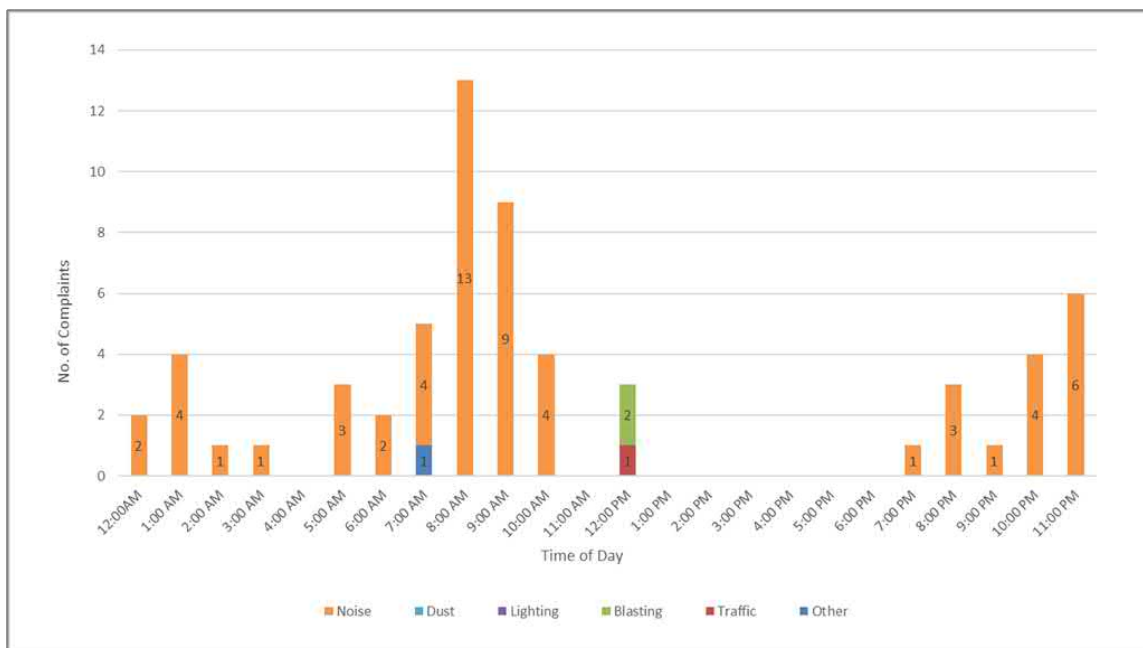
**Figure 19 2021 Complaints by Time of Day**

**Figure 19** shows the time of day that complaints were made during 2021. Analysis of this data shows that noise complaints are generally made in the early morning and late evening, whereas blast related complaints are generally made in the middle of the day.

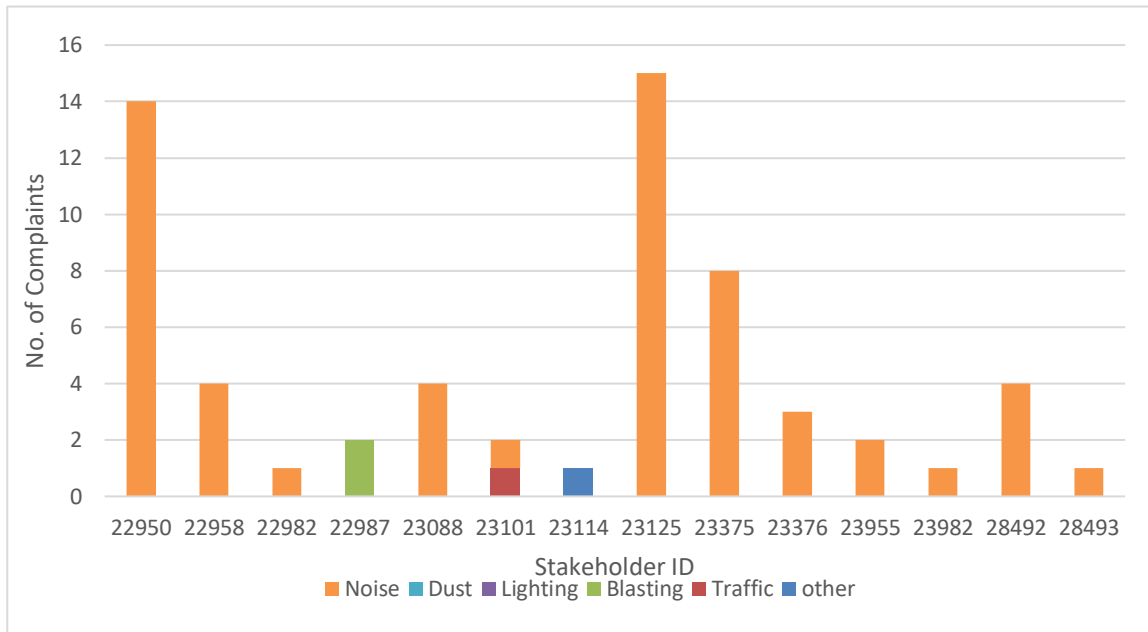
**Figure 20 2021 Complaints by Complainant ID**

**Figure 20** shows the number of complaints made by each complainant during 2021. The 62 complaints were made by 14 individuals during 2021 and approximately a 60% of all complaints (37) were made by three complainants. These were predominantly in relation to noise.

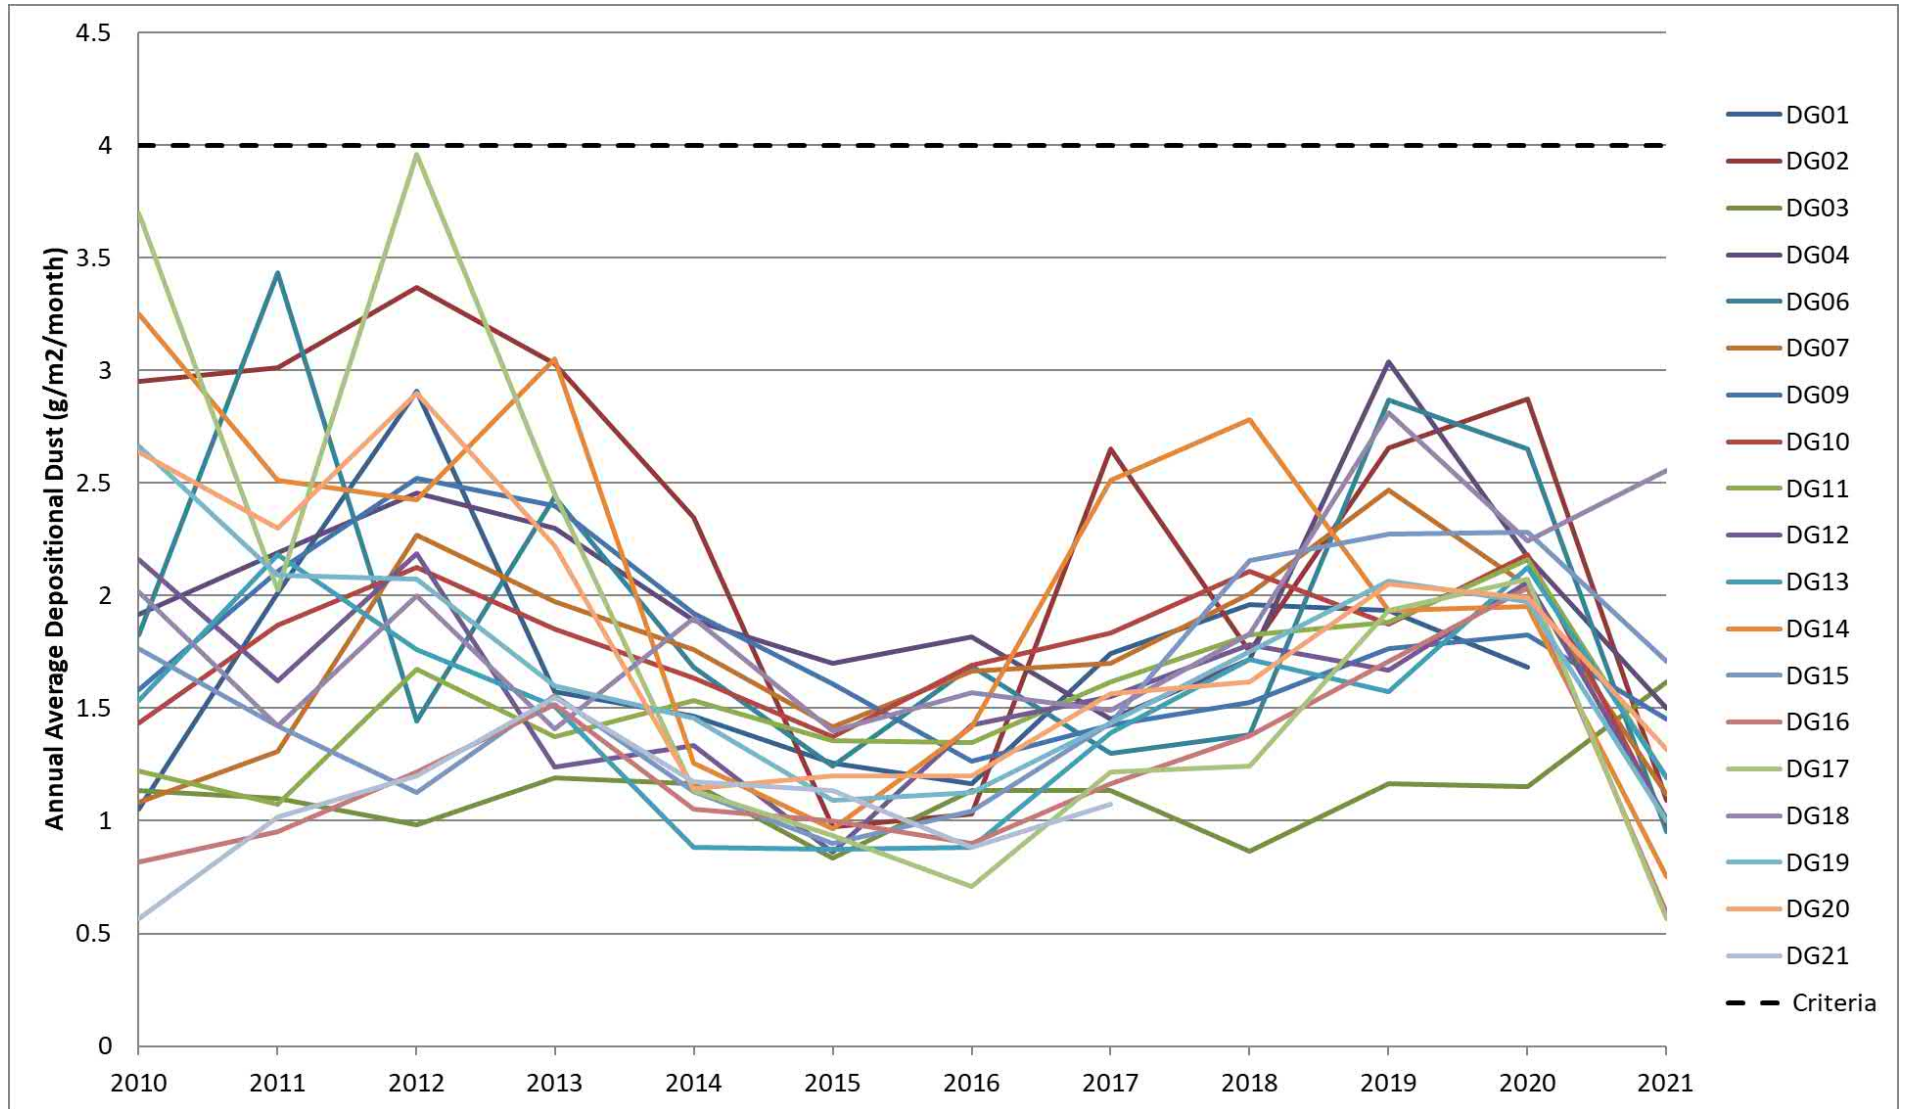
Figure 23 Long Term Annual Average Depositional Dust Monitoring Results – 2010 to 2021

A long-term trend analysis of air quality monitoring results at Mangoola has been undertaken using data from July 2010 to December 2021 to identify any trends in the monitoring data over the life of the project. These graphs are presented in **Appendix C**. Depositional dust monitoring results have been variable since mining operations commenced in 2010, however results generally peaked in 2012 and declined to the lowest results during 2015-2016. Results were generally increasing during 2017-2019 which correlates with low rainfall and the ongoing drought conditions. Increased rainfall in 2020 resulted in lower results than the previous few years (refer **Appendix B**). Ongoing rain during 2021 saw results drop lower than those in 2020 close to the level of 2015-2016.

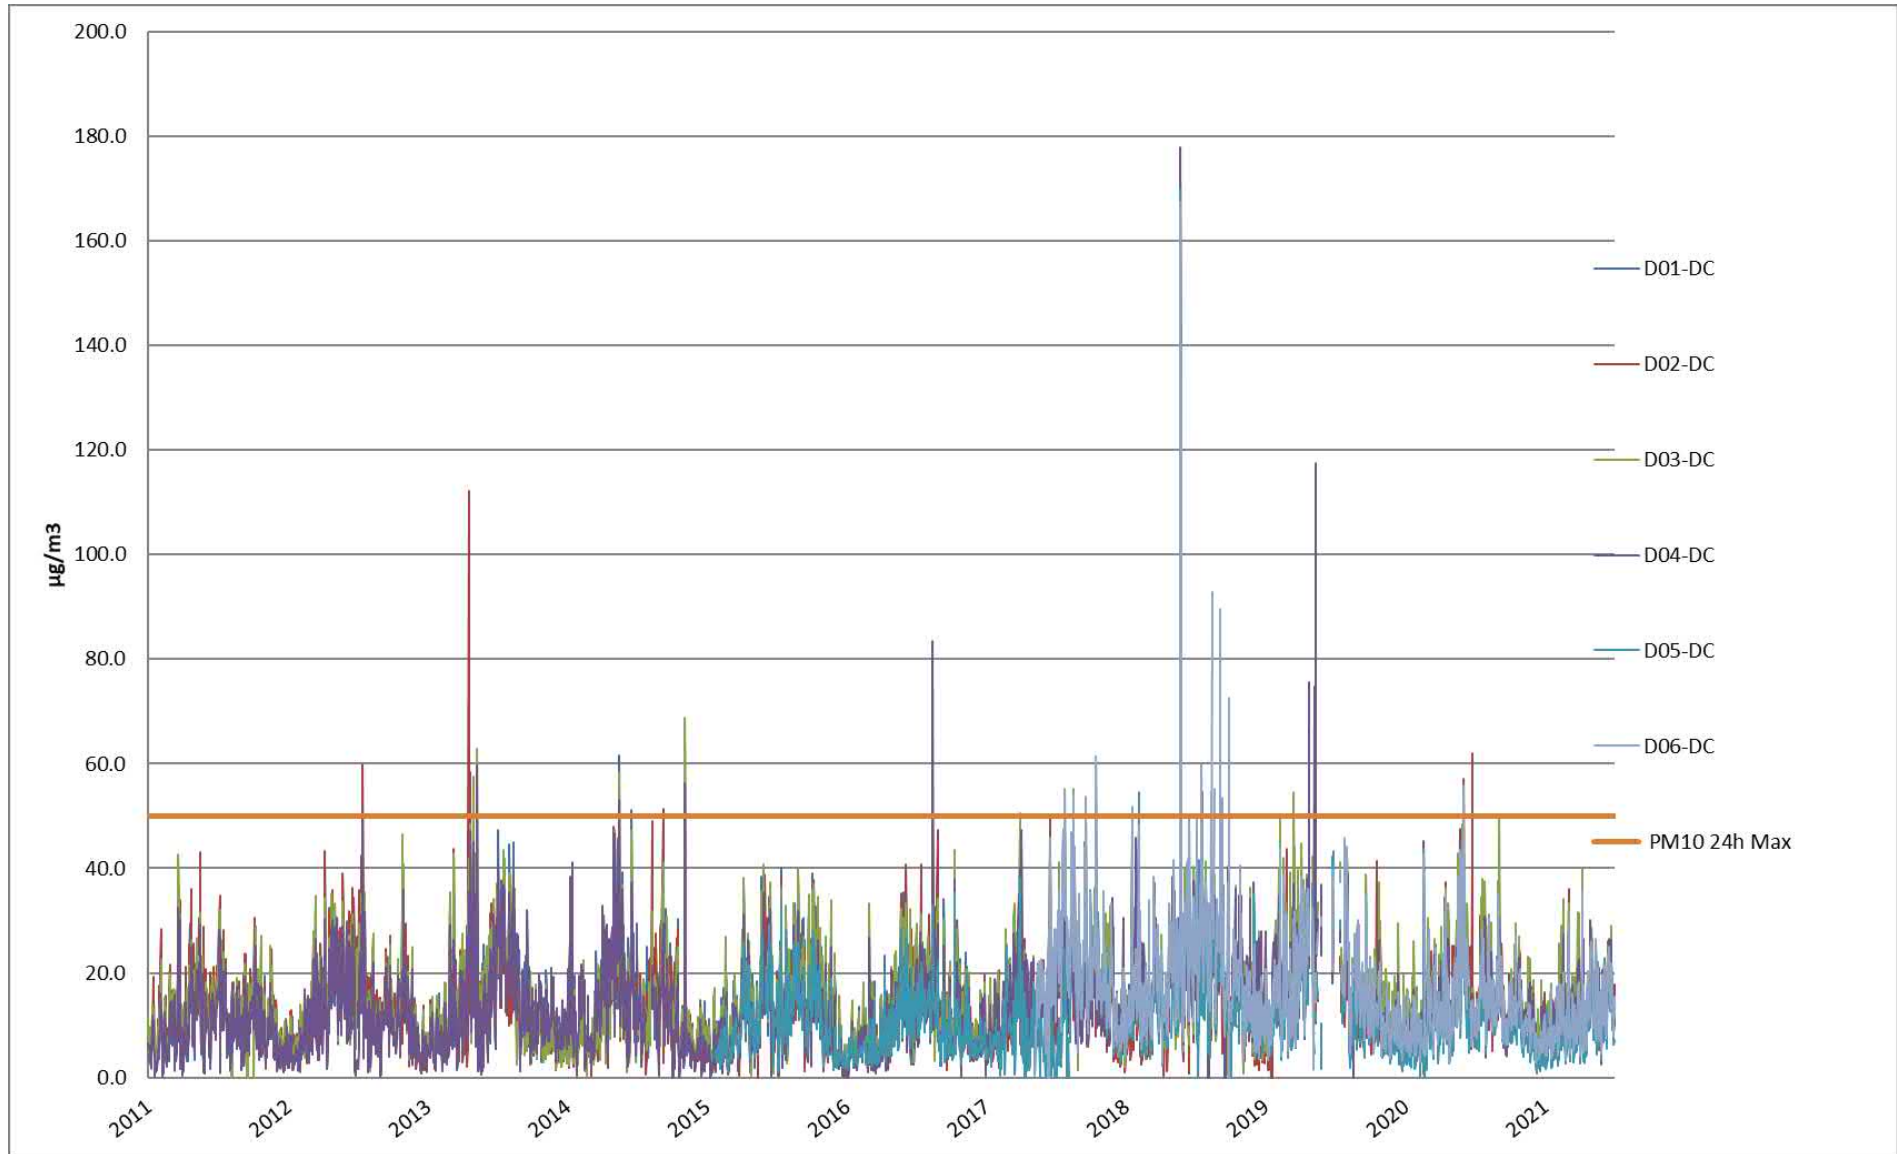
Figure 25 Long Term 24h PM<sub>10</sub> TEOM Monitoring Results – 2011 to 2021

The 24hr maximum TEOM data show seasonal peaks in the summer months. The annual average TEOM results have remained consistent with results from 2011 through to 2017 and results have been generally increasing during 2018-2019 which correlates with low rainfall and the ongoing drought conditions. Increased rain during 2020 decreased results to be consistent with those from 2015 to 2017. Ongoing rain during 2021 saw 24hr maximum TEOM (averages) remain consistent with those in 2020.
