RAVENSWORTH OPERATIONS

GLENCORE

Heritage Management Plan

Number: RAVCX-307024981-3052

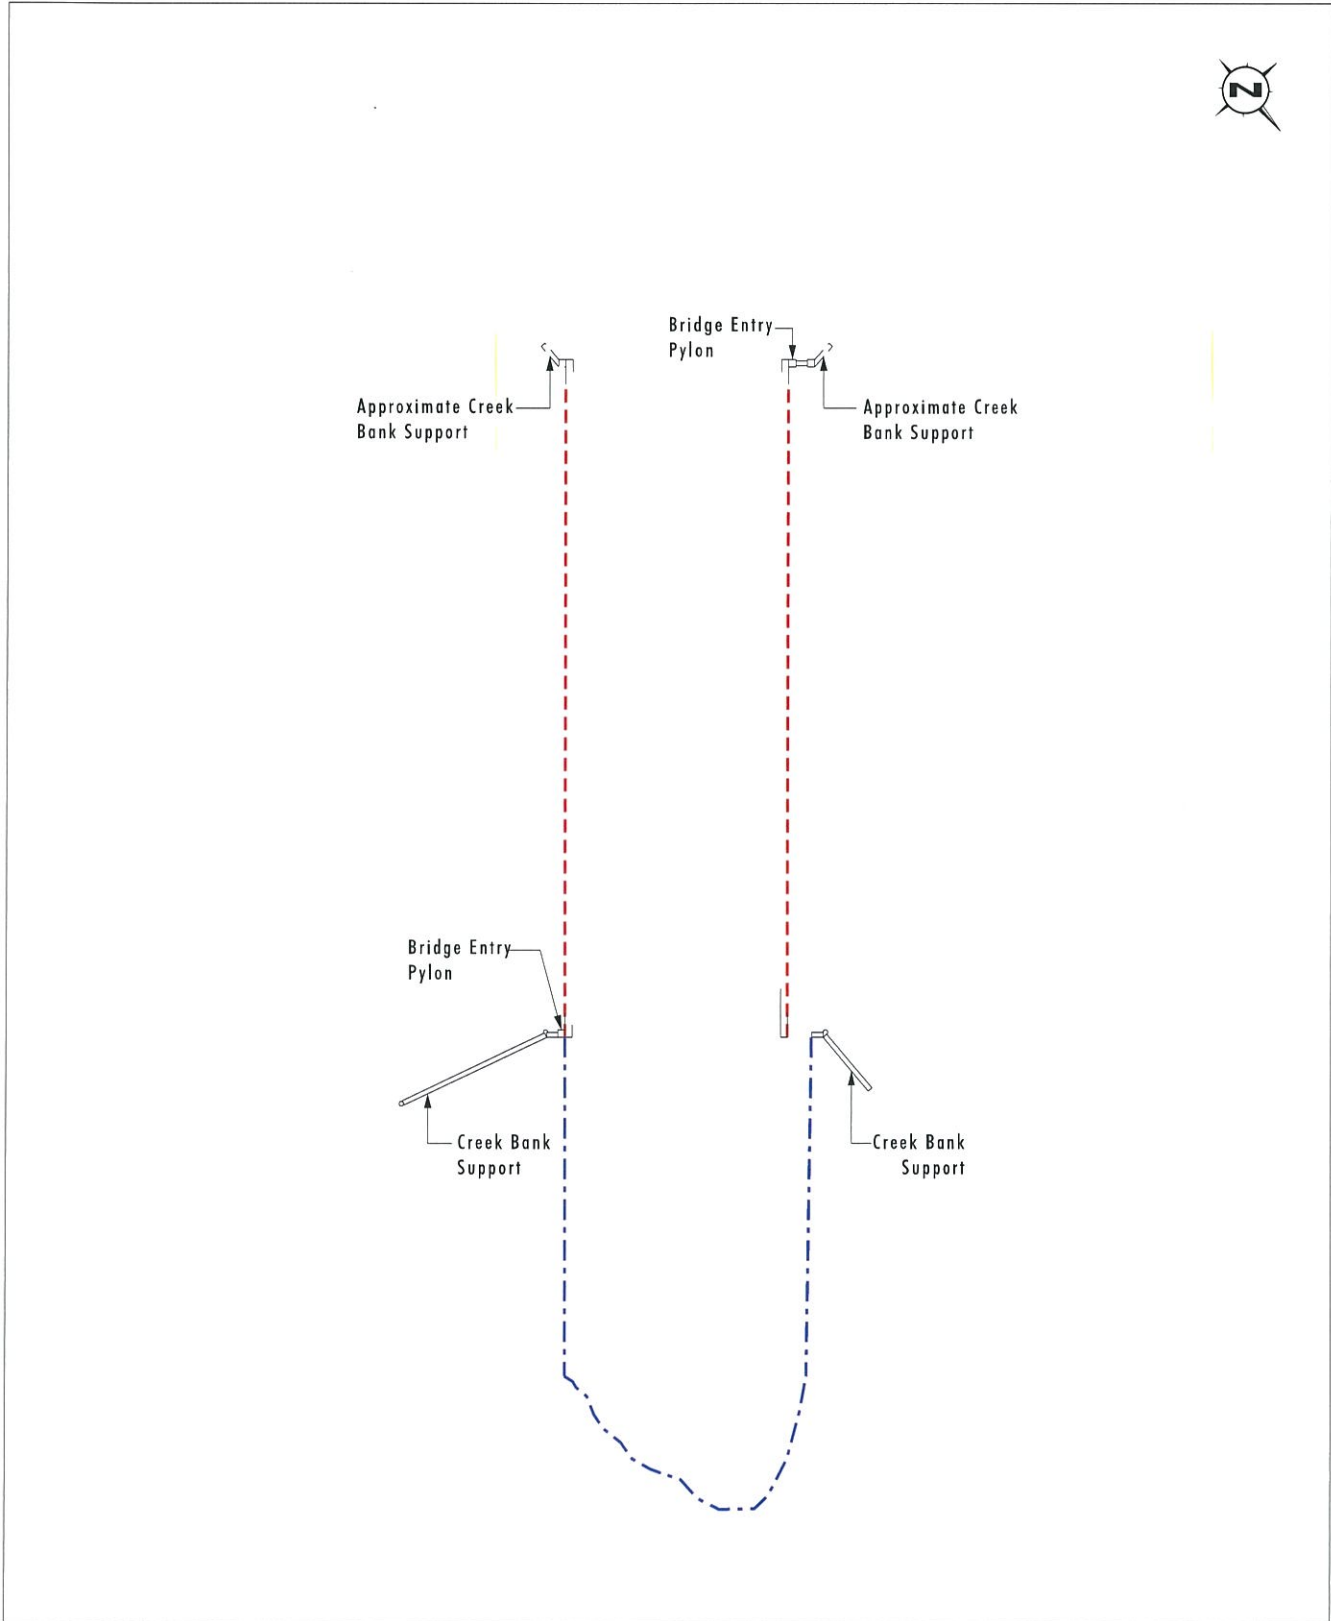
FIGURE 2.1
Site HH1

Site HH1, a bridge over Emu Creek (refer to **Figure 2.1**) consists of a timber deck with no guard rail (refer to photograph HH1-05). The timber superstructure of the bridge is supported by timber piers/piles driven into the creek bed and timber trusses. At either end of the bridge the timber trusses consist of horizontal beams spanning the bridge width. The central truss has an additional two diagonally crossing beams forming a lattice design across the width of the bridge (refer to photograph HH1-10). The road approach ramp on either side of the bridge is supported by earthen embankments contained by timber beams/planks (refer to photograph HH-12).

The dilapidated condition of the bridge, and Occupation Health and Safety concerns, allowed only for an estimate of the measurements of certain elements including the length of the bridge and size of the west embankment supports. As such, **Figure 2.1** (and corresponding **Figure A1**) are schematic rather than comprising a measured drawing.

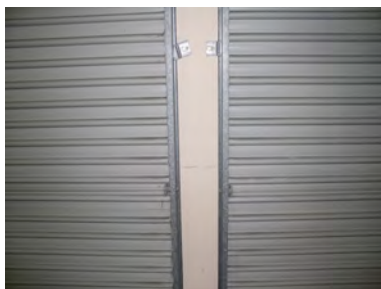
Figure 3463.jpg

Room No.	Room Name	Type / Finish	Comments	photograph
1	Garage Orientation /Element name		Generally good condition with some wall cracking.	
	Floor	concrete	Good condition. Smooth trowel with surface cracks.	3460.jpg
	Wall North	Plasterboard painted Colorbond Roller Doors	3 roller doors. Horizontal crack in NE corner. Horizontal crack along setting of plasterboard.	3463.jpg
	Wall East	As above	Door to exterior is jammed. Hollow Core door required to be replaced by external door.	3460.jpg
	Wall South	As above	Damage to corner of room in lower corner of WC.	3461.jpg
	Ceiling	Plasterboard	Good condition. Cracks on setting Line. Crack in SE corner.	3462.jpg
	Cornice	Plasterboard 90mm Scotia	Good condition. Crack in SE corner.	
	Fixtures	Retractable Clothes Line	Clothes Line located in recess beside laundry and WC.	3461.jpg

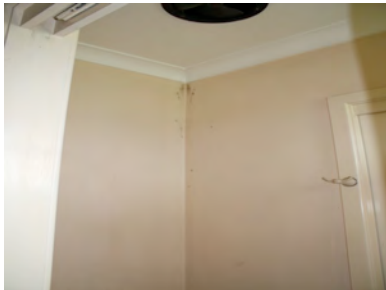
Figure 3465jpg

Room No.	Room Name	Type / Finish	Comments	photograph
2	WC and Shower		Generally satisfactory condition	
	Orientation /Element name			
	Floor	Concrete. Ceramic Tiled finish.	Good condition	
	Wall North	Fibre Cement. Ceramic Tiled Skirting	Good condition	
	Wall East	As Above	Sliding door functioning	
	Wall South	Wall Tiles and Fibre Cement	Good condition	
	Wall West	Fibre Cement. Ceramic Tiled Skirting	Sliding Door functioning	
	Ceiling	Plasterboard. Painted in gloss finish.	Ceiling fan requires new grille	3465jpg
	Cornice	Scotia 90mm	Crack in SW corner.	
	Fixtures	WC	Plastic Cistern. Operable	3464jpg
		Shower	Sliding shower screen. Aluminium powder coated. Operable.	3466jpg

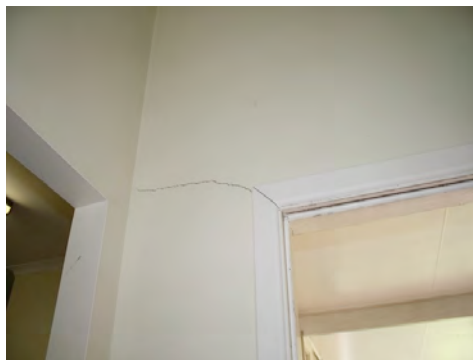
Figure 3474jpg

Room No.	Room Name	Type / Finish	Comments	photograph
4	Kitchen		Generally good condition	
	Orientation /Element name			
	Floor	Timber. Sheet vinyl finish	Good condition	
	Wall North	Plasterboard painted. 150 mm skirting.	100mm high skirting. Crack in NW corner adjacent to D7. W5 Counter weight missing on sash.	
	Wall South	Plasterboard painted. Tiled splashback	Crack over door head (D8) on east. Splashback sound. Requires partial regrouting.	3474jpg 3475jpg
	Wall East	As above	Kitchen bench and cupboards in good condition.	
	Wall West	As above		
	Ceiling	Plasterboard painted flat finish.	Ceiling Fan, Exhaust fan, AC Register. Small crack adjacent to on west.	
	Cornice	Scotia 90mm		
	Fixtures	Kitchen cupboards	Sound condition	3471jpg
		Fan	Good condition	
		Air conditioning grille		
		Exhaust fan

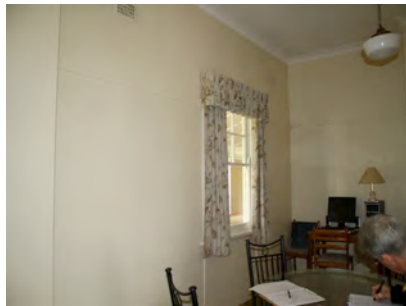
Figure 3476jpg

Room No.	Room Name	Type / Finish	Comments	photograph
5	Meals		Generally good condition. Older section of house. Curtains and pelmets in good condition.	
	Orientation /Element name			
	Floor	Timber. Sheet vinyl finish	Good condition	
	Wall North	Sheet linings painted. 150 mm skirting.	Picture rail at door head height. Wall mounted light.	3476jpg
	Wall South	As above	Picture rail. Vertical cover moulds under windows.	
	Wall East	As above	Picture Rail	
	Wall West	As above	Picture Rail. Cover moulds at corner.	
	Ceiling	Plasterboard painted flat finish.	Central pendant light	3477jpg
	Cornice	Scotia 90mm	Good condition.

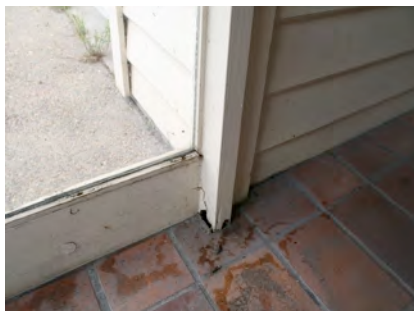
Figure 3483jpg

Room No.	Room Name	Type / Finish	Comments	photograph
6	Outdoor screened area Orientation /Element name		Skillion roof addition to house. Generally satisfactory condition with some cracking in quarry tiles and rotting of timber posts at bases.	
	Floor	Concrete slab with Quarry tiles	Cracking in places. Crack along north/south located 5 rows from east. Diagonal Crack located 8 rows to south.	3481jpg 3482jpg
	Wall North	Timber frame and ledge.	Glass at lower section and shade cloth at upper section. Rotting of timber columns at base.	3478jpg
	Wall South	Weatherboards	Smaller profile than western wall.	
	Wall East	As for north wall in part. Splayed weatherboards in part.	Rotting of timber columns at base.	3483jpg
	Wall West	Splayed Weatherboards	Position of former door to TV room evident in wall fabric.	3479jpg
	Ceiling	Fibre cement painted	Moulded joints.	
	Cornice	Timber quad painted	Good condition.

Fixtures	BBQ and brick base	Sound	3480jpg
		Hose tap on standpipe	Capstan missing.	3479jpg
	Comments		No subfloor ventilation on south due to addition of concrete slab. Check for termites and allow for ventilation if required.	3484jpg

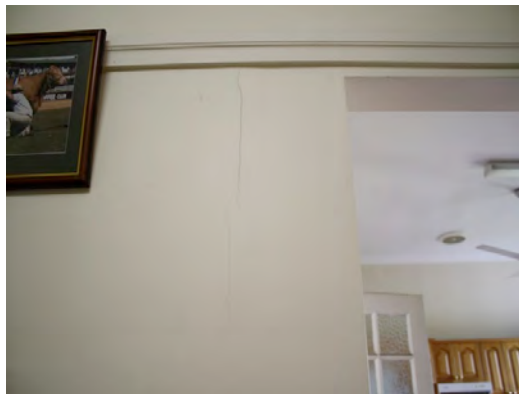
Figure 3485jpg

Room No.	Room Name	Type / Finish	Comments	photograph
7	Lounge/TV Orientation /Element name		Generally good condition. Older section of house. Curtains and pelmets and carpet in good condition.	
	Floor	Timber. Carpet finish	Good condition	
	Wall North	Sheet lining. Painted	Picture rail. Crack in north-west corner below picture rail. Surface mounted cables in north-east corner.	
	Wall South	As above	Picture rail	
	Wall East	As above	Picture rail. Vertical crack adjacent to doorway. Evidence of former door in location of W8	3485jpg 3487jpg 3486jpg
	Wall West		Cupboards. Good condition	3488jpg
	Skirting	Timber skirting. Painted	200mm high generally.	
	Ceiling	Plasterboard painted with flat finish.	Double fluorescent light. North/south crack to west of light. Bubble in finish.	3489jpg 3486jg
	Cornice	90mm scotia	sound

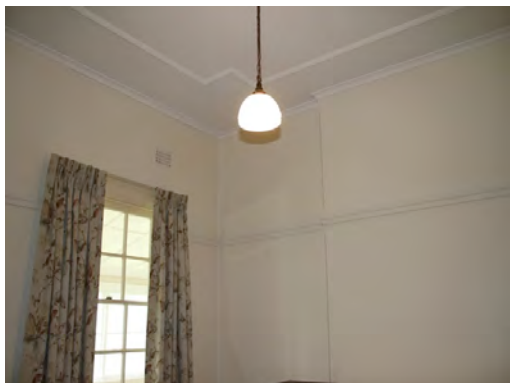
Figure 3496jpg

Room No.	Room Name	Type / Finish	Comments	photograph
9	Bedroom		Generally good condition. Curtains and carpet in good condition.	
	Orientation /Element name			
	Floor	Timber. Carpet finish	Good condition	
	Wall North	Sheet lining. Painted	Picture rails. Plaster is weak at the back of fireplace.	3496jpg
	Wall South	As above	Picture rails. Corner cupboard in timber boarding. Former shelf fixing holes.	3497jpg
	Wall East	As above	Picture rails. Solid Core panelled door painted.	3496jpg
	Wall West	As above. Cover moulds under west windows	Picture rails.	
	Skirting	Timber skirting. Painted	200mm high generally.	
	Ceiling	Fibrous plaster. Painted with flat finish.	Surface mounted pendant light.	3495jpg
	Cornice	75mm scotia timber. Painted		
	Fixtures	Mirrored cupboard door	Bevelled edge. Minor surface damage at base.

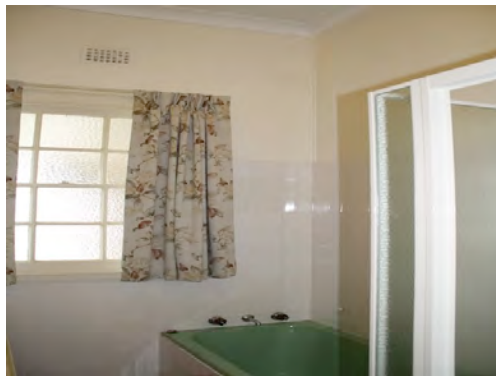
Figure 3507jpg

Room No.	Room Name	Type / Finish	Comments	photograph
12	Bathroom		Generally good condition. Curtains and tiles in good condition.	
	Orientation /Element name			
	Floor	Likely to be timber or compressed sheet. Tile finish		
	Wall North	Plasterboard. Ceramic Tile	Corner crack to cover mould in north-east corner.	3508jpg
	Wall South	As above	Ceramic tile to shower and over bath. Tiles marked at high level in central location.	
	Wall East	As above		3507jpg
	Wall West	As above. Glazed highlight		3506jpg
	Ceiling	Plasterboard. Painted	Crack north/south in centre. Simple cowl light fitting.	
	Cornice	90mm Scotia. Painted	Crack in east section of cornice.	
	Fixtures	Vanity basin. Bench. Acrylic top and basin.	Good condition	
		Exhaust Fan		
		Bath. Shower	Cast Iron bath. Good condition	3507jpg
	Comment		Sound with exception of crack in north-east corner. Fixtures are serviceable.

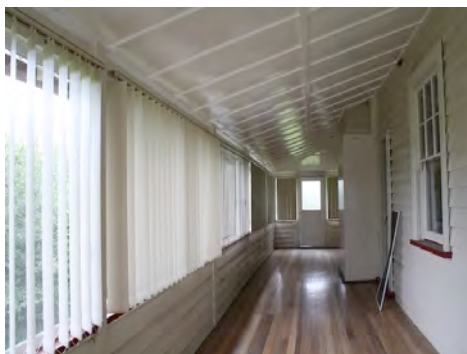
Figure 3516jpg

Room No.	Room Name	Type / Finish	Comments	photograph
15	South Verandah		Generally good condition. South verandah appears to be an addition.	
	Orientation /Element name			
	Floor	Timber. 65mm wide T&G board. Clear finish.	Good condition.	3515jpg
	Wall North	Splayed and chamfered weatherboards. Painted.	Wall vents partially covered by ceiling.	3516jpg
	Wall South	Splayed and chamfered weatherboards. Painted. Aluminium sliding windows over.	Good condition	3516jpg
	Wall East	Splayed and chamfered weatherboards. Painted.	Good condition	3513pg 3514jpg 3515jpg
	Wall West	Splayed and chamfered weatherboards. Painted.	Good condition	3516jpg
	Ceiling	Plywood or masonite	Cover battens. Painted gloss.	3517jpg
	Fixtures	Chimney	Rendered masonry. Painted.	3517jpg
	Comment		Minimal artificial lighting. One light in south-east corner. Floors have good fall outwards.

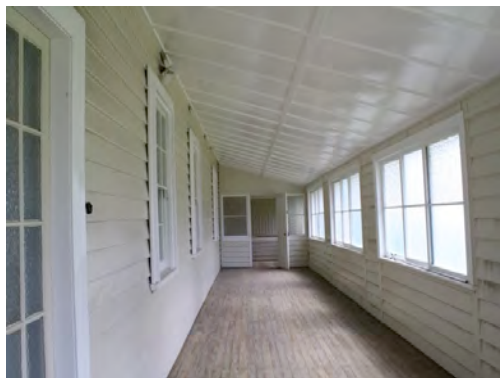
Figure 3519jpg

Room No.	Room Name	Type / Finish	Comments	photograph
16	West Verandah		Generally good condition.	
	Orientation /Element name			
	Floor	Timber. 65mm wide T&G board. Unfinished.	Previous vinyl finish removed.	3518jpg
	Wall North	Splayed and chamfered weatherboards to lower level. Windows with patterned glass to upper level.	Wall vents partially covered by ceiling.	3518jpg
	Wall South	As above	Good condition	3519jpg
	Wall East	Splayed and chamfered weatherboards. Painted.	Good condition	3519jpg
	Wall West	Splayed and chamfered weatherboards. Painted. Timber sliding windows over.	Good condition	3518jpg
	Ceiling	Plywood or masonite	Cover battens. Painted gloss.	3519jpg
	Fixtures	Wood box	Located in north-west corner.	3518jpg
			2 wall lights in east wall. One missing diffuser cowl.	3519jpg
	Comment		Good condition. Floor has good fall outwards.

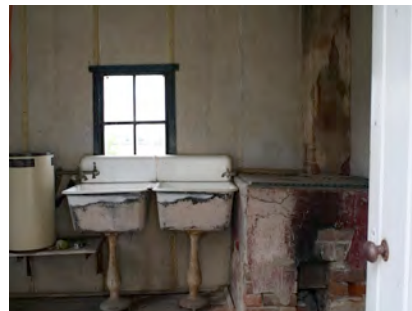
Figure 3440jpg

Gutters	Galvanised Iron. Quad. Painted	Check watertightness and replace if required. Repaint.	3438jpg
	Fixtures	Laundry sinks (number 2)	Cast iron on pedestals. Conserve.	3440jpg
		Cool room		3440jpg
		HWS		3441jpg
		Pump		3443jpg
		Copper	Set in partially rendered brick structure. Conserve copper in situ.	3442jpg 3440jpg

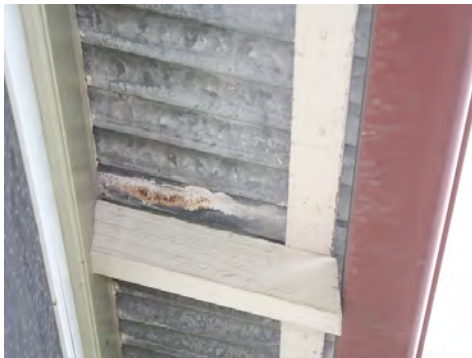
Figure 3531.jpg

East Elevation	Splayed and chamfered weatherboards. Painted.	Paint weatherboards when required. Repair boards at ends where end-grains are deterioration and replace if required	3431jpg 3430jpg 3434jpg
	West Elevation	Splayed and chamfered weatherboards. Painted.	Paint weatherboards when required. Repair boards at ends where end-grains are deterioration and replace if required.	3528jpg 3453jpg 3456jpg 3458jpg
	Enclosed Verandah	Splayed and chamfered weatherboards. Painted	Sliding timber windows. Maintain and protect this area.	
	Roof	Corrugated Iron	Signs of some oxidation and deterioration. Replace only those sheets that allow water penetration and only if required. Replace with matching galvanised iron profile.	3426jpg 3531jpg
	Gutters	Quad. Colorbond	Replace gutters and downpipes if required. Replace with half round gutters and circular diameter downpipes in galvanised steel or colorbond.	3531jpg

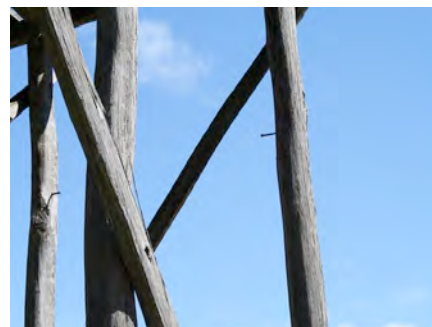
Figure 3549jpg

Item No.	Name	Type / Finish	Comments	photographs
2 and 3	Water Tank			
	Orientation /Element name			
	Support Structure	Timber Logs	Timber logs in ground as supports posts. Machined timber cross bracing bolt fixed to posts. Check and repair joints if required with galvanised wire and new galvanised bolts where required. Retain existing timber members and install new secondary timber structure where required.	3405jpg 3410jpg 3549jpg 3547jpg
	Platform for Water Tanks	Timber	Machined timber bearers and joists. Spaced timber boards showing signs of rot. Remove tanks and repair platform. Replace boards where required.	3409jpg 3407jpg
	Water Tank	Galvanised Iron	Galvanised iron oxidised and deteriorated. Remove loose sections of galvanised iron. Tanks may need to be removed as platform unstable and loose sections of iron. Replace with new Galvanised Steel tanks.	3408jpg 3409jpg
	Plumbing	Galvanised steel pipes	Remove plants from base of tanks. Repair plumbing and do not water around posts.

The Water Tanks are a significance part of the rural complex and should be protected and preserved. The galvanised tanks have deteriorated to such an extent that it may be hard to secure these and they could present a danger in high winds and hence it would be practical to remove the tanks. New galvanized water tanks should be installed if the existing cannot be secured. The tank stands should be protected and preserved. This will require repair work to fix the platforms and fixing of all structural members. New galvanized steel bolt fixings should be used and the original fixings retained. Galvanised wire can also be used to reinforce joints.

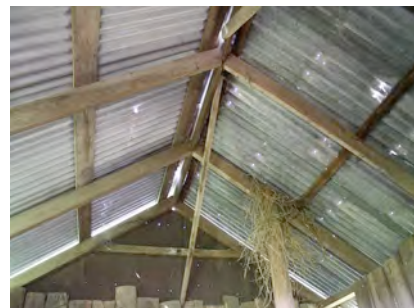
Figure 3557jpg

Room No.	Room Name	Type / Finish	Comments	Photographs
5	Stables		Stable has been built from recycled materials surrounded by post and rail fenced yard. Slabs are machined with circular saw markings and no evidence of adze working. Slabs are fixed with galvanised wire and nails.	3558jpg
	Orientation /Element name			
	Wall North	Timber slab	Machined timber slabs with circular saw markings. Stamped sheet iron to gable end.	3413jpg 3414jpg
	Wall East		Log supports. Machined timber slabs.	3412jpg
	Wall South	Timber	Log supports and machined timber slabs. Open to yard fenced with timber post and rail.	3418jpg 3419jpg
	Wall West	Timber	Log supports and machined Timber slabs.	3567jpg 3415jpg 3416jpg
	Ceiling/ Roof	Galvanised Steel	Galvanised steel shows signs of oxidation and pitting. Machined timber purlins and rafters.	3557jpg
	Floor	Dirt . brick and sandstone flagging	Likely to be reused material from older outbuilding.

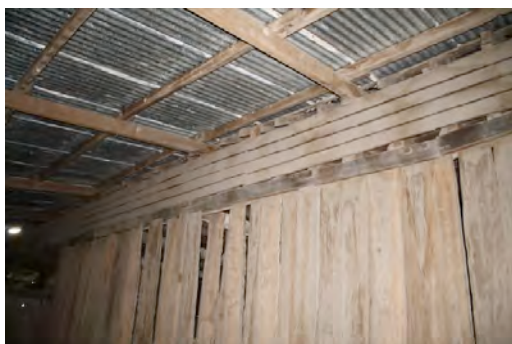
Figure 3643jpg

Ceiling	Underside of Galvanised Iron roof	Machined timber rafters and purlins.	3643jpg
	Columns/posts	Timber logs. Hewn squared timber posts.		
	Floor	Close spaced timber boards	Timber T&G boards to east section. Deterioration and some structural collapse in floor. Timber boards butt jointed in western section of room. Check for termites and place new secondary floor members if required.	
	Fixtures	Shearing Machines	Remnants of shearing machines stamped <i>Lister</i> . Paint shearing machines with penetrol.	3633jpg 3635jpg 3647jpg 3650jpg

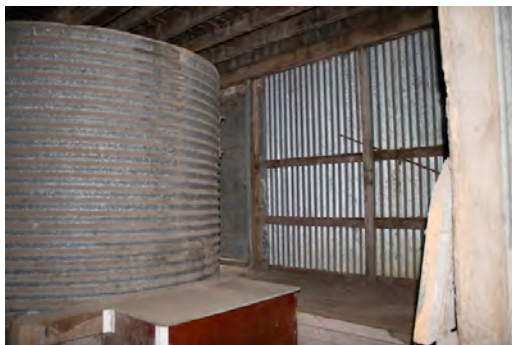
Figure 3652jpg

Fixtures	Water Tank	Galvanised steel on a timber base	3651jpg
		Timber chest	Timber clad box along length of southern wall appears to be for storage.

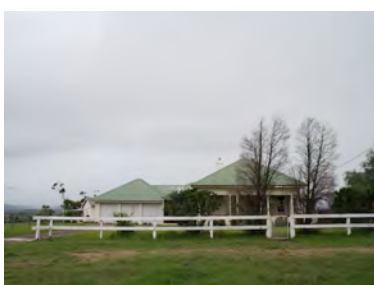
Figure 3426jpg

Built Item	Fences	Type / Finish	Comments	Photographs
	Name Refer to Figure 3 Site Plan for fence location			
	Orientation /Element name			
	House / Garden F1		Surrounding the House and Garden: Timber post and rail painted. Fence built with timber logs in ground and machined timber rails. Fixed with nails and notch in posts. Galvanised steel garden gate and steel grid -Maintain and paint fences and gate when required.	3426jpg 3427jpg 3455jpg
	Stable F2 F3		Adjacent to Building 4: Timber slab fence and timber post and rail. Slab fence is a later construction built with machined slabs- Remove if required. Post and rail fence is built with recycled materials including early split slabs- Retain this fence as evidence of the use of this building.	3532jpg 3537jpg 3536jpg
	Stable F4 F5		Adjacent to Building 5: Post and rail enclosing horse training yard. Fence is a later construction built with second hand timbers and joined with galvanised wire- Remove this fence if required. Post and rail fence to the west shows signs of earlier use of wire in posts indicating use for sheep farming before cattle and horses- Preserve the post and rail fences to the west.	3418jpg 3419jpg 3568jpg 3569jpg

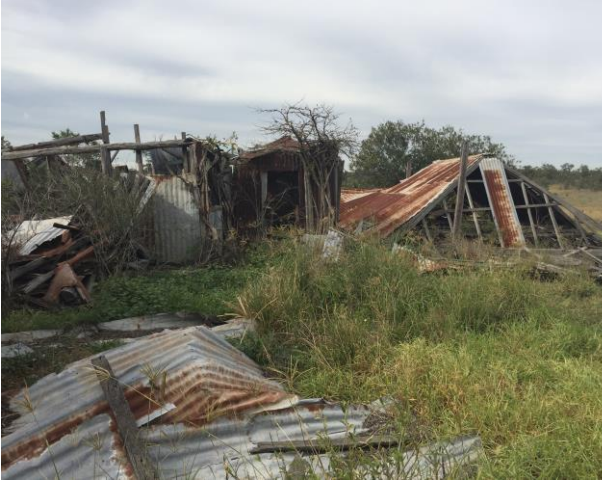
When listed as a heritage item, the building was still standing, however it has now entirely collapsed. The cottage had pressed metal ceilings, verandah on three sides and additional buildings to the north and east. There is no evidence of a chimney. A large collapsed corrugated iron shed is located to the south east of the cottage and another concrete and iron structure with a below ground cistern is located to the south. These buildings are located on what was formerly J H Zerk's land and were associated with dairying activities on the property.

Figure 4 The remains of Fairview and associated outbuildings

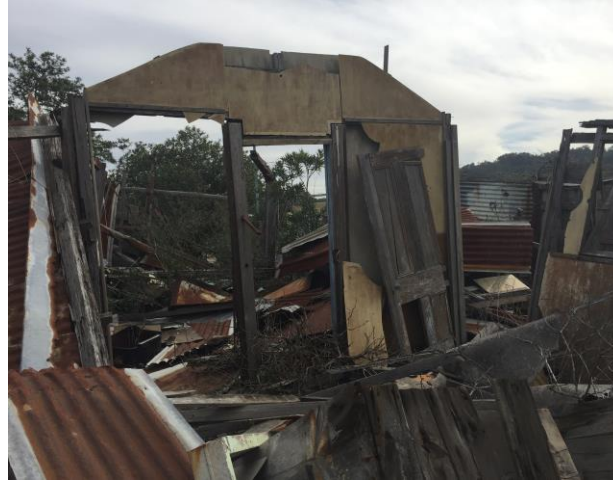
Figure 5 Latter additions to the rear and north of Fairview showing asbestos lining

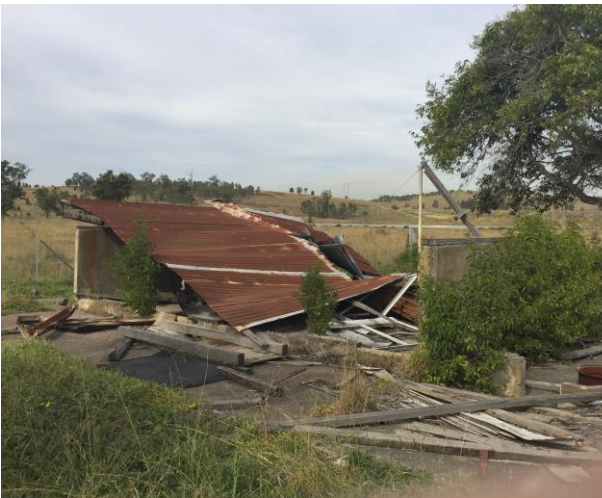
Figure 6 View of the shed to the south east

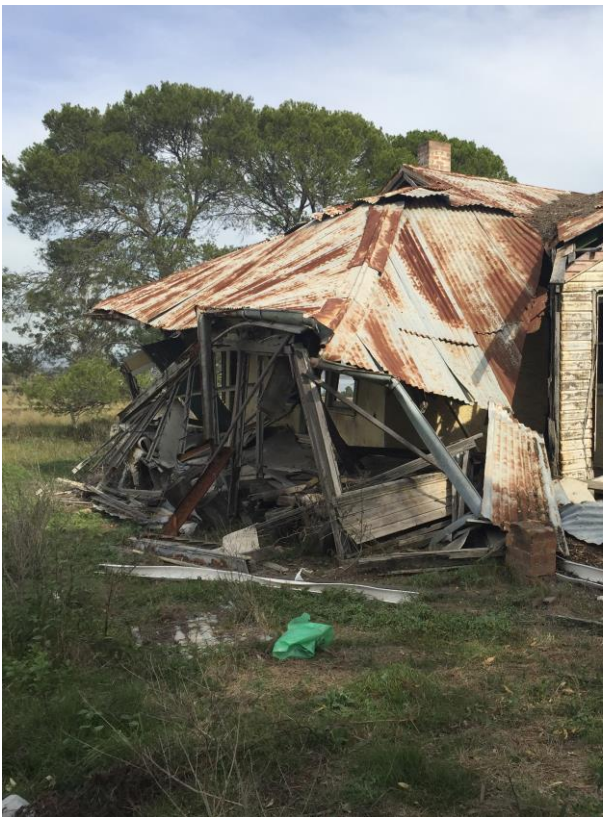
Figure 9 View of collapsing eastern side of Hillcrest

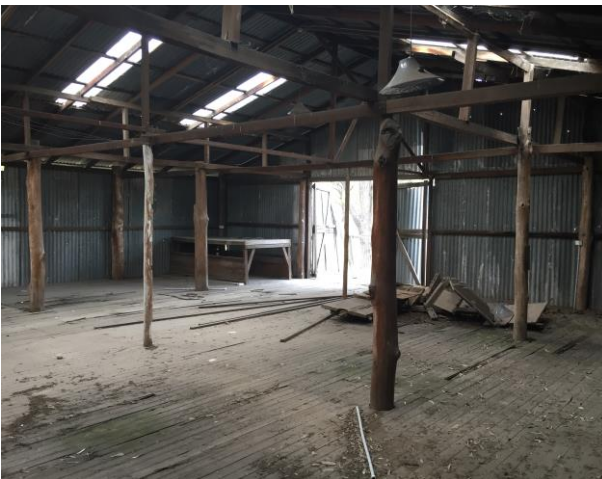
Figure 13 Interior shearing shed

There is a corrugated iron garage and sheds to the northwest of the main building and a laundry to the rear. Pines have been planted along fence lines and some exotic planting survives around the laundry. A shearing shed is located 100m to the north of the house and is in relatively good condition with original roof, walls, timber frames and foundations intact, while the floor and sheep pens are partially intact. The shearing shed comprised of a number of iron sheets that were branded 'Lysaght ORB Australia'. John Lysaght began importing corrugated iron into Australia in the 1850s. The first Australian Lysaght manufacturing plant opened in Newcastle in 1921, producing rolled and galvanised sheets. The shearing shed therefore post-dates 1921. Hillcrest has been assessed as significant in its demonstration of architectural development during the early part of the 20th century. Hillcrest is an example of one of the less wealthy subdivisions of this period.

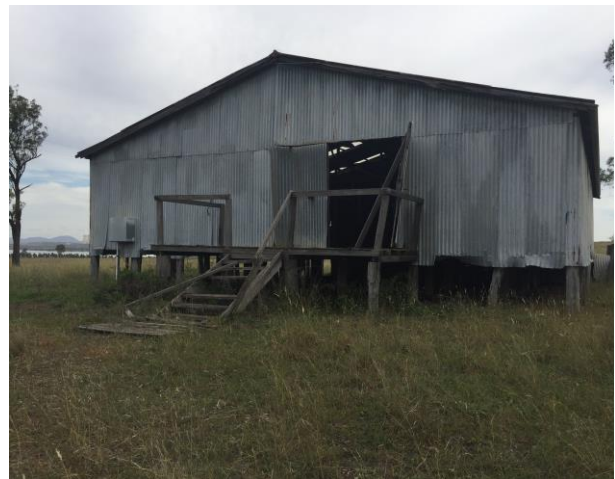
Figure 14 Exterior shearing shed

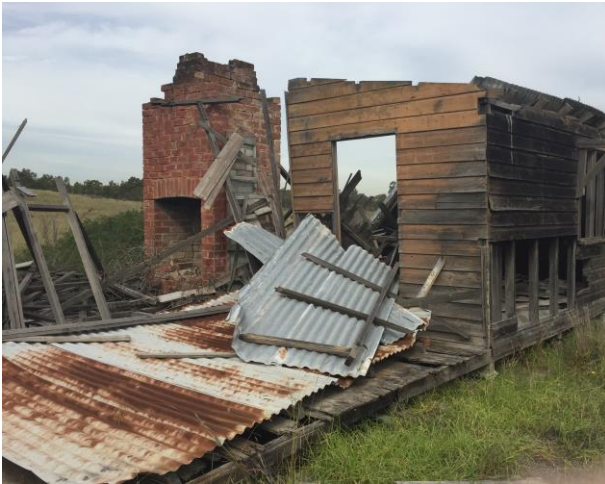
A small cottage is located approximately 700m to the east of the main house. It has almost completely collapsed, but appears to have comprised of weatherboard cladding, iron roof, three rooms, a large brick fireplace and verandah facing west. The style of the building, machine made bricks and use of 'rose head' nails indicate a date of late 19th century early 20th century. There are two large corrugated iron water tanks to the north of the house and fence lines and exotic plantings, including roses, are still evident. A wrecked car dating to the 1940s is located in the paddock to the north.

Figure 15 Rose cottage

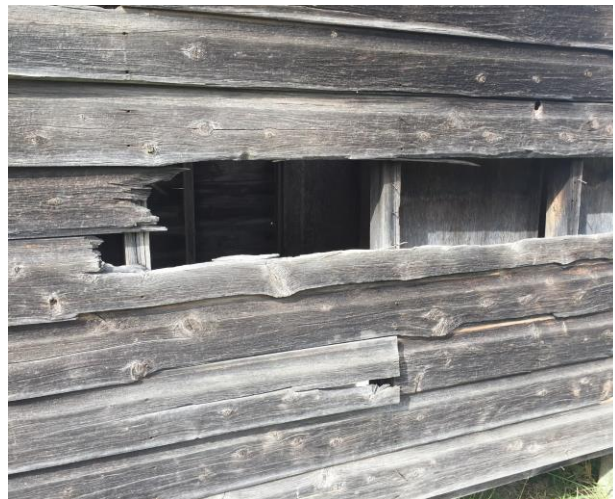
Figure 18 Weatherboards on the western side of Rose Cottage

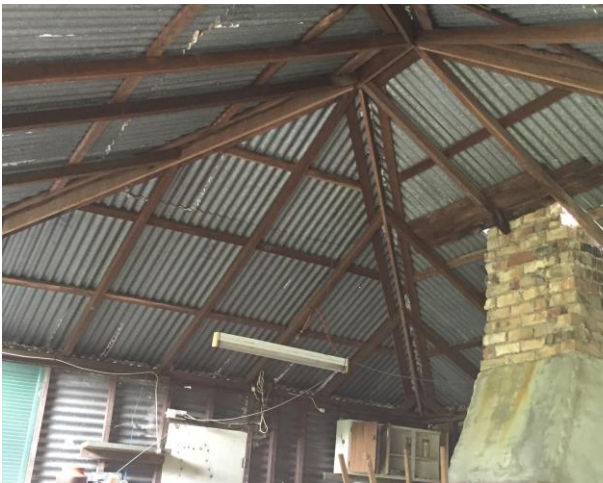
This simple cottage has a timber frame, corrugated iron clad walls and roof and a verandah on three sides. The interior was never clad and the large brick chimney is partially rendered in cement. The building has exposed wiring and a tank at the rear for water supply. The western side of the building has collapsed and a bathroom has been added to the rear. The interior contains several beds and it appears to have been in use by squatters. This simple building was likely to have been constructed in the middle of the 20th century as a temporary residence for farm workers.

Figure 22 Fire place chimney and interior roof structure at the Northern Valley Cottage

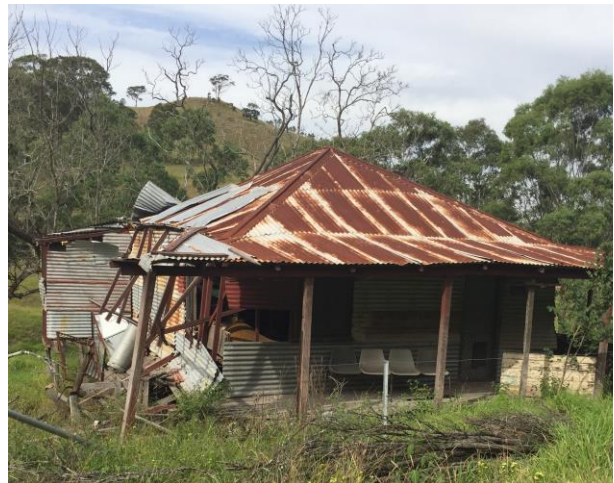
Figure 23 Northern Valley Cottage, the northern verandah has collapsed
