## BULGA COAL COMPLEX

### Annual Environmental Management Report 2010

**June 2011**

**GSS ENVIRONMENTAL**  
Environmental, Land and Project  
Management Consultants

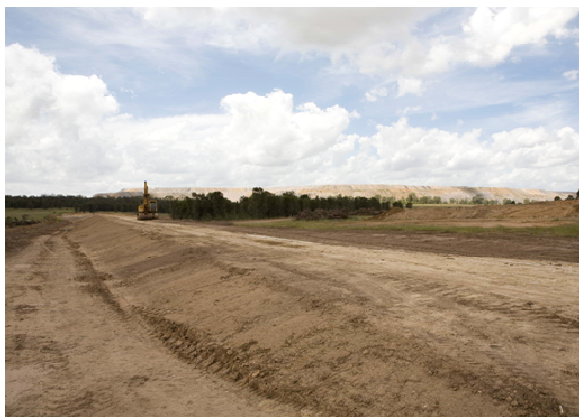
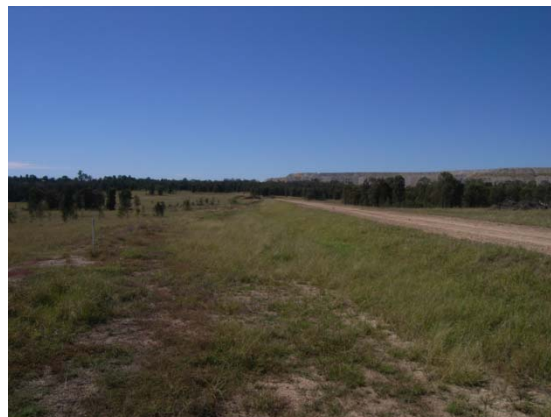
**Plate 2.1 – Wollombi Brook Flood Levee (2009, 2010)**

- The second main ventilation shaft and fan at Blakefield South was completed in 2010. This ventilation fan draws from the underground while the first ventilation fan now pushes air into the underground workings. Balancing the rate of both fans creates a positive pressure across the longwall mining face and increases the safety and rate at which mining can take place;
- Wollombi Brook Flood Levee. The flood levee commenced in late 2009 was completed and all exposed areas grassed in early 2010, see **Plate 2.1**;

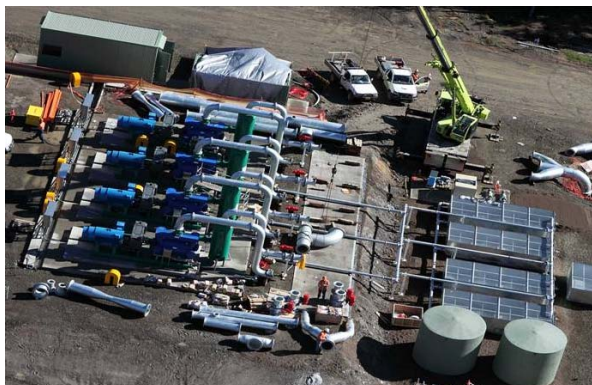
**Plate 2.2 – Goaf Gas Drainage Suction Plant**

- Goaf suction plant. The vacuum pumps and associated equipment was constructed beside the existing Energen gas flares, see **Plate 2.2**. Two of the four pumps were commissioned in 2010 with the remaining two coming on line in 2011; and

A Goaf suction plant, illustrated in **Plate 2.2** was constructed during 2010 and was operational by October 2010. Two of the four pumps of the facility are currently operating, with the intention to increase to full vacuum pumping in 2011. Underground in-seam gas drainage also took place during 2010. This involved the drilling of horizontal holes from the underground directly into the Blakefield seam to accelerate the extraction of methane in areas where the surface pre-mining drainage had not reduced the coal gas content to an acceptable level for development mining. The gas extracted by this process was drawn out by the surface gas wells.

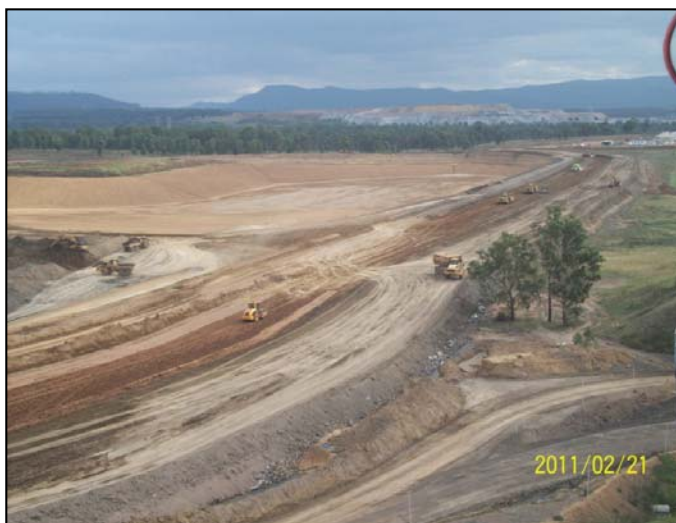
**Plate 2.3 – Construction of CHPP Surge Dam**

During 2010, the Bulga Coal Surface Operations commenced construction of a 3,000ML CHPP Surge Dam, seen in construction in **Plate 2.3**. This dam will form an integral component of the Bulga Coal Complex Water Management Plan (WMP), incorporating the Integrated Water Management System that will service both the Underground and Surface Operations in accordance with the operating philosophy documented in the approved WMP.

Dam construction was not completed during the 2010 reporting period. Ongoing delays which have resulted mainly from rainfall throughout 2010 have pushed the expected completion date to Quarter 3, 2011.

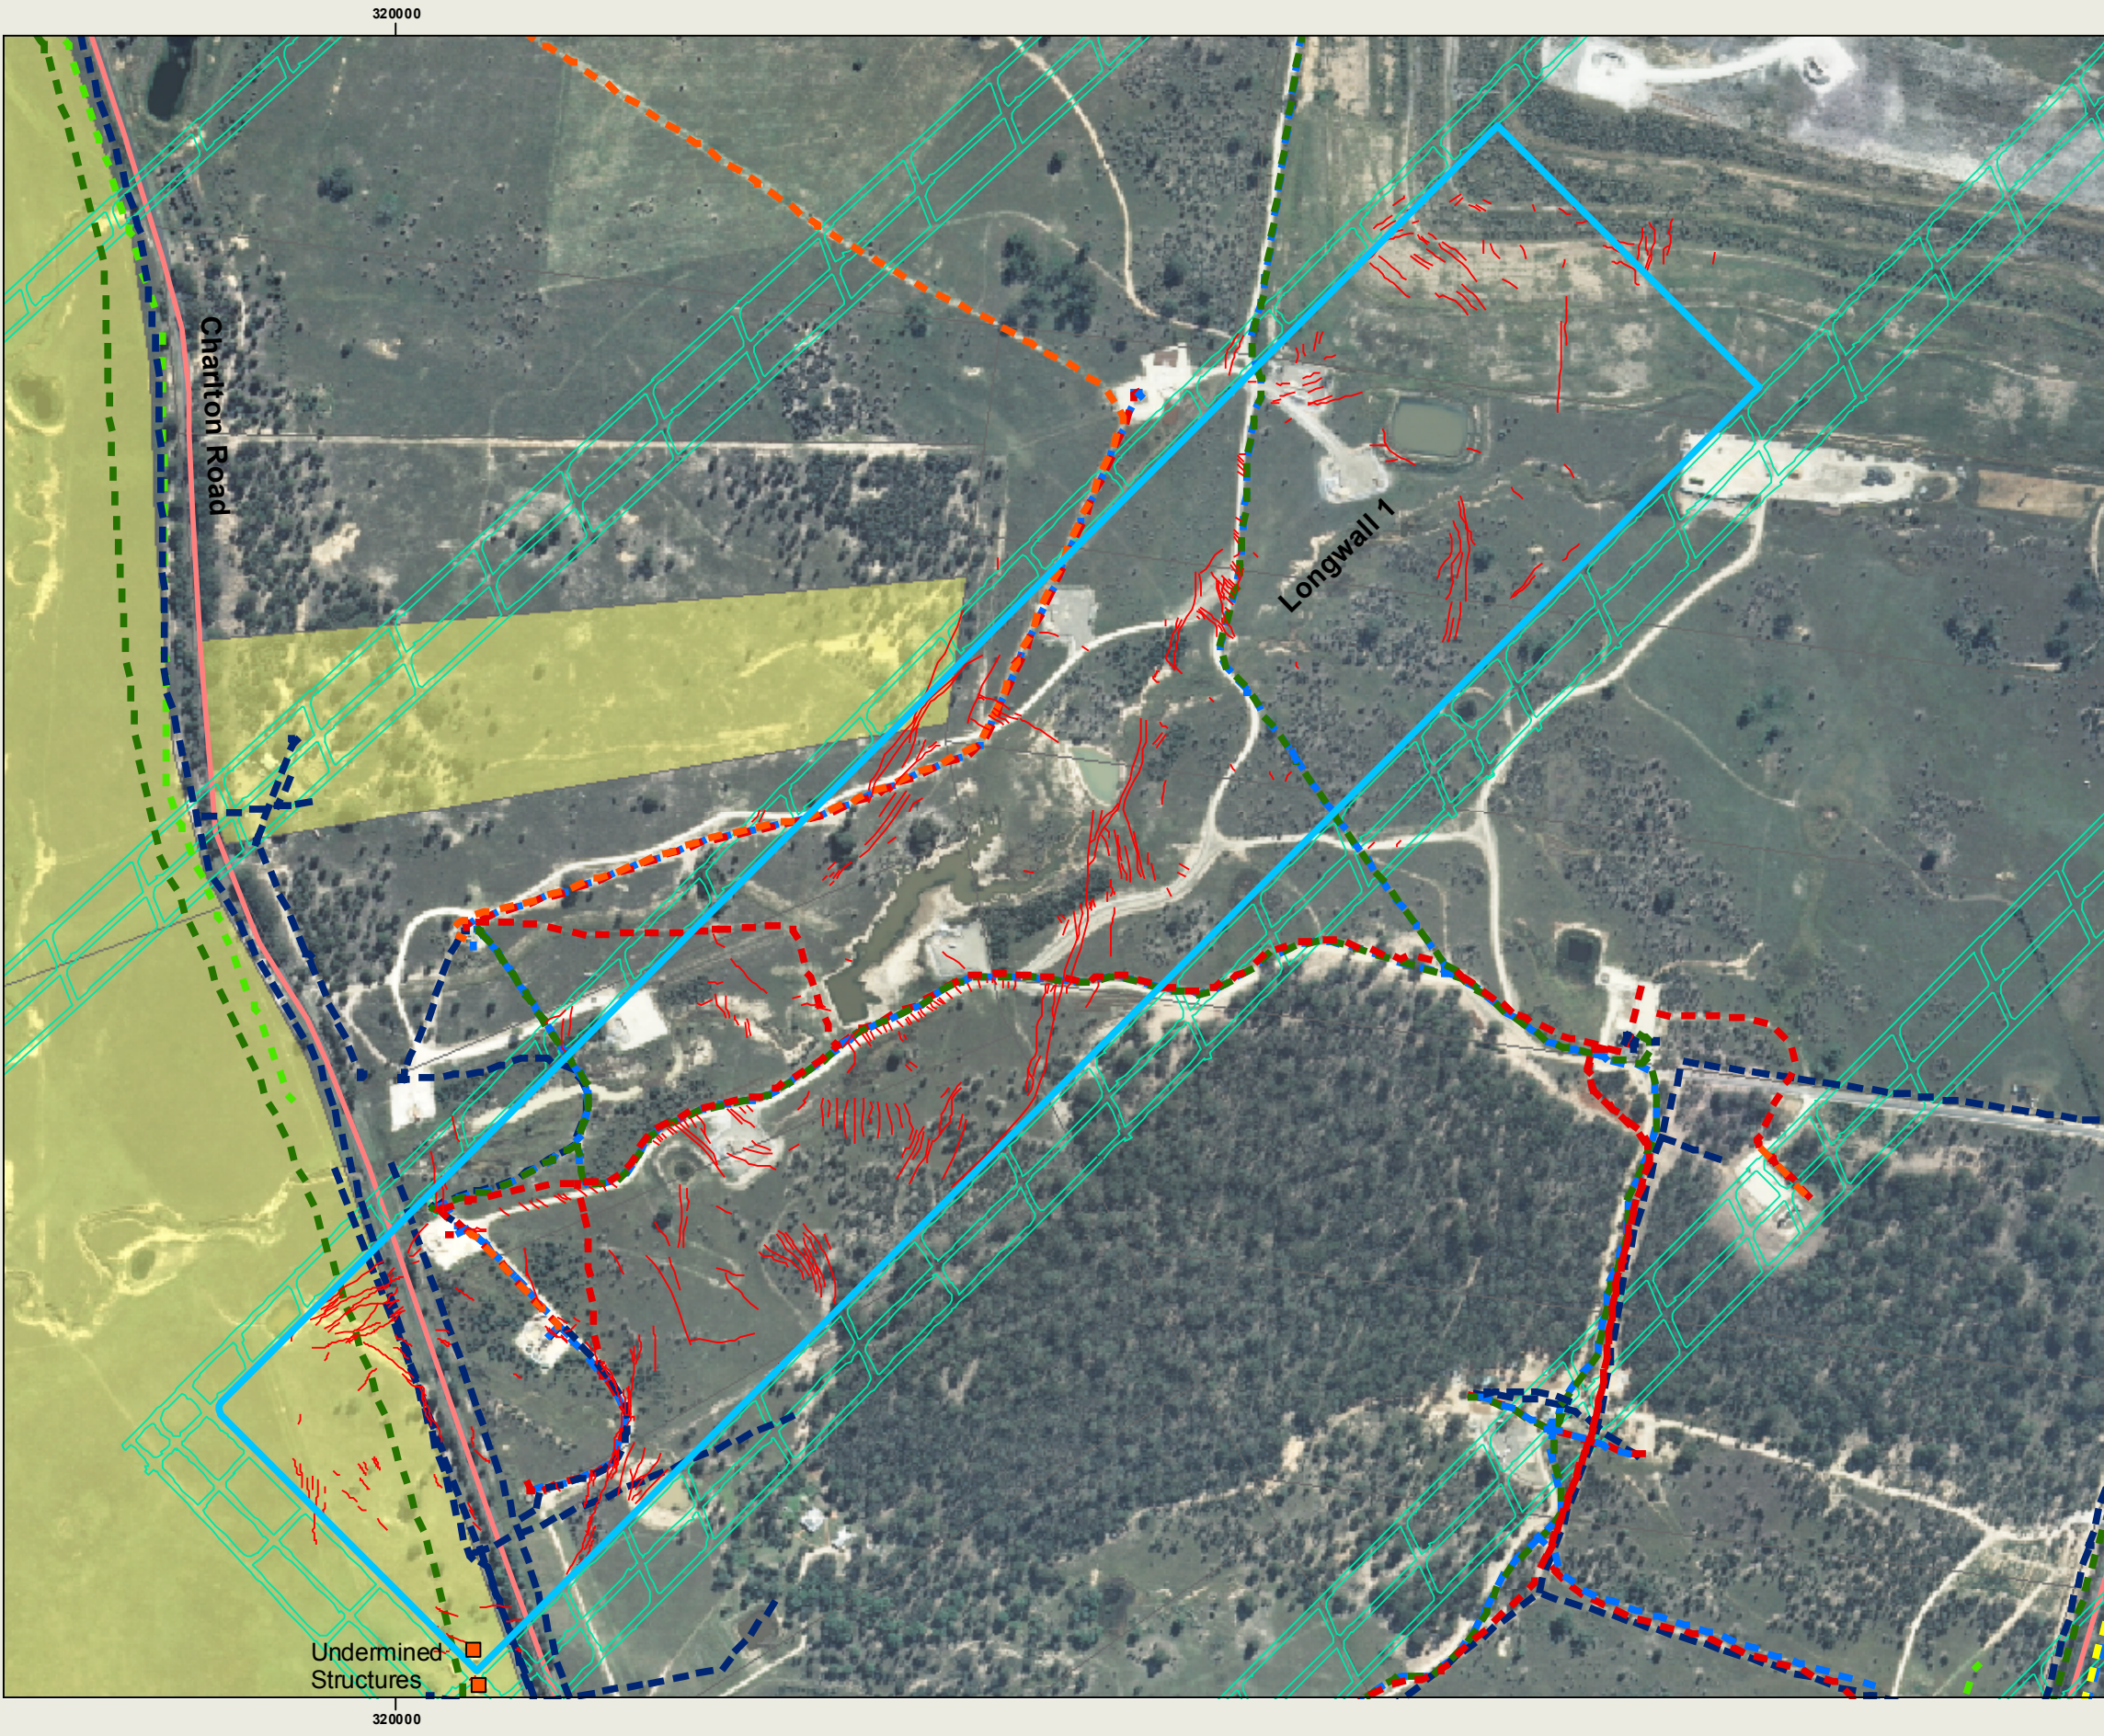
**Figure 3.9b**

**SUBJECT TO UNDERMINING (BLAKEFIELD SOUTH SEAM)**

-   Blakefield South Mine Workings
-   Area Undermined
-   Subsidence Repairs
-   Communications Service
-   Electrical Service
-   Mine Water Service
-   Telstra Service
-   Optic Fibre Service
-   Gas Drainage Service
-   PID Service
-   Road
-   Private Properties

**Figure 3.9A** and **3.9B** illustrate the areas subject to undermining in 2010.

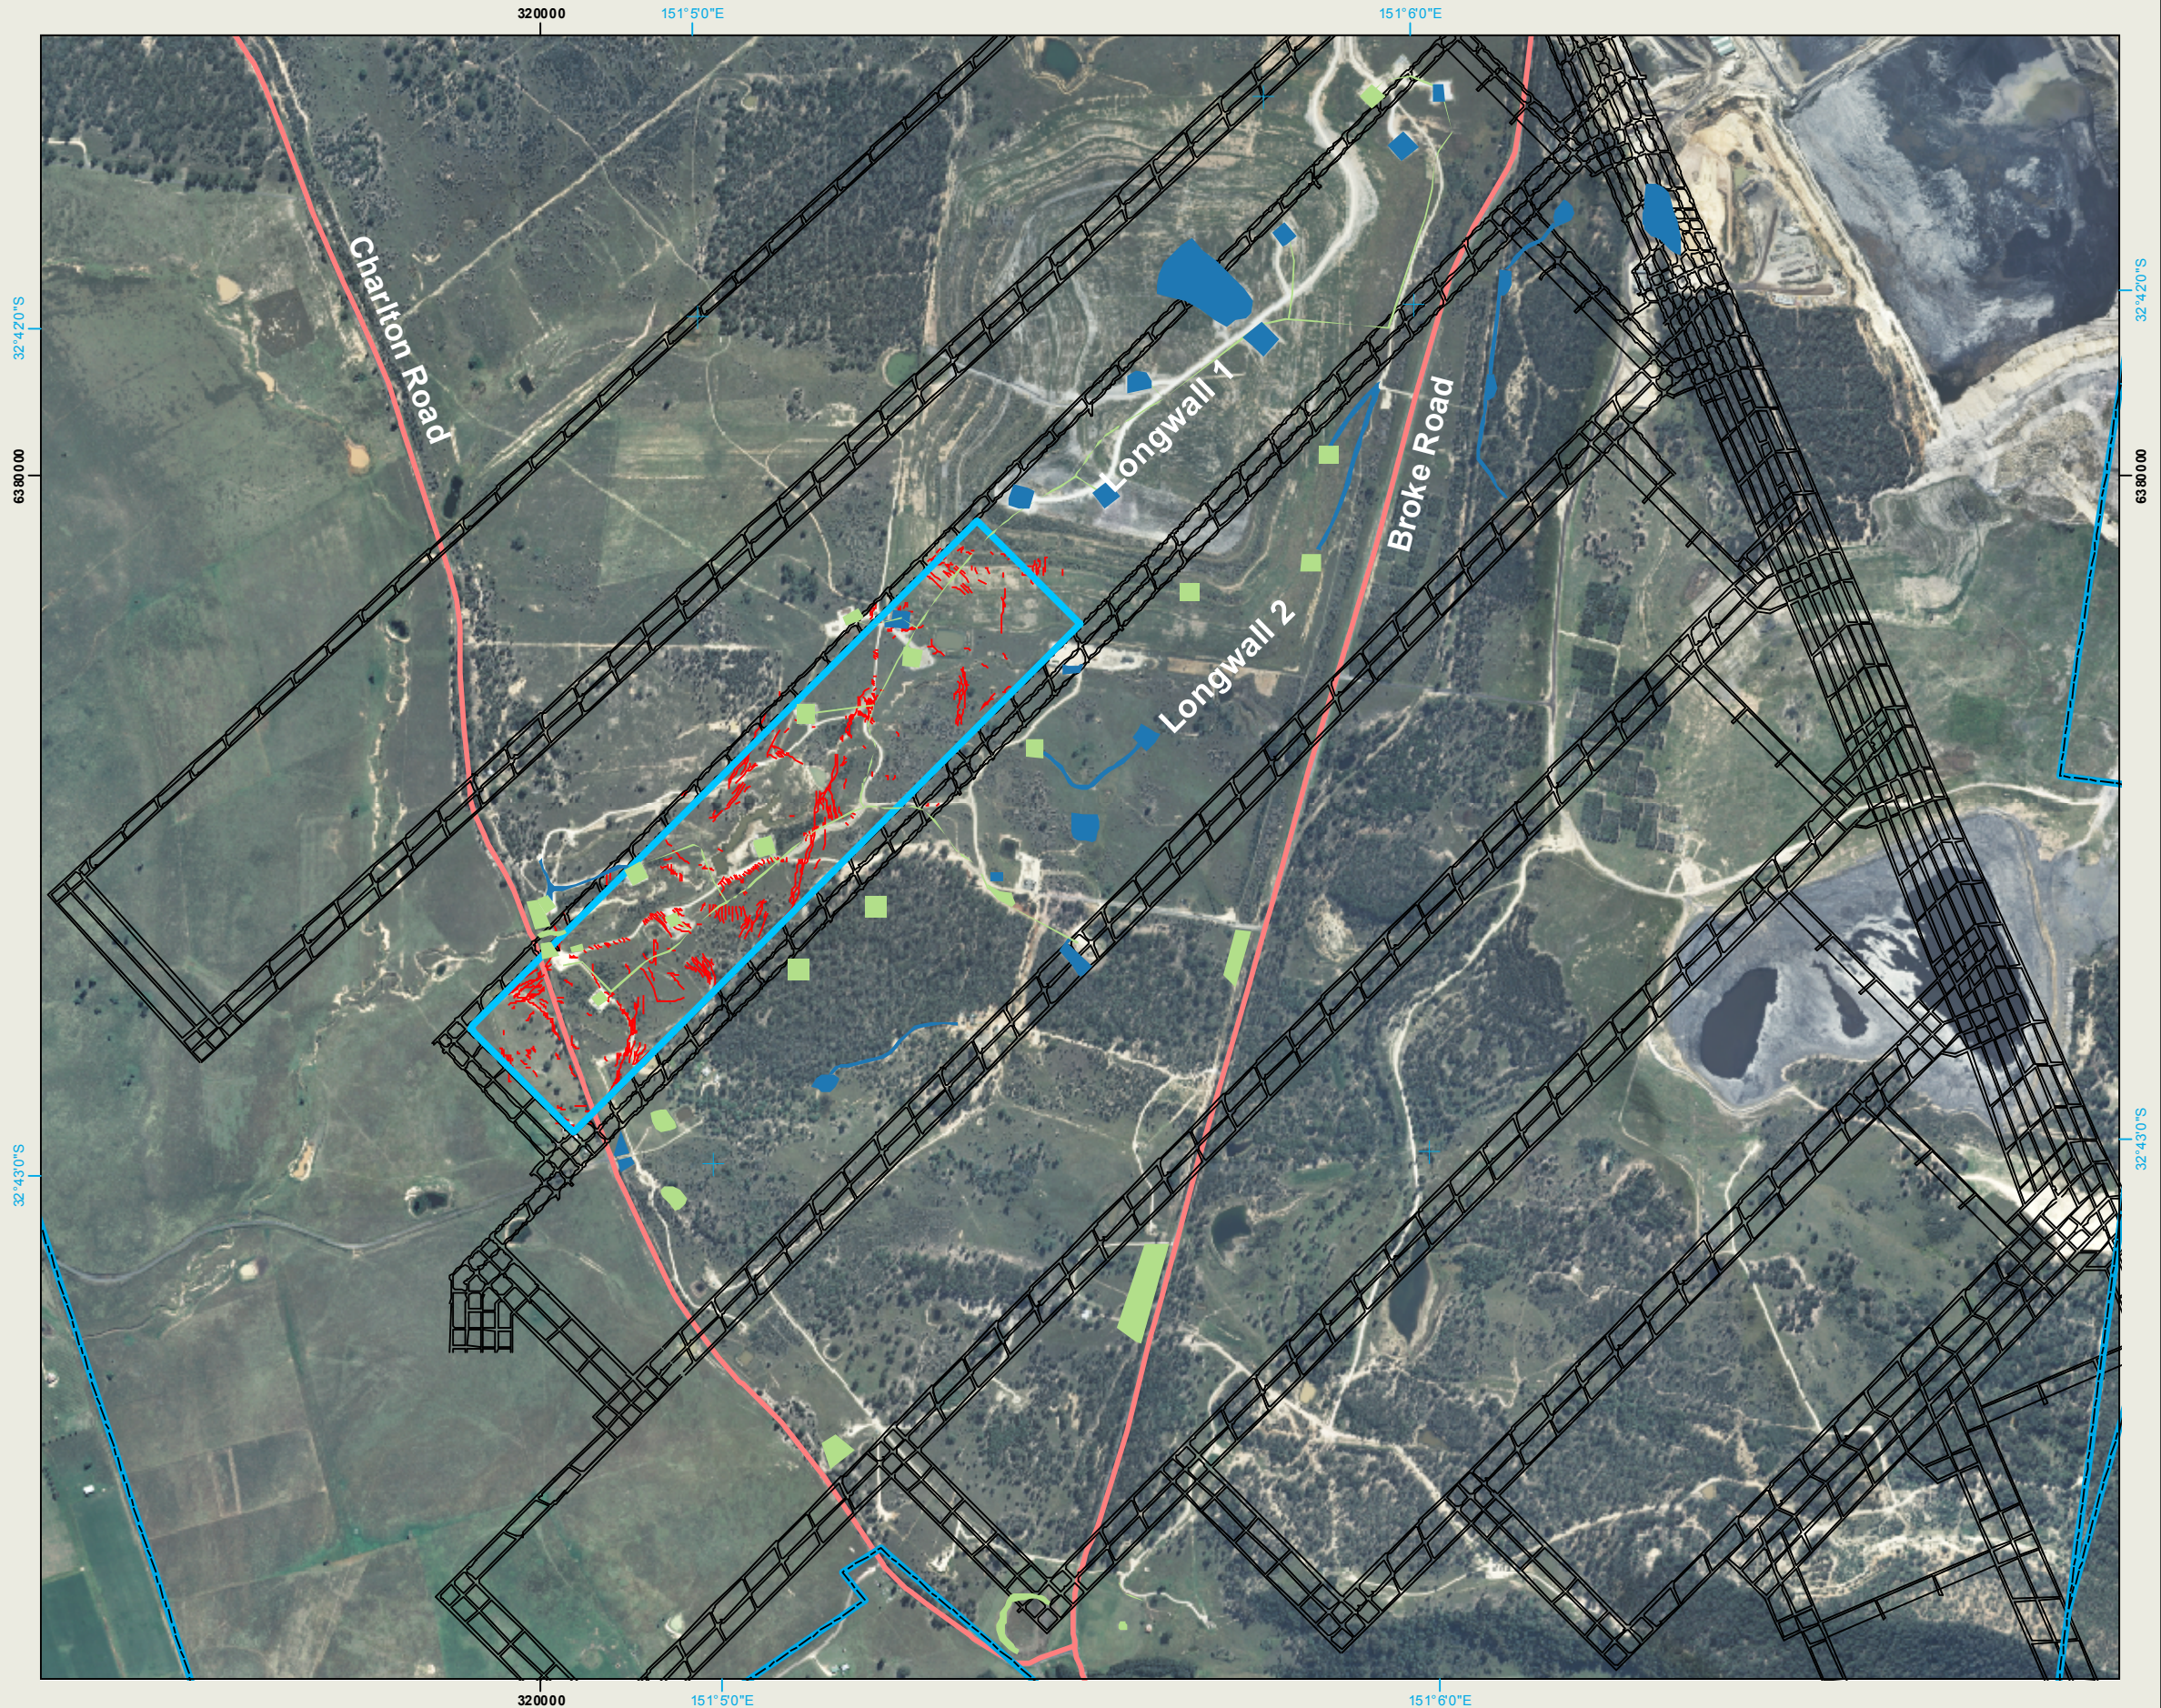
# Figure 5.1b

# TOTAL DISTURBANCE AND REHABILITATION (BLAKEFIELD)

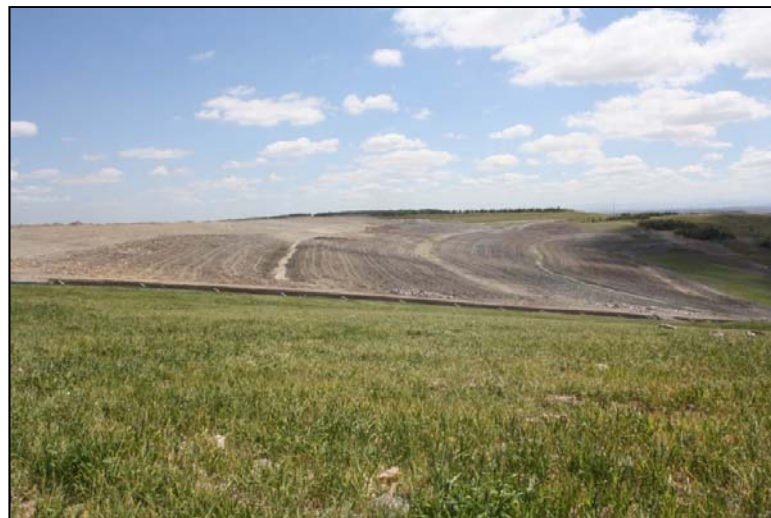
**Plate 5.1 – Ramp 12 Rehabilitation**

**Plate 5.1** shows the Ramp 12 rehabilitation completed in 2010. The foreground showing germination of the cover crop which was seeded in late September. The remaining area shown in the plate was seeded in December and as of early January minimal germination was observed.

In 2010 40 Hectares of pasture mix was sown in Q3 utilising two ameliorant treatments (5ha topsoil and 35ha compost). The pasture mix, as detailed below consisted of cover crop species, annual and perennials. A promising strike has been observed with the September seeding with constant light rainfall in the weeks following completion.

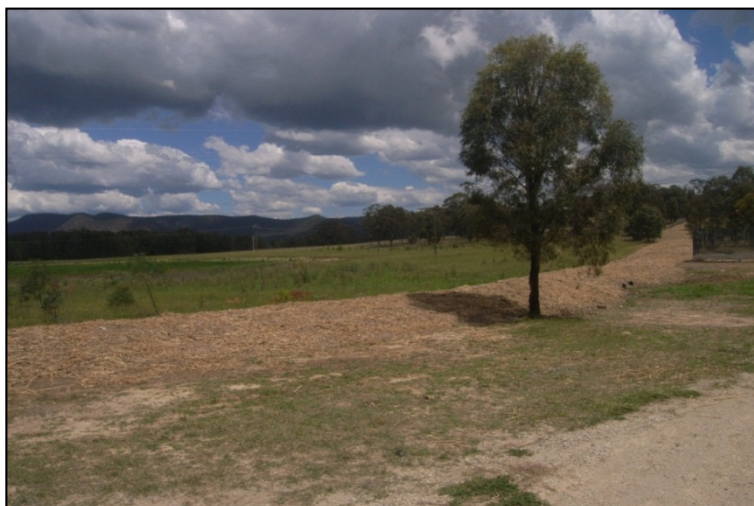
**Plate 5.2 – Before Seed Mix Application**

Pipelines were laid connecting goaf wells on Longwall 1 to the central gas flaring facility, creating a disturbance area of approximately 1.52ha. All pipelines have been rehabilitated during the reporting period, which involved lightly tilling the earthen bund covering the pipeline and spreading pasture seed mix. Due to the amount of pipelines laid out during the reporting period (and proposed for future underground mining at the Bulga Coal Complex) a Pipeline Rehabilitation Procedure was developed and implemented to standardise the rehabilitation process. **Plate 5.2** shows a pipeline near Broke and Charlton Road that has been seeded and spread with hay to encourage germination and surface cover on disturbed areas. **Plate 5.3** shows the same location at a later date with observed successful seed germination and stabilisation of the disturbed area.

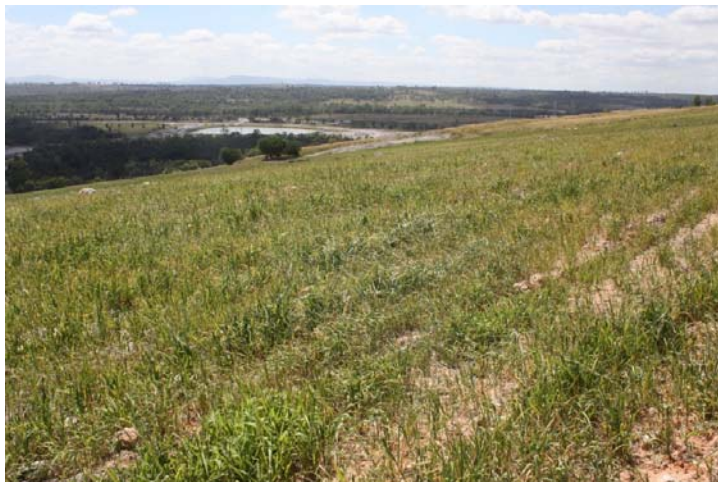
**Plate 5.4 – Ramp 12 Pasture Seed**

This rehabilitation approach is considered a trial because it is the first of such type of design to be applied at Bulga. Success of this design will promote an application of the design for future rehabilitation areas. **Plate 5.4** shows Ramp 12 pasture seed as seen facing an easterly direction.

The purpose of this structure is to convey runoff from the rehabilitated slope into a sediment dam for sediment control, promoting a stable landform.
