OCEANIC COAL AUSTRALIA LIMITED
Mining Operations Plan
Closure of the OCAL Complex

OCCP-SLR-DOM00-CM-RPT-001

Mining Operations Plan

Closure of the OCAL Complex

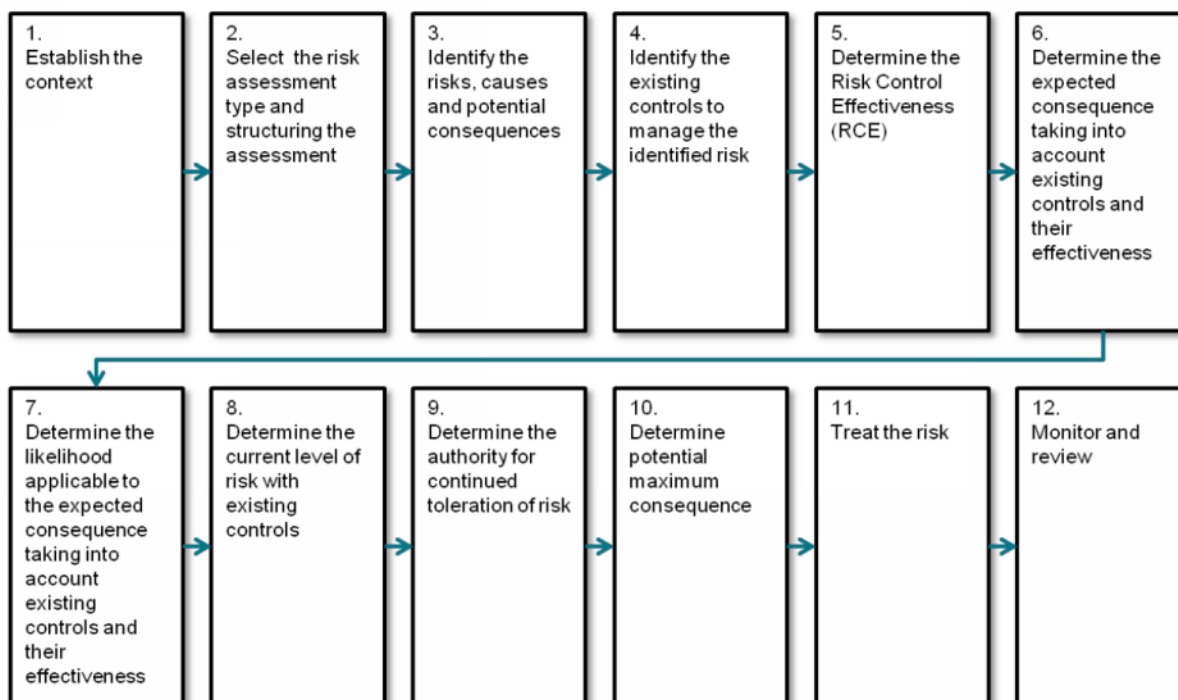
Figure 2 The 12 Steps Risk Management Process (GCAA Standard Risk Management)

The risk management process is summarised in **Figure 2**:

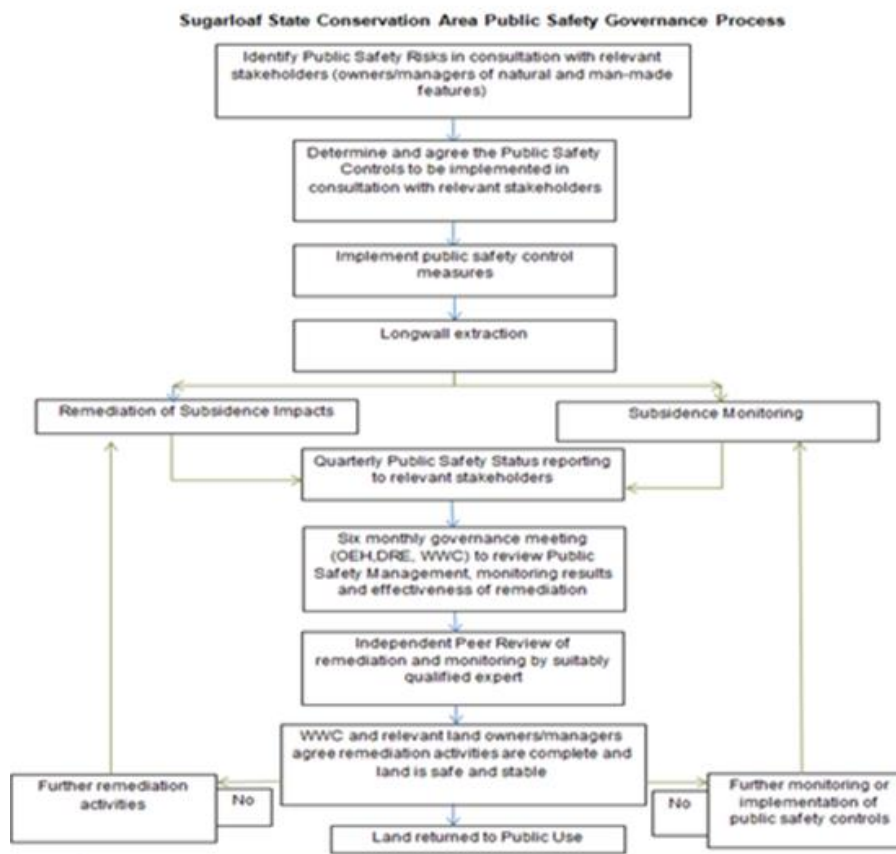
Figure 3 Sugarloaf State Conservation Area Public Safety Governance Process

OCAL is committed to remediating subsidence impacts that pose a risk to the public or the environment. OCAL has an extensive Public Safety Governance Process in place which has been developed in consultation with key stakeholders. An overview of this governance process is detailed in **Figure 3**.

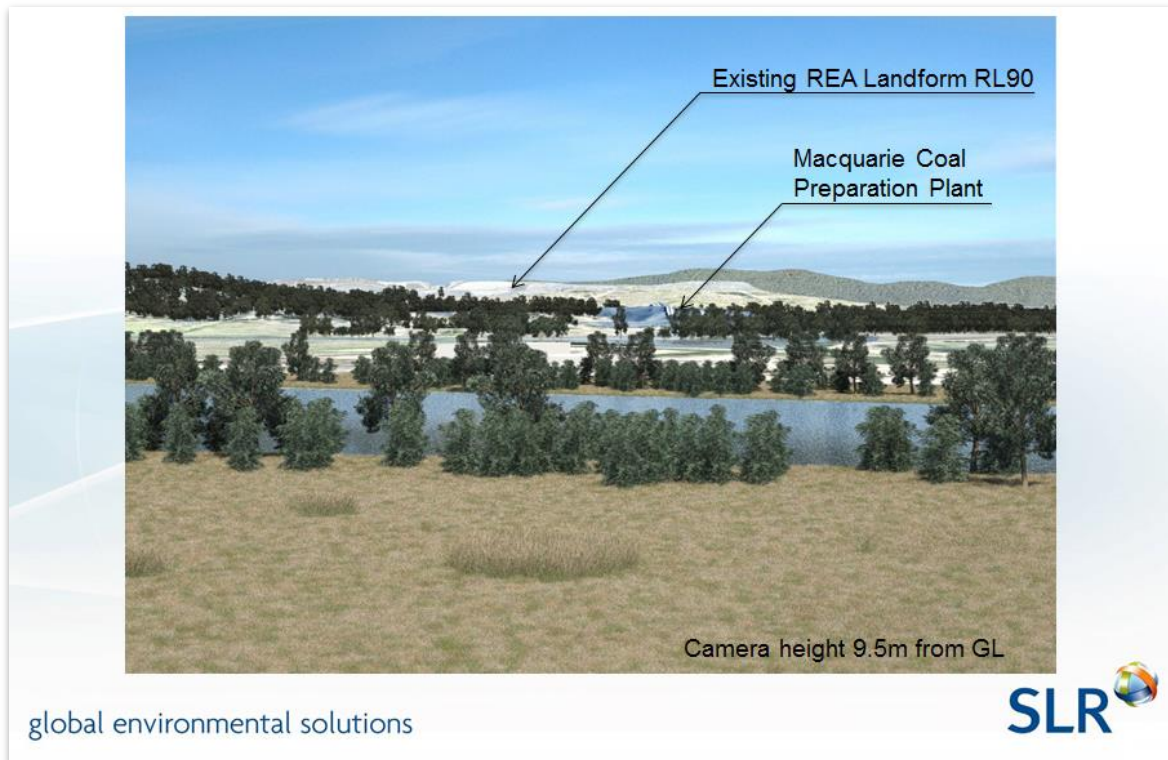
Figure 4 Existing view from TC Frith Avenue, Boolaroo (note camera height is 9.5m from ground level)

Figures 4 - 7 below show the modelled outputs for views from TC Frith Avenue as well as the Weir road in Boolaroo.

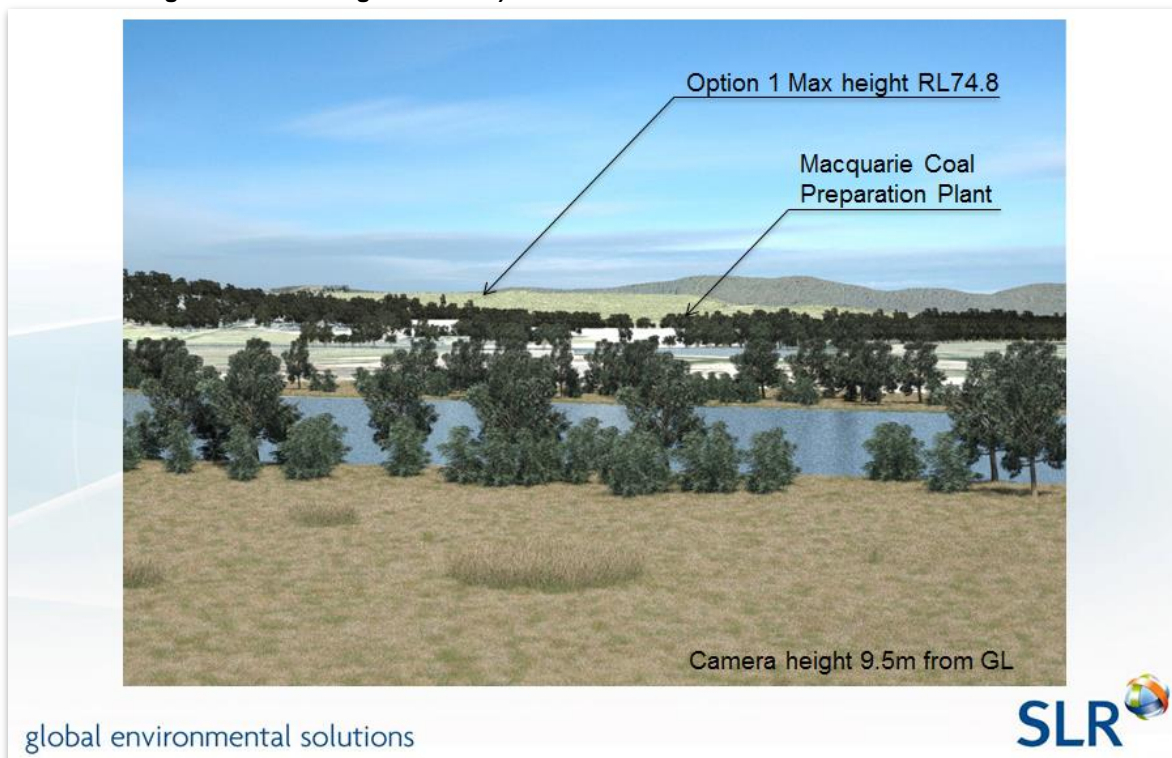
Figure 5 View from TC Frith Avenue, Boolaroo following reshaping and rehabilitation.(note camera height is 9.5m from ground level)

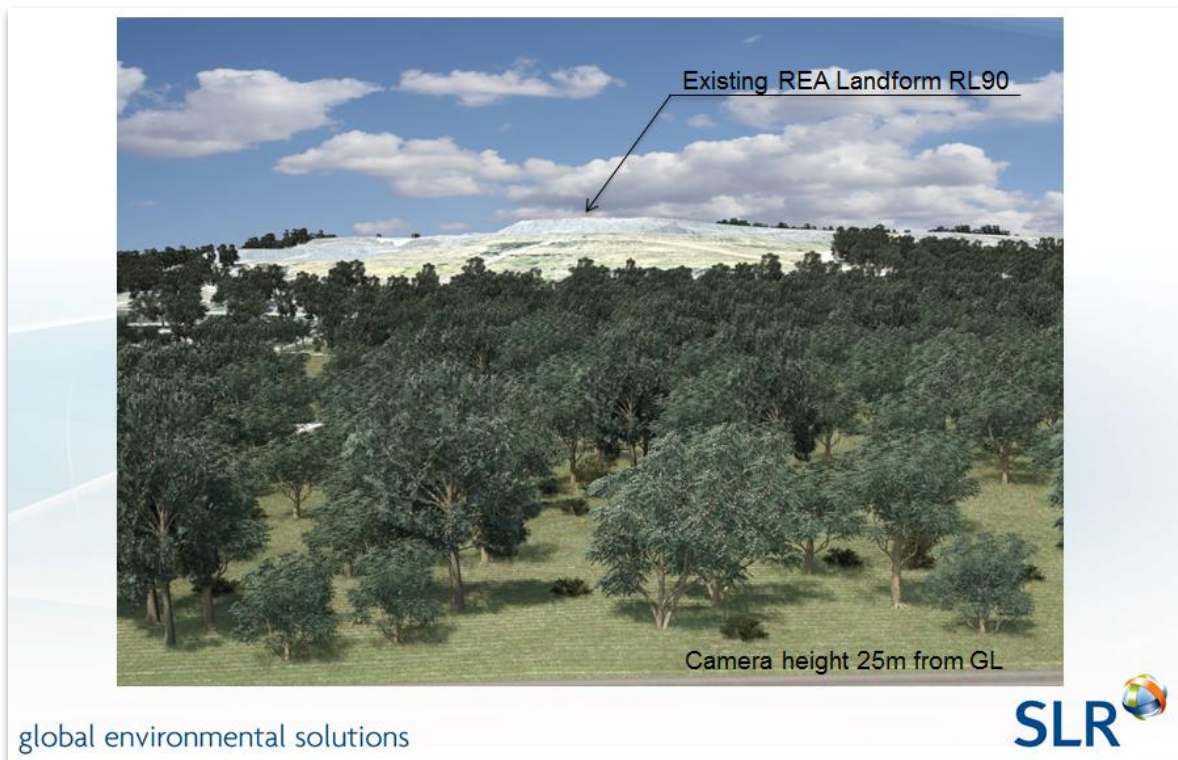
Figure 6 Existing view from Weir Road, Boolaroo (note camera height is 25m from ground level)

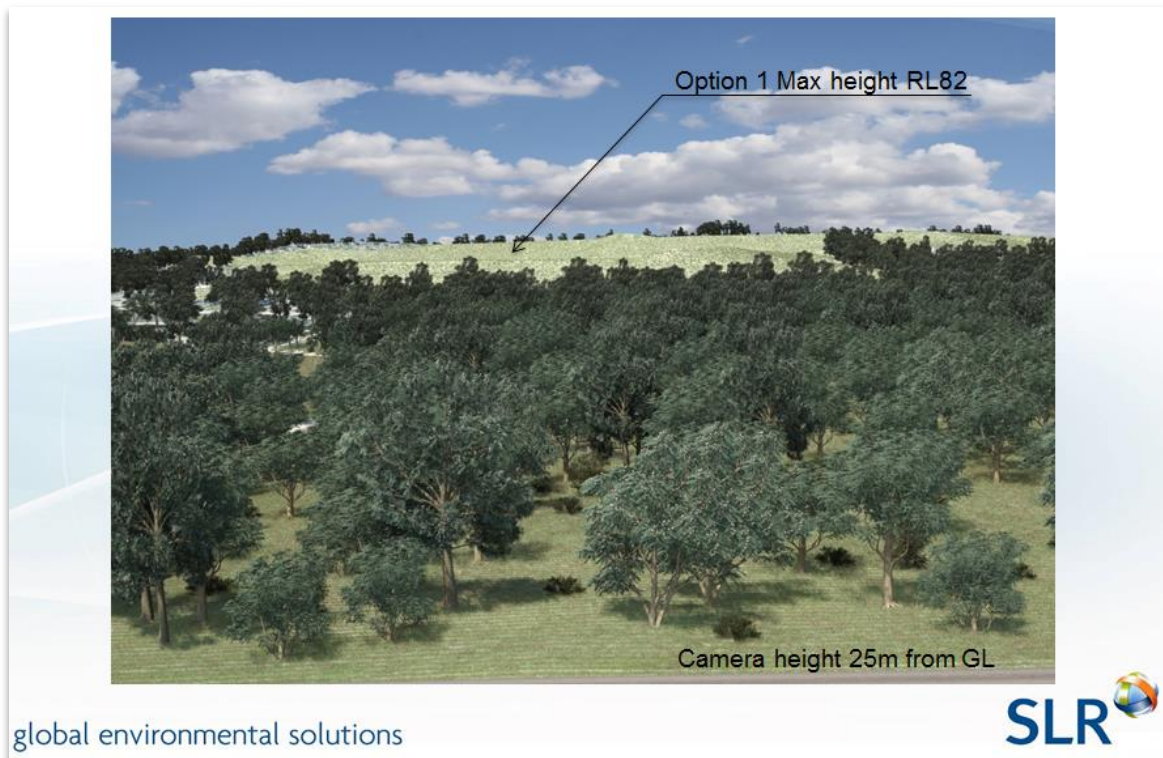
Figure 7 View from Weir Road, Boolaroo following reshaping and rehabilitation (note camera height is 25m from ground level)

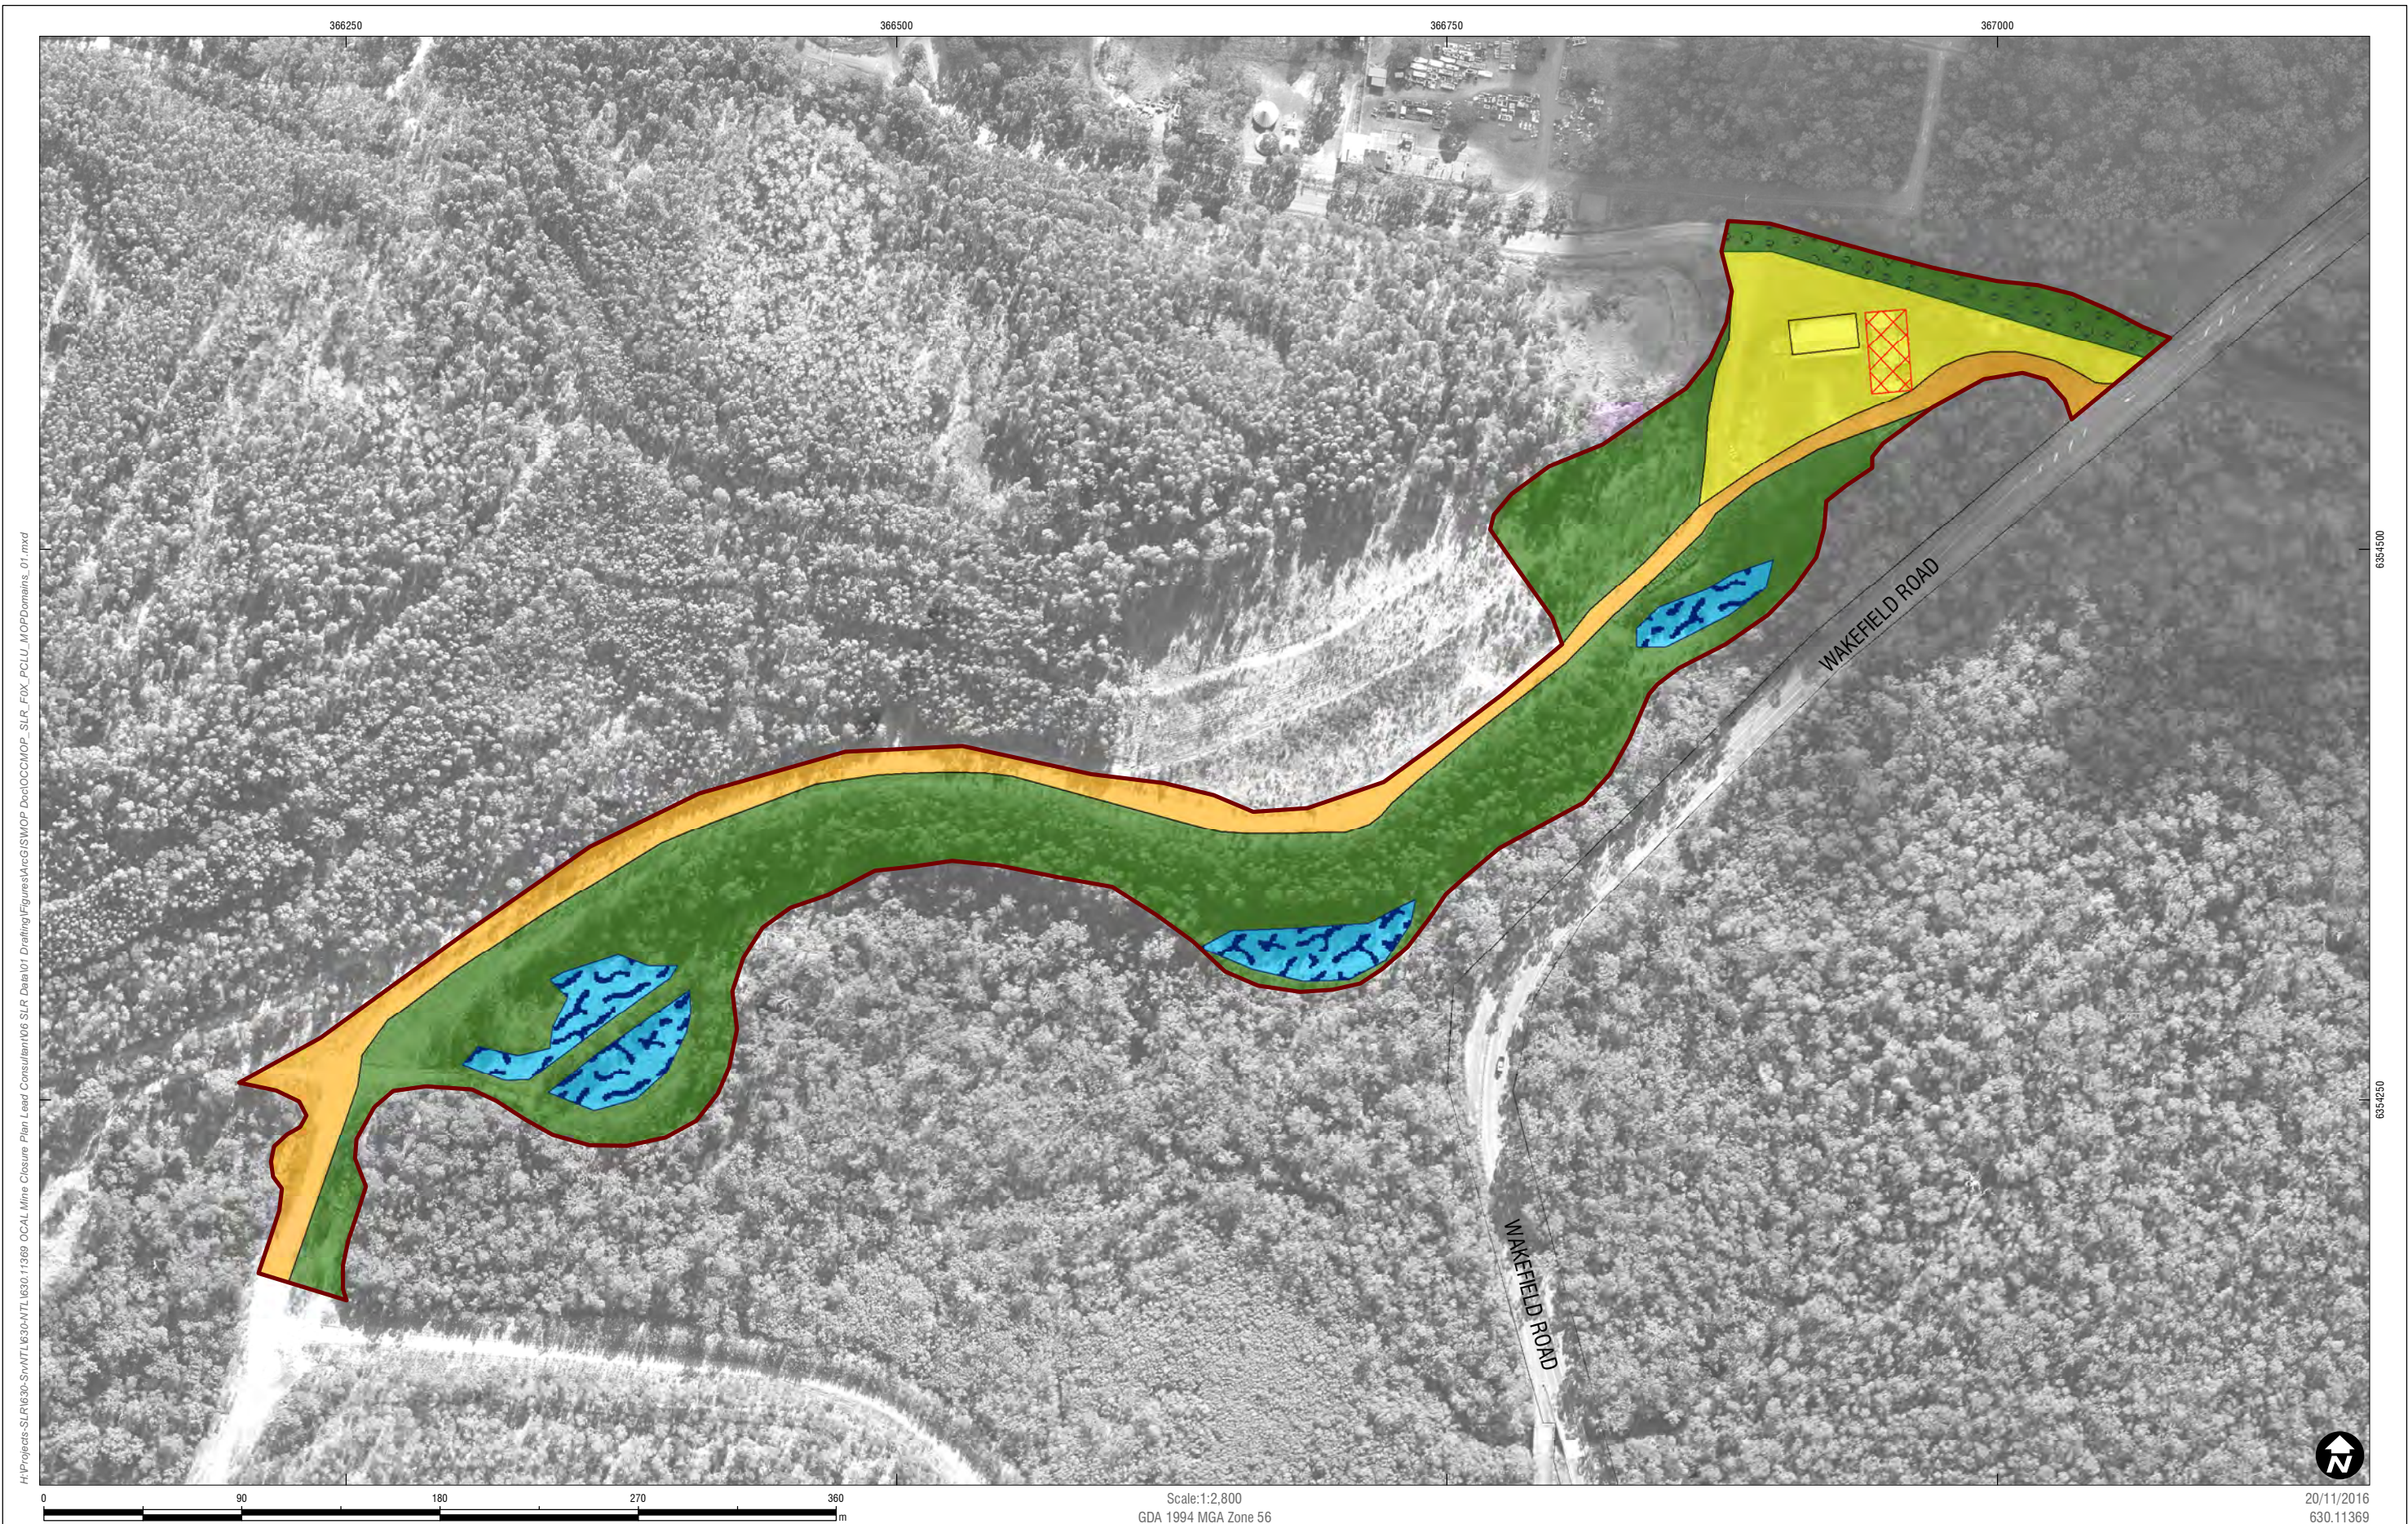
FIGURE 12

The final land use outcomes adopted for Domain 1 (shown in **Figure 12**) are summarised below:

- The existing car park, hardstand, workshop and stores shed will be retained for the temporary storage of OCAL assets until they are either sold or removed from the site. Once this is complete, the site will be made available to be leased by a third-party. This includes the retention of the oil-water separator, security fence and gates;
- The 11kV power and potable water will be retained to continue to be provide electricity and water to the site from the existing WWC pit top facilities (see Domain 6);

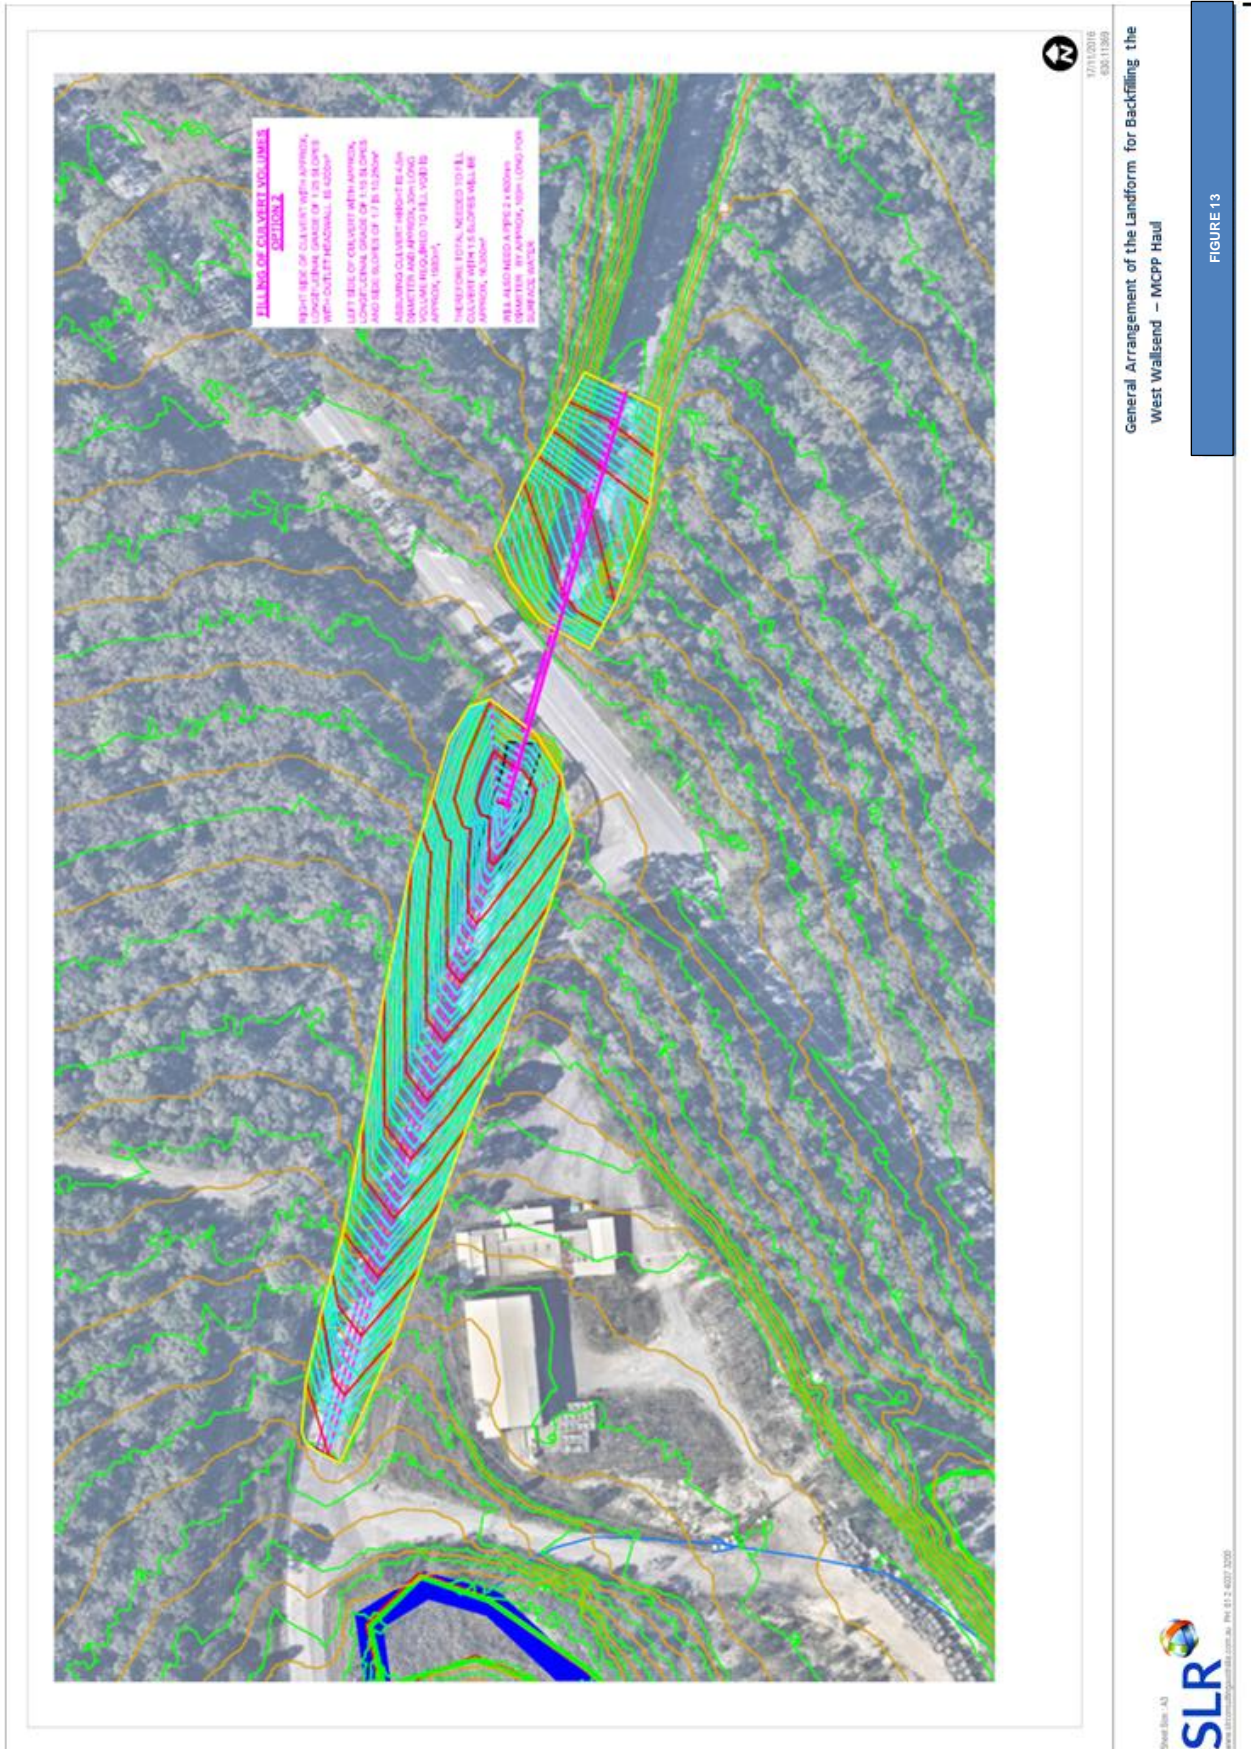
FIGURE 13

Figure 13 shows the general arrangement for grouting and backfill of the Wakefield Road Underpass and associated road cuttings. In summary the following activities will be required;

- Ripping of the existing bitumen on the haul road surface, with it to be left in place given that it will be covered with backfill;
- Install subsoil drains prior to filling the culvert to half height with engineered fill;
- Pump a lean mix slurry (5 Mpa) to underside of culvert to within 1 m from the top;
- General fill either side of culvert; including filling the road excavation (14,500 m³);
- Stormwater pipe 600 mm (reinforced concrete) to be placed under roadway with headwalls to allow some water to continue to pass under the road;
- Scour protection installation on the downstream side to allow water to be transferred off the landform and back into the natural system; and
- Topsoiling, revegetation to bushland.

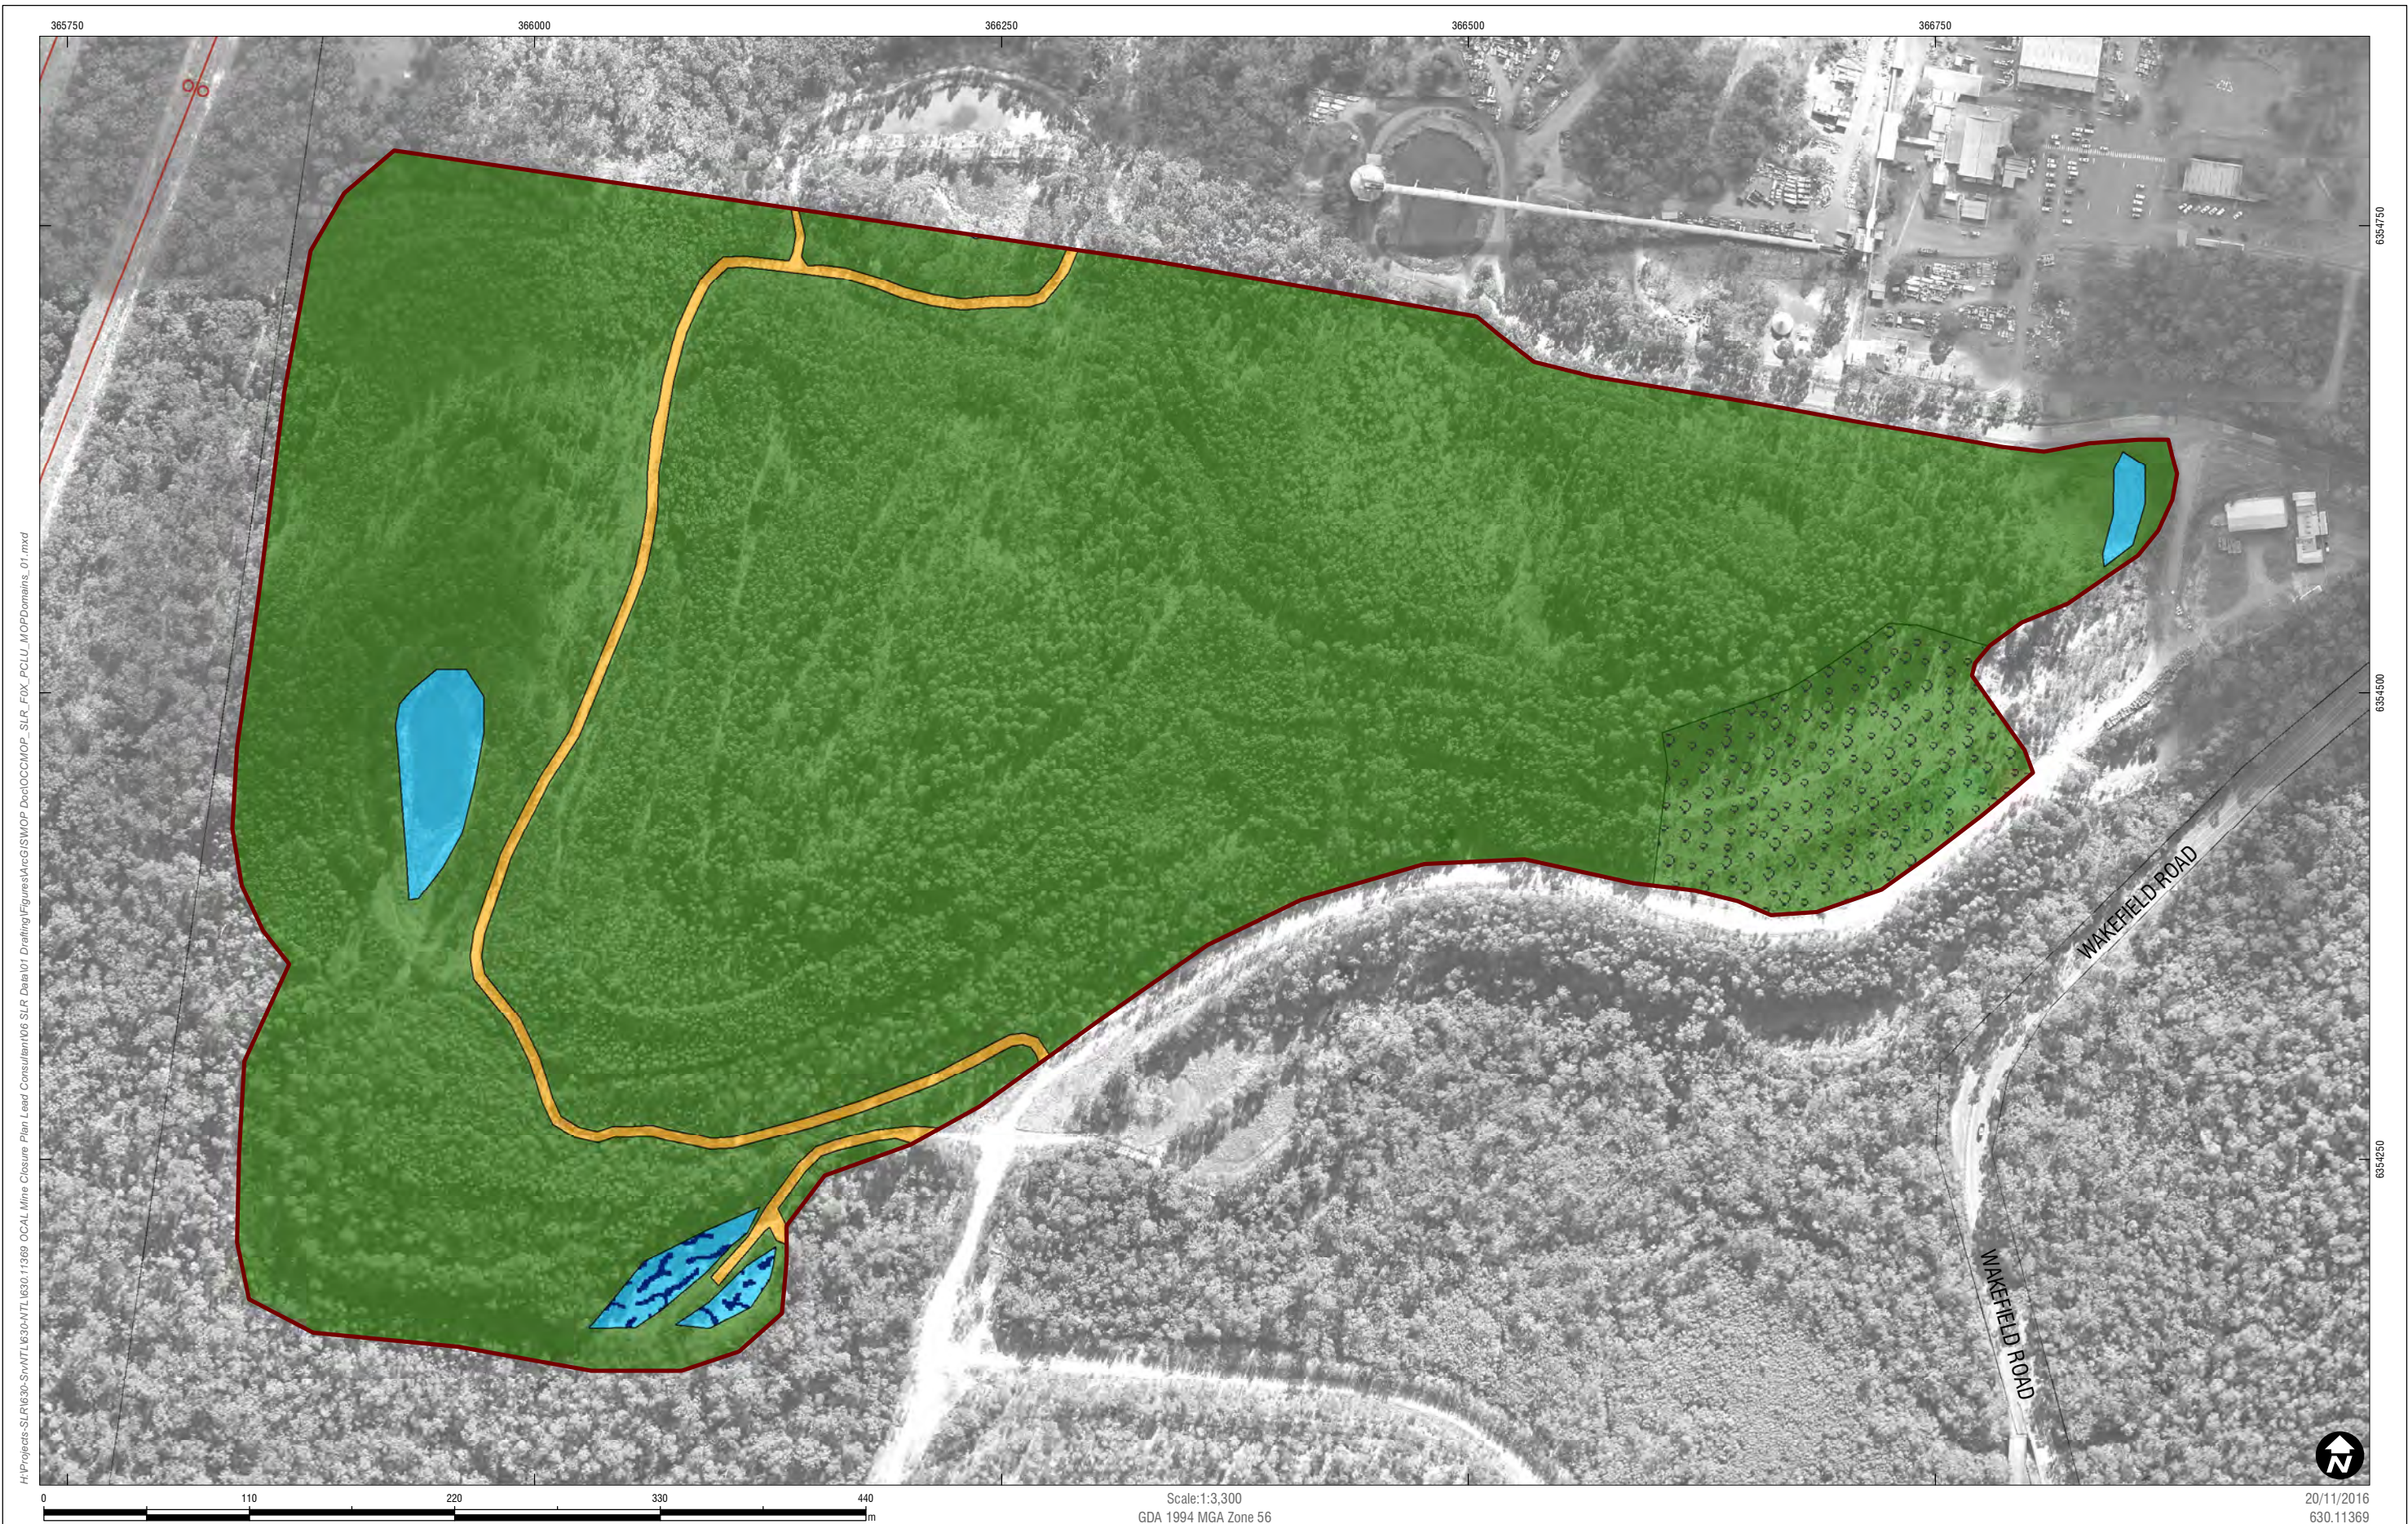
FIGURE 15

The final land use outcomes (shown in **Figure 15**) were adopted based on land use options from the work above; this is outlined as:

- A total of 39.55 ha of existing rehabilitated land will be retained as bushland;
- The Dams J and K will be retained as water for native fauna, with no further works being required;
- Dam B will require some minor upgrade works and it will be retained as an active water management structure to allow discharge from the site via the existing EPL through EPA licenced discharge point 2 off site in Domain 14; and
- The 2.6 ha area of existing post-2011 rehabilitation will be monitored and maintained as required to meet the Westside rehabilitation success criteria prior to relinquishment.

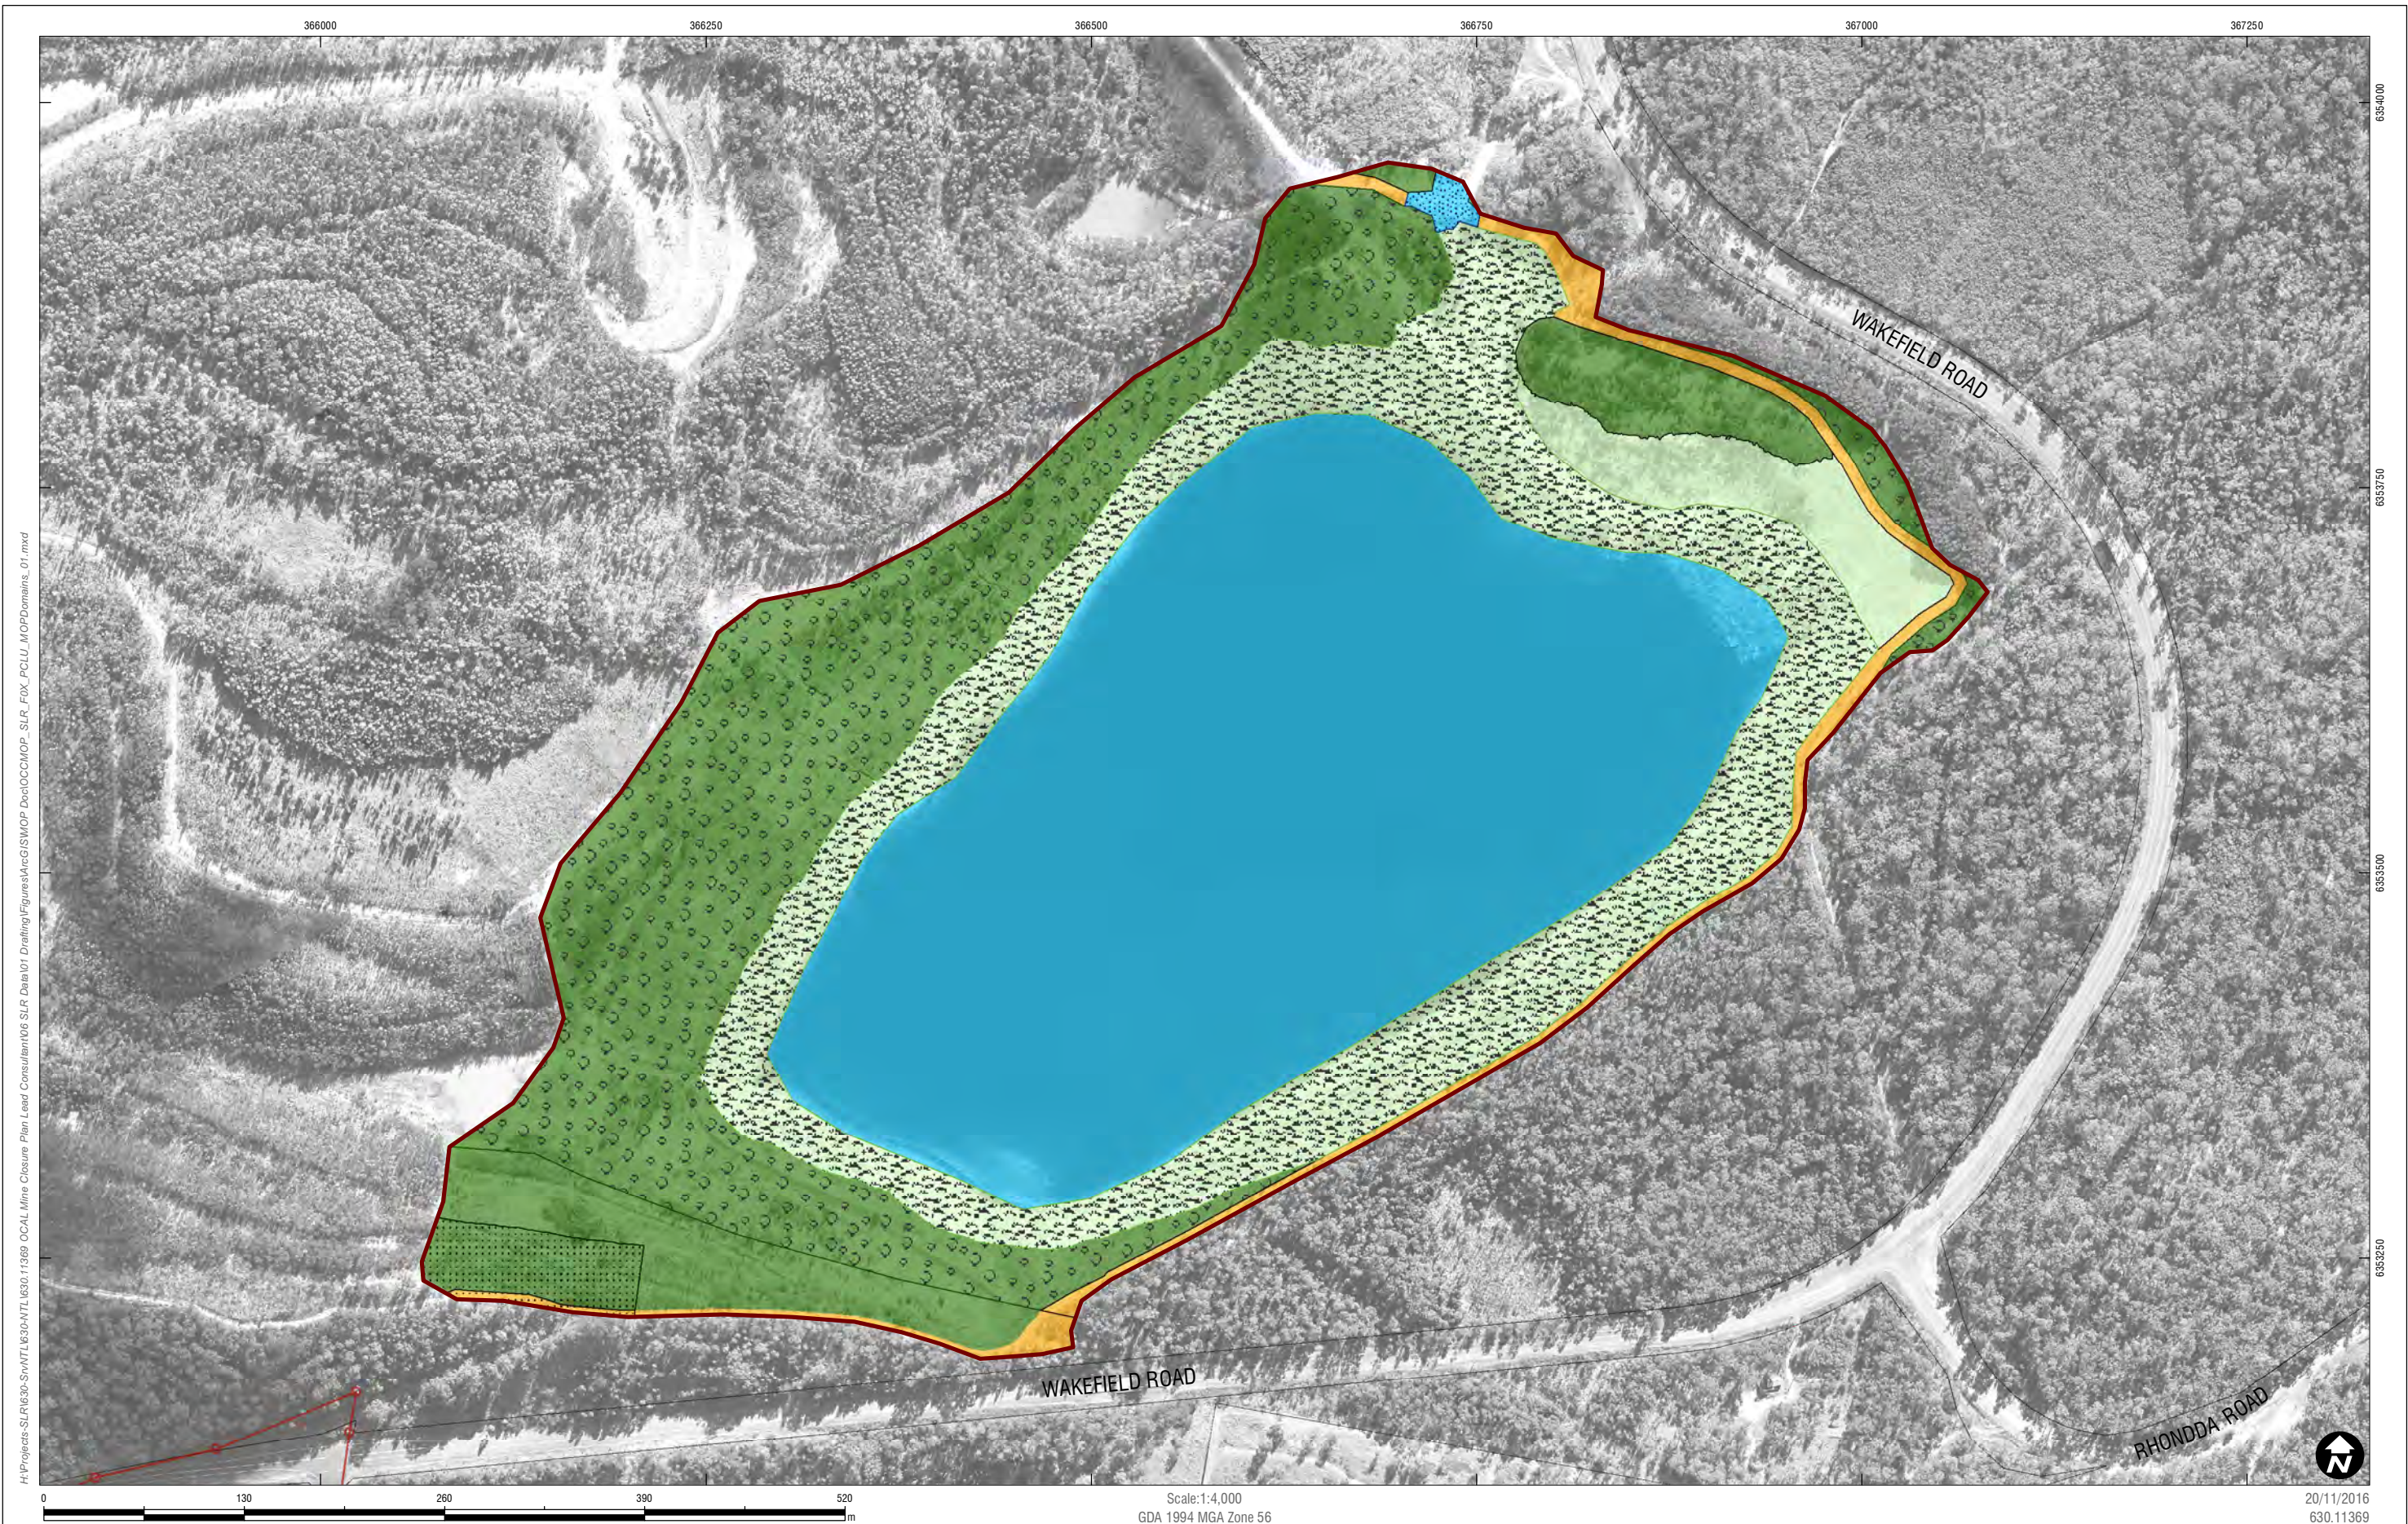
FIGURE 19

The final land use outcomes (shown in **Figure 19**) were adopted based on land use options from the work above; this is outlined as:

- A total of 13.11 ha will be rehabilitated as bushland with a further 9.45 ha of pasture. Pasture will be established in the areas below RL12 which is the established high water mark of the void controlled via the inlet of the spillway to be constructed;
- The access tracks will be maintained for light vehicle access to the site to facilitate land management, monitoring and maintenance. The tracks will also allow access for any bushfire mitigation or fire-fighting that may be required;
- The final void and spillway includes an approximate area of 19 ha which will change through the fluctuation of the water level in the void; and
- The entire area of existing and proposed rehabilitation will be monitored and maintained as required to meet the Westside rehabilitation success criteria prior to relinquishment.

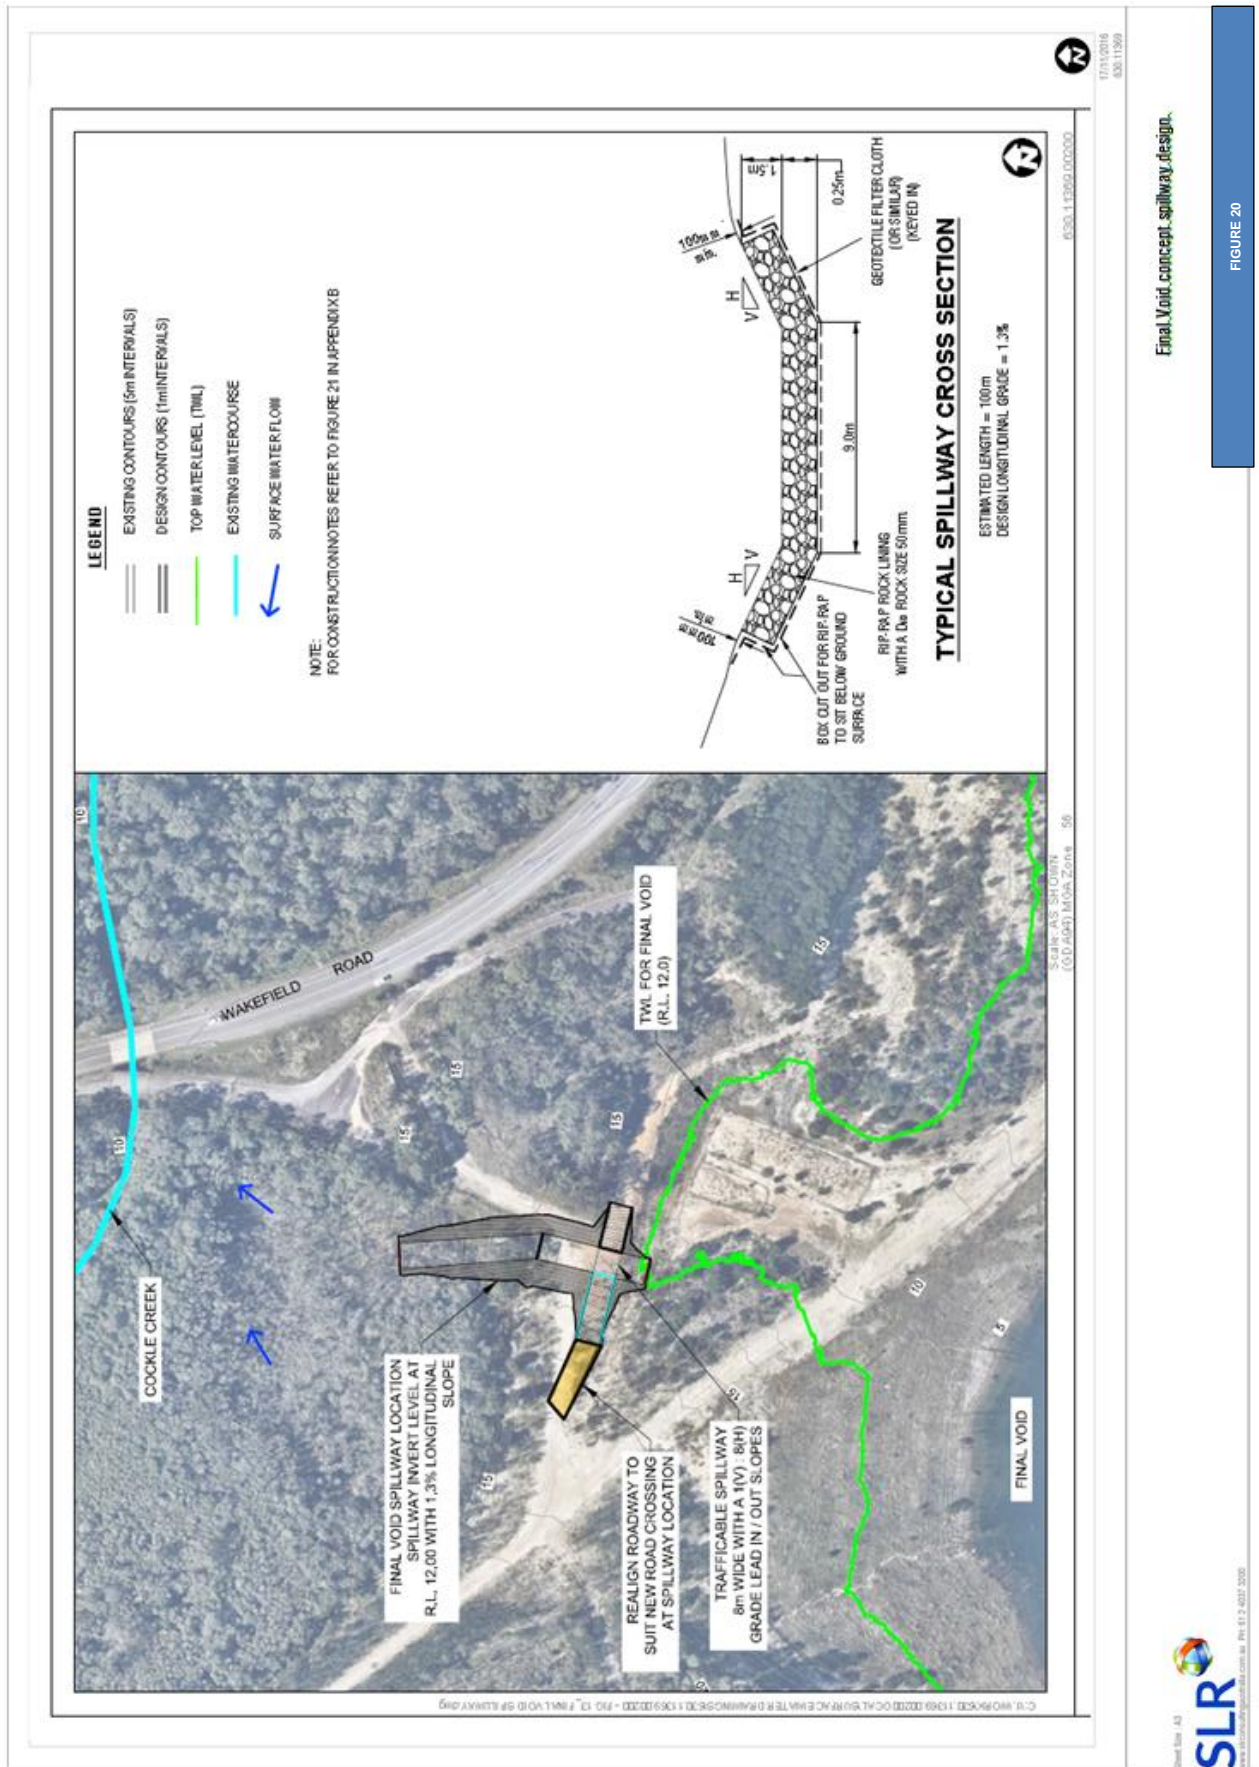
FIGURE 20

See the final void conceptual spillway design in **Figure 20**.

Final Void concept spillway design

The FVMP (GHD 2010) recommended a spillway location on the eastern side of the final void which would report to Diega Creek. During preparation of the DCMP it was determined that a more suitable location for this spillway is located on the northern side of the final void which would report to Cockle Creek via the supplementary licenced discharge EPA Point 4 – WST. This decision was influenced by the capacity of downstream water conveyance structures (i.e. bridges and culverts) and location of existing licenced discharge points.
