OCEANIC COAL AUSTRALIA LIMITED
Mining Operations Plan
Closure of the OCAL Complex

OCCP-SLR-DOM00-CM-RPT-001

Mining Operations Plan

Closure of the OCAL Complex

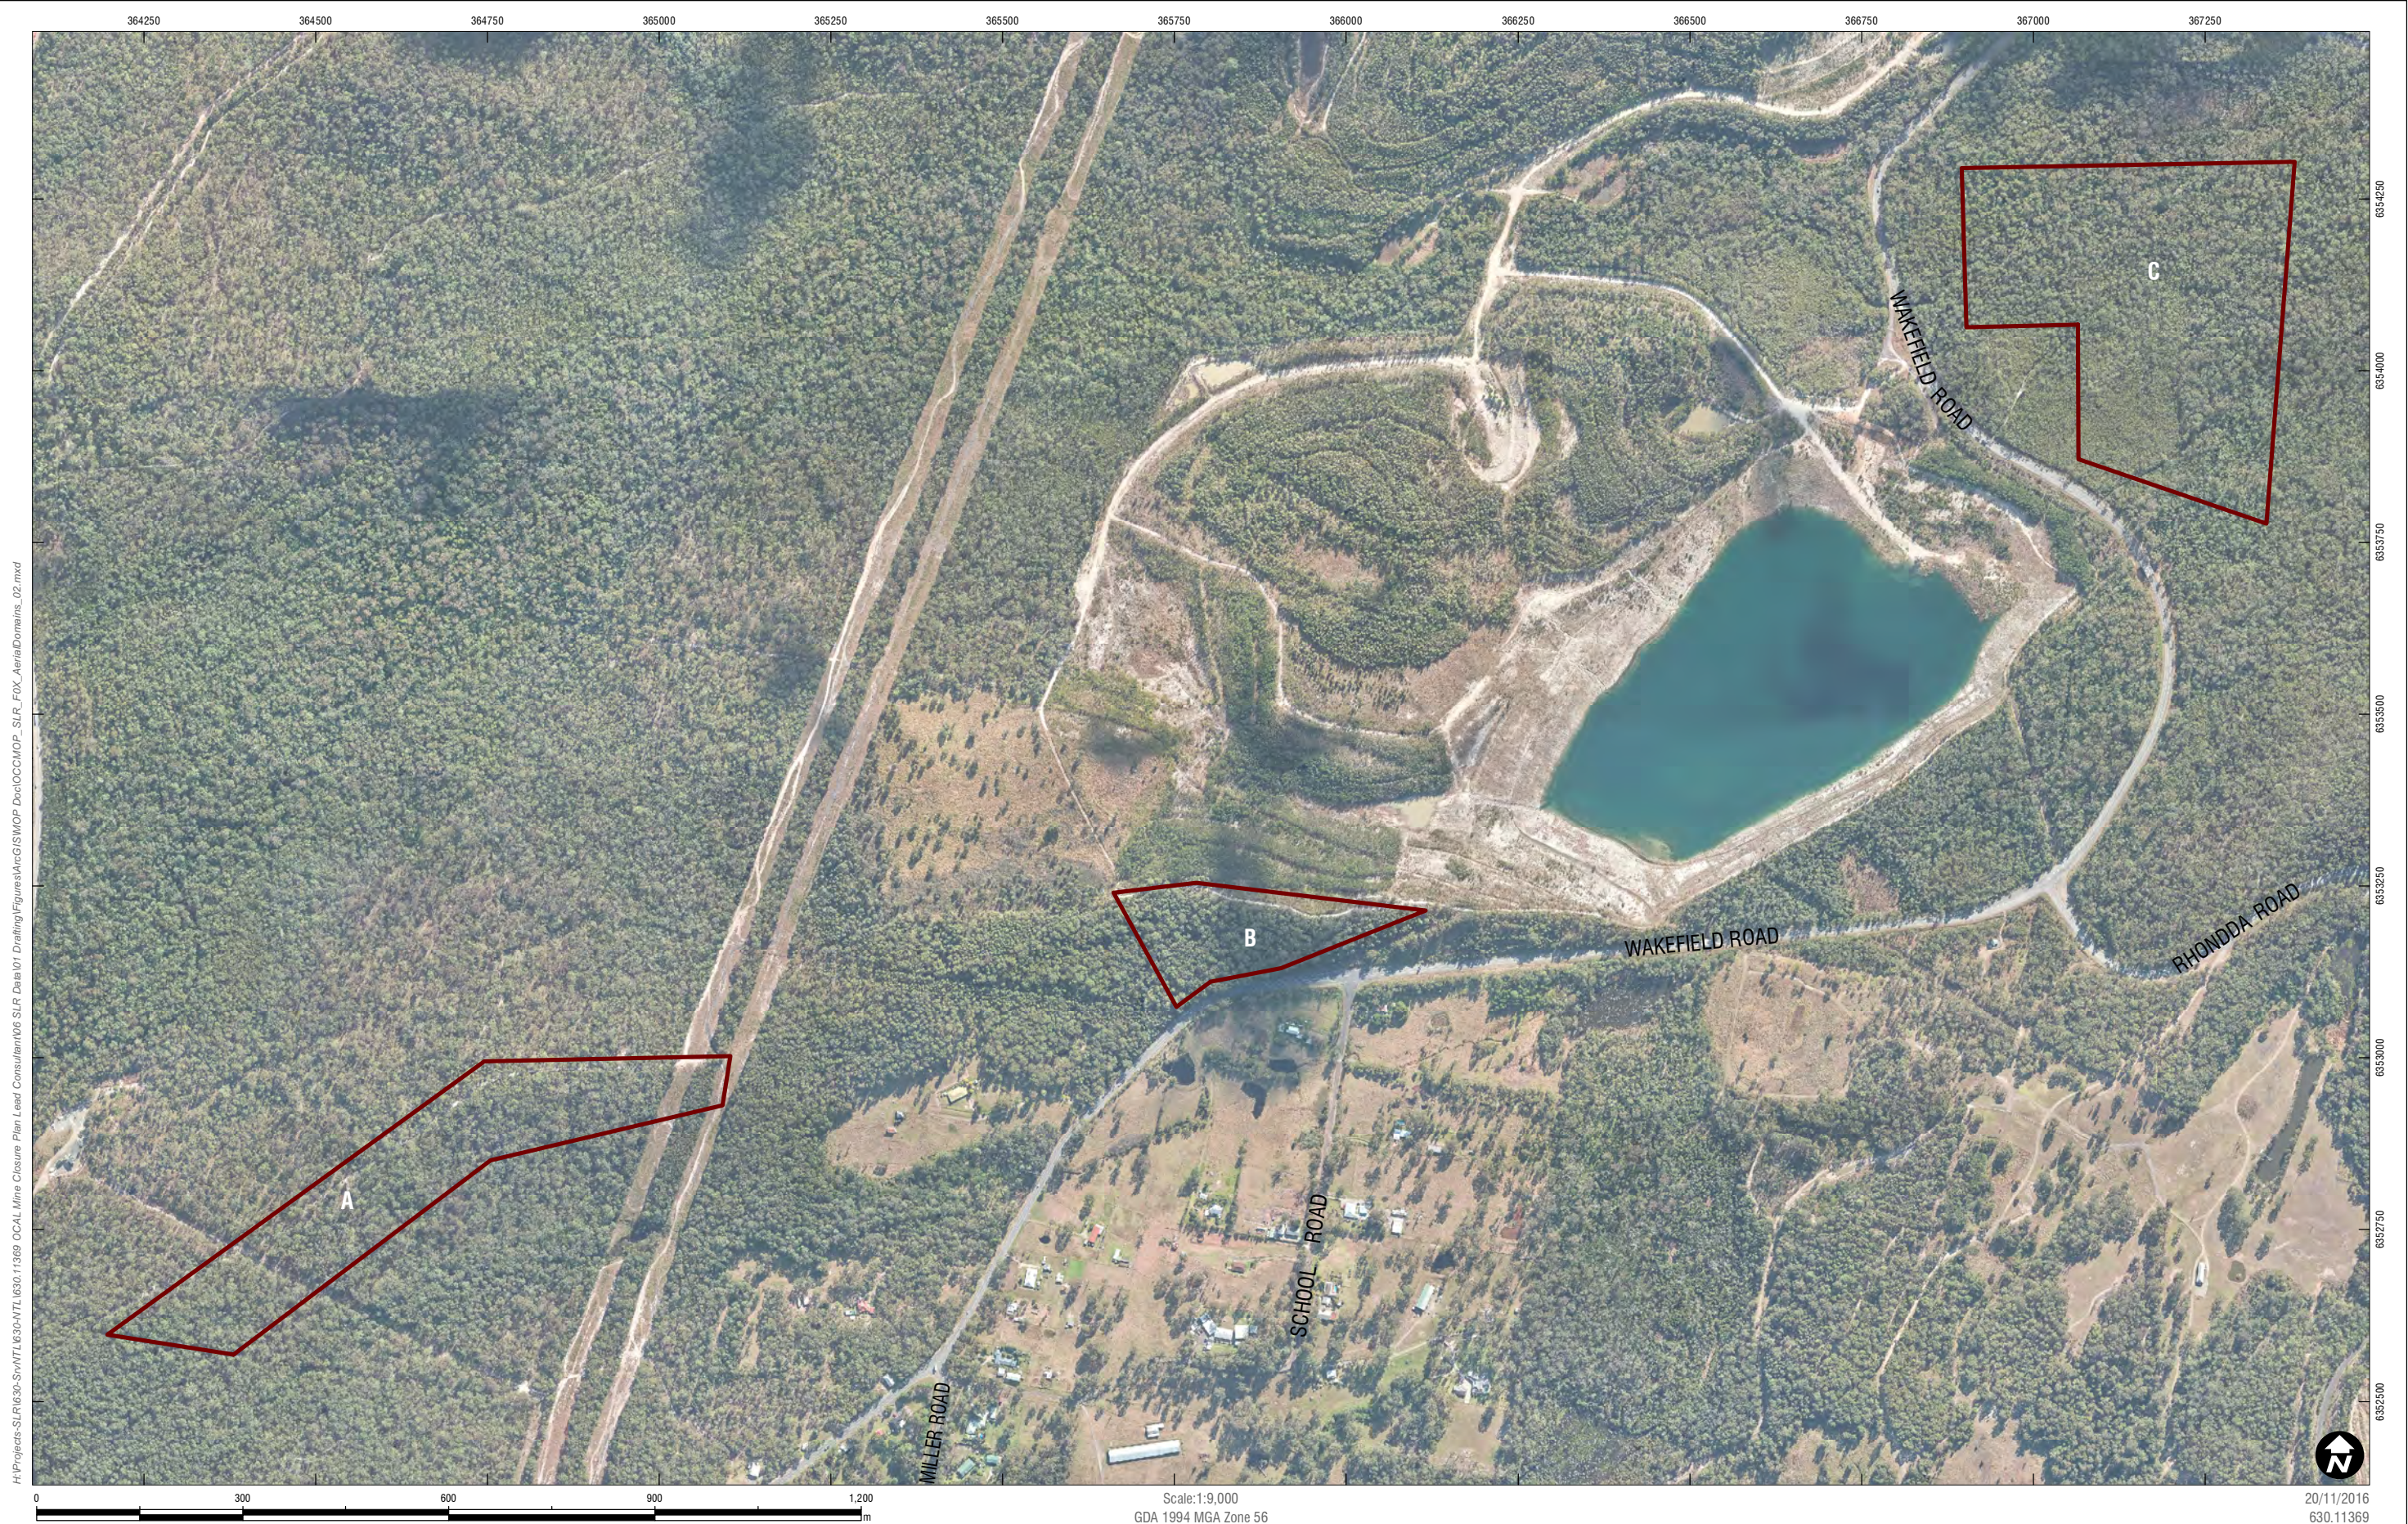
The following **Figure 21** show the existing arrangement of Domain 5 as at July 2016.

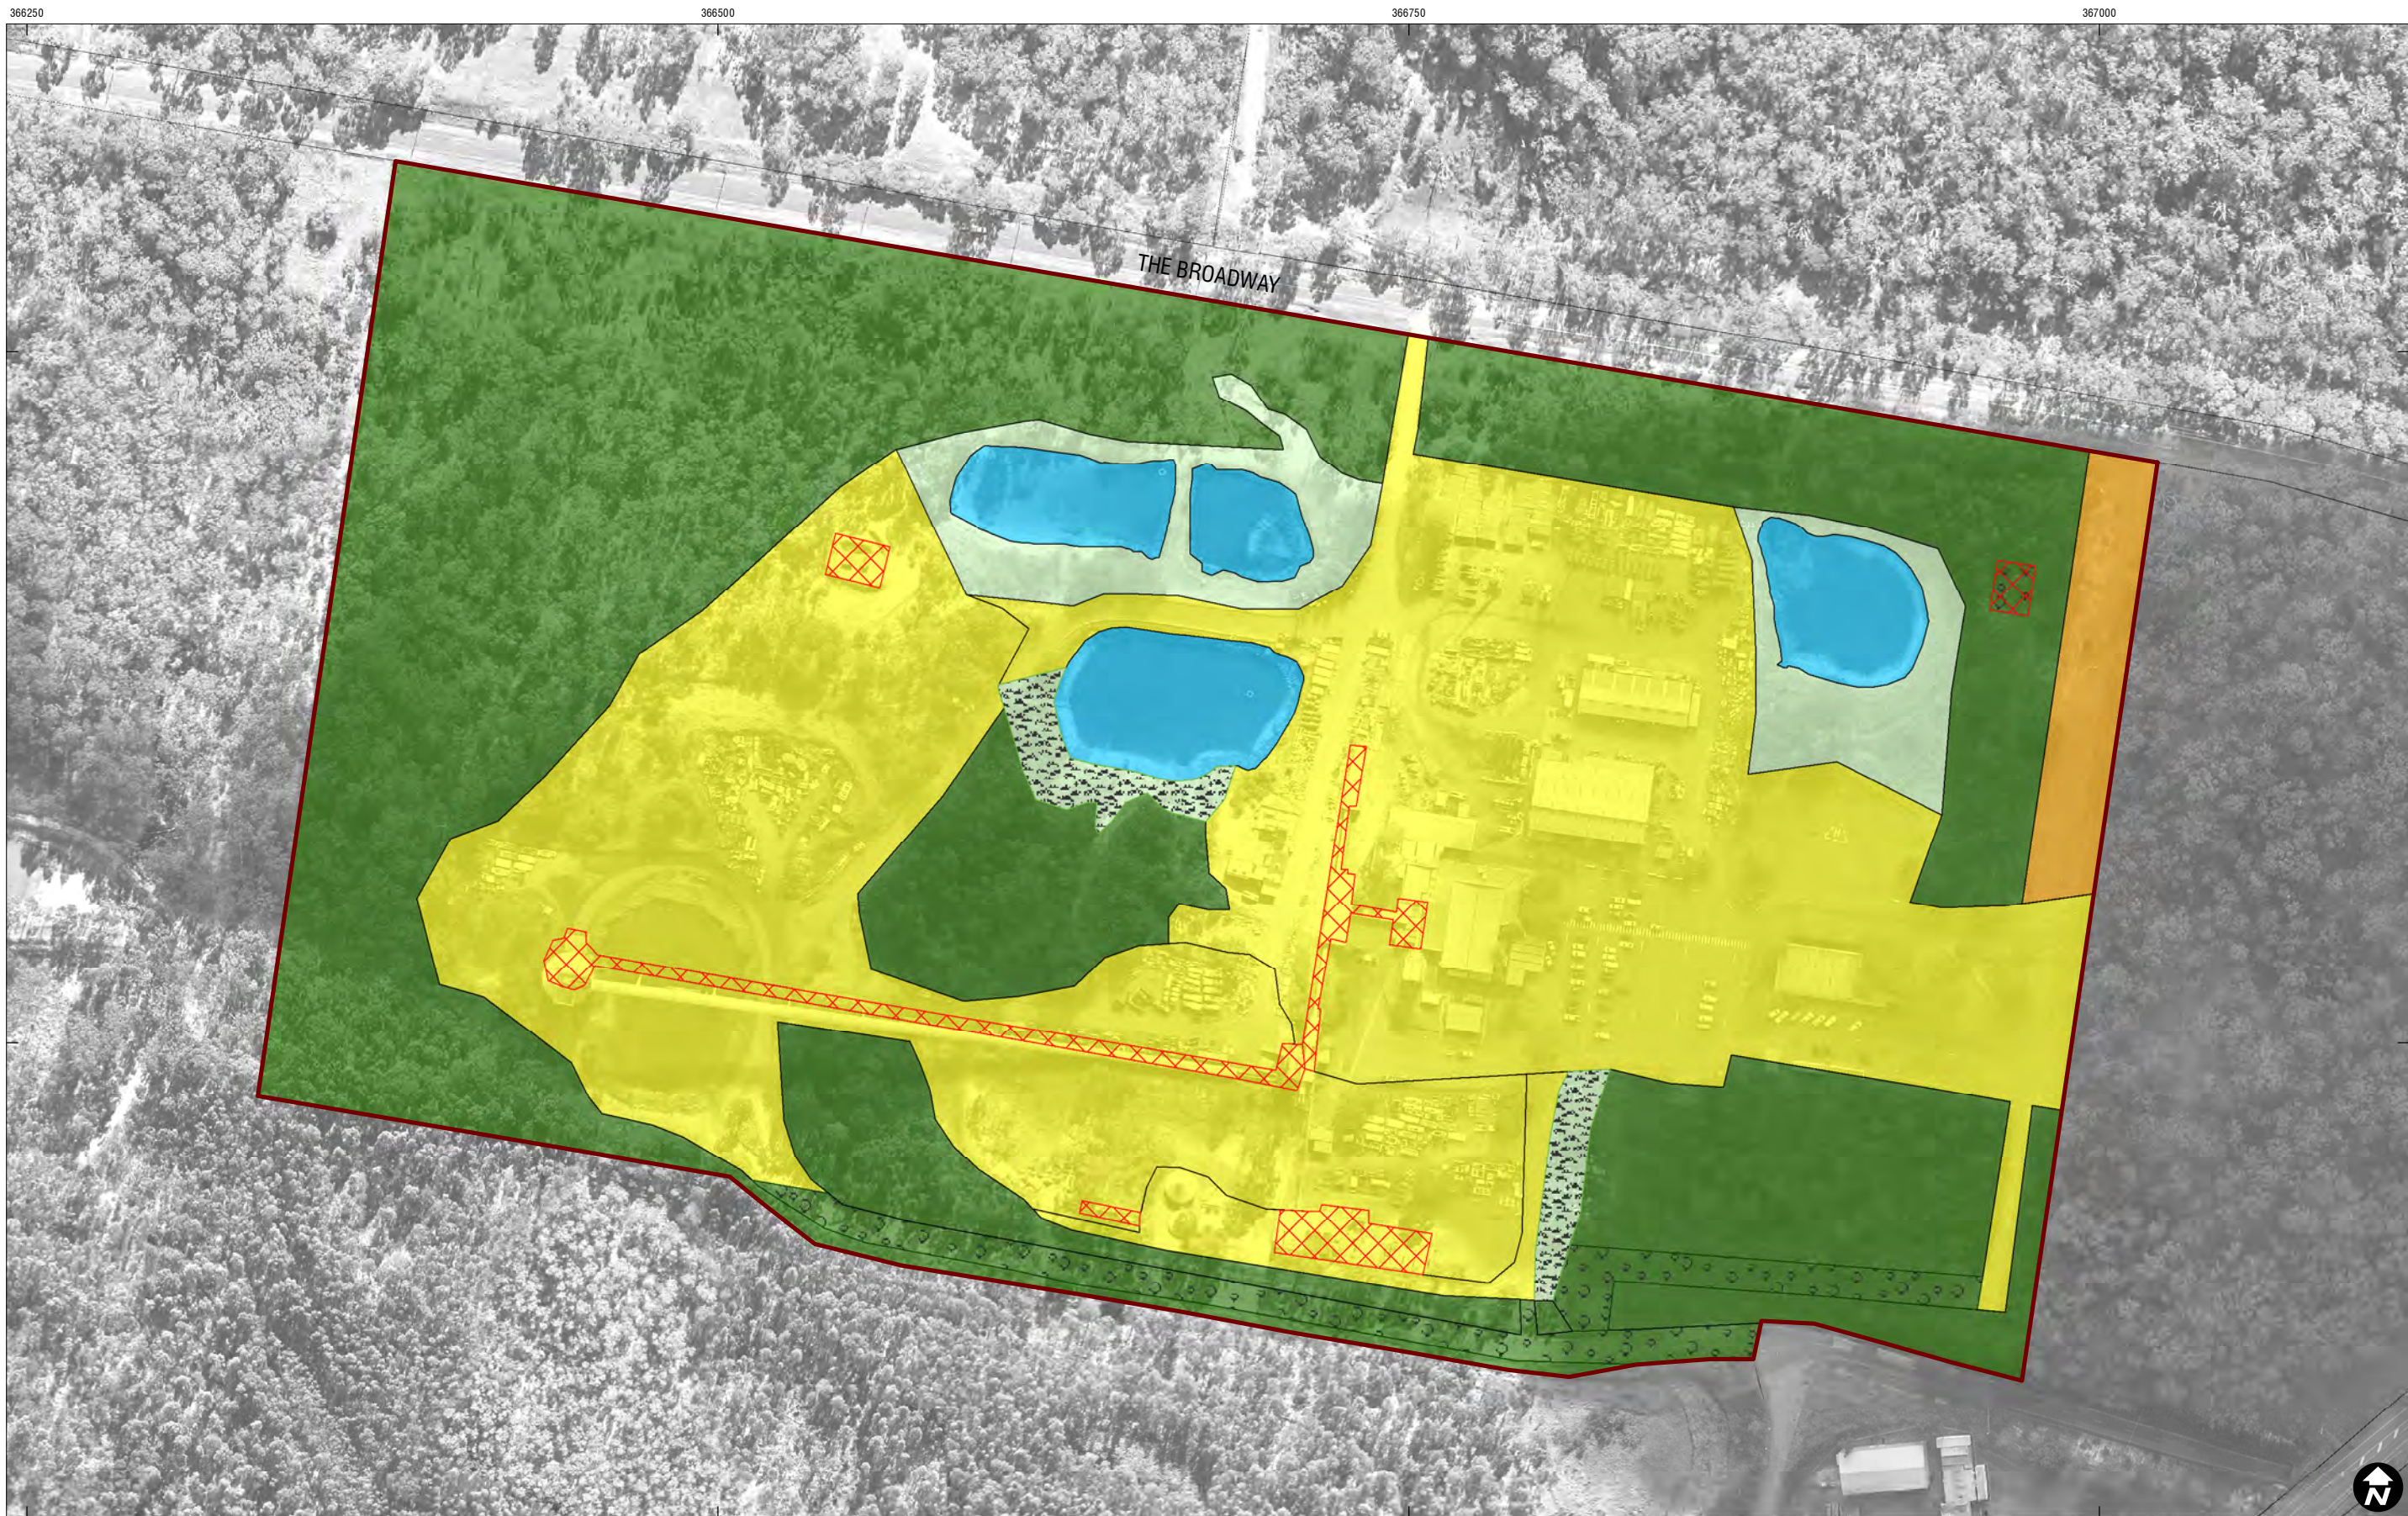
FIGURE 24

The final land use outcomes (shown in **Figure 24**) were adopted based on land use options from the work above; this is outlined as:

- Approximately 10ha of the existing infrastructure and/or hardstands will be retained for light industrial use;
- All buildings other than coal clearance infrastructure (e.g conveyors, bins and gantries) will be retained;
- The access road (0.41 ha) will be maintained for access to the site for light industrial use and to facilitate access for any bushfire mitigation or fire-fighting that may be required;
- Retention of the licenced discharge points; and
- Top Dam, Bottom Dam and North East Dam will be retained.

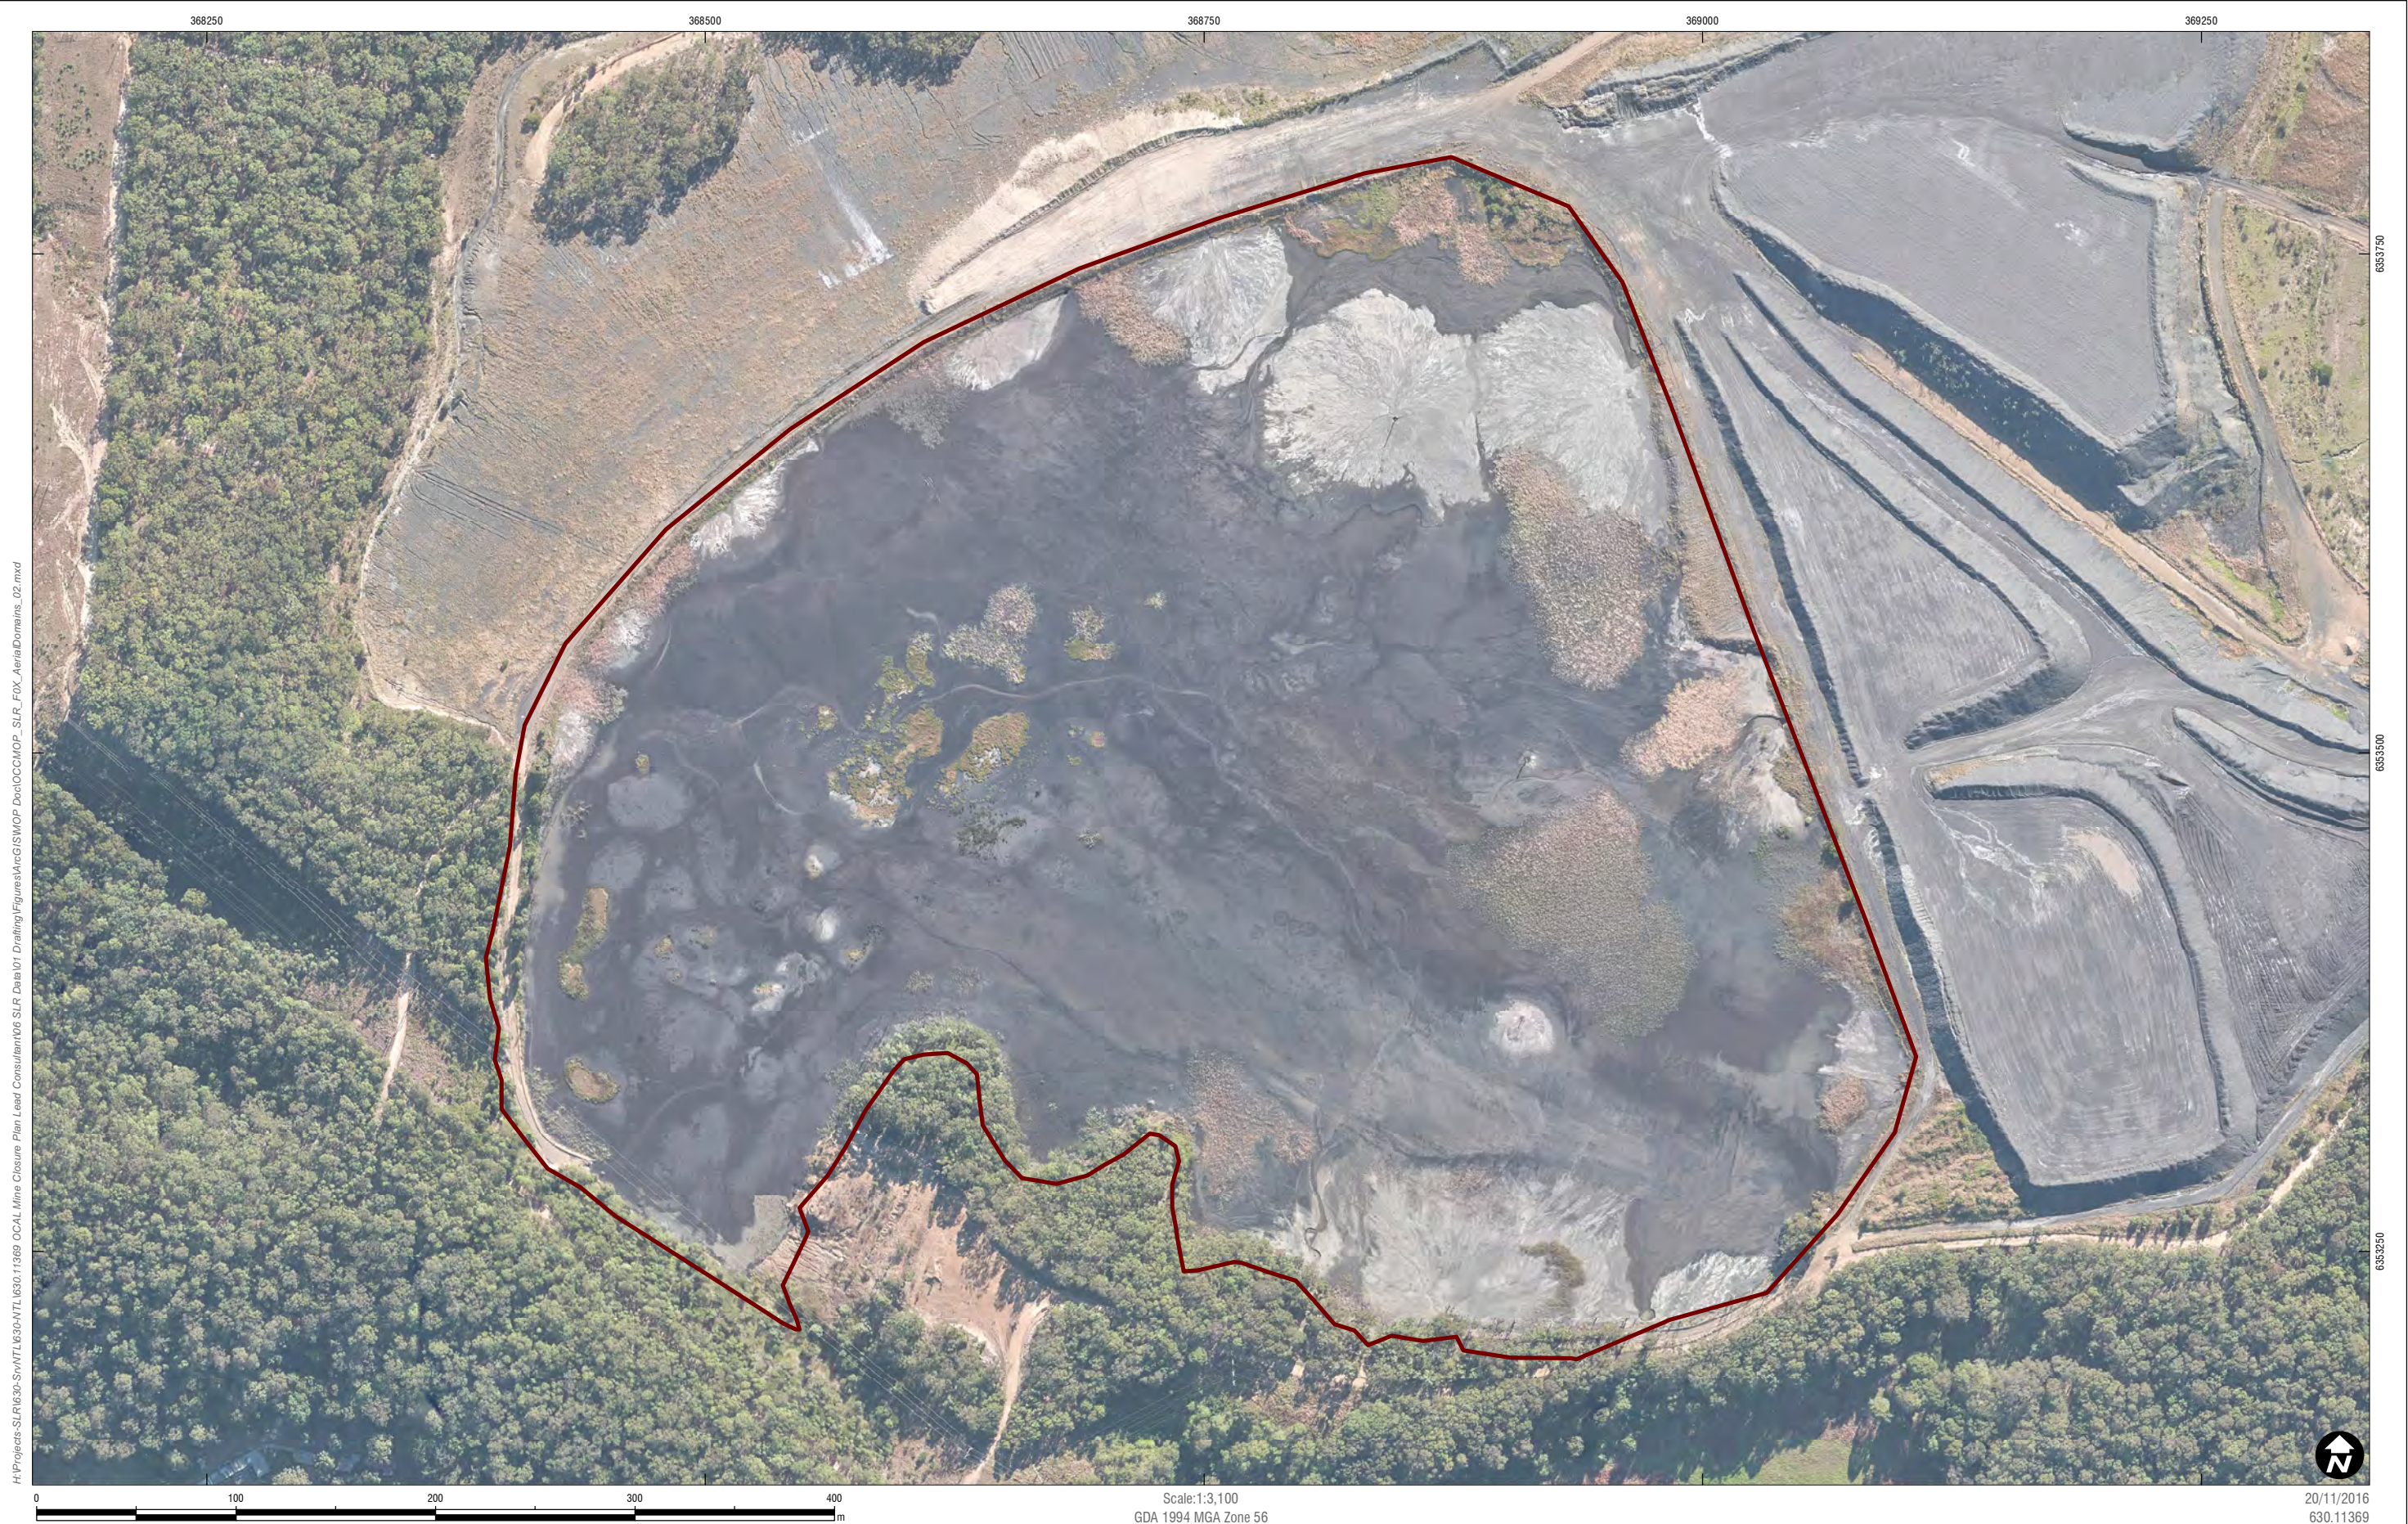
Figure 25 shows the existing arrangement of Domain 7 as at July 2016.

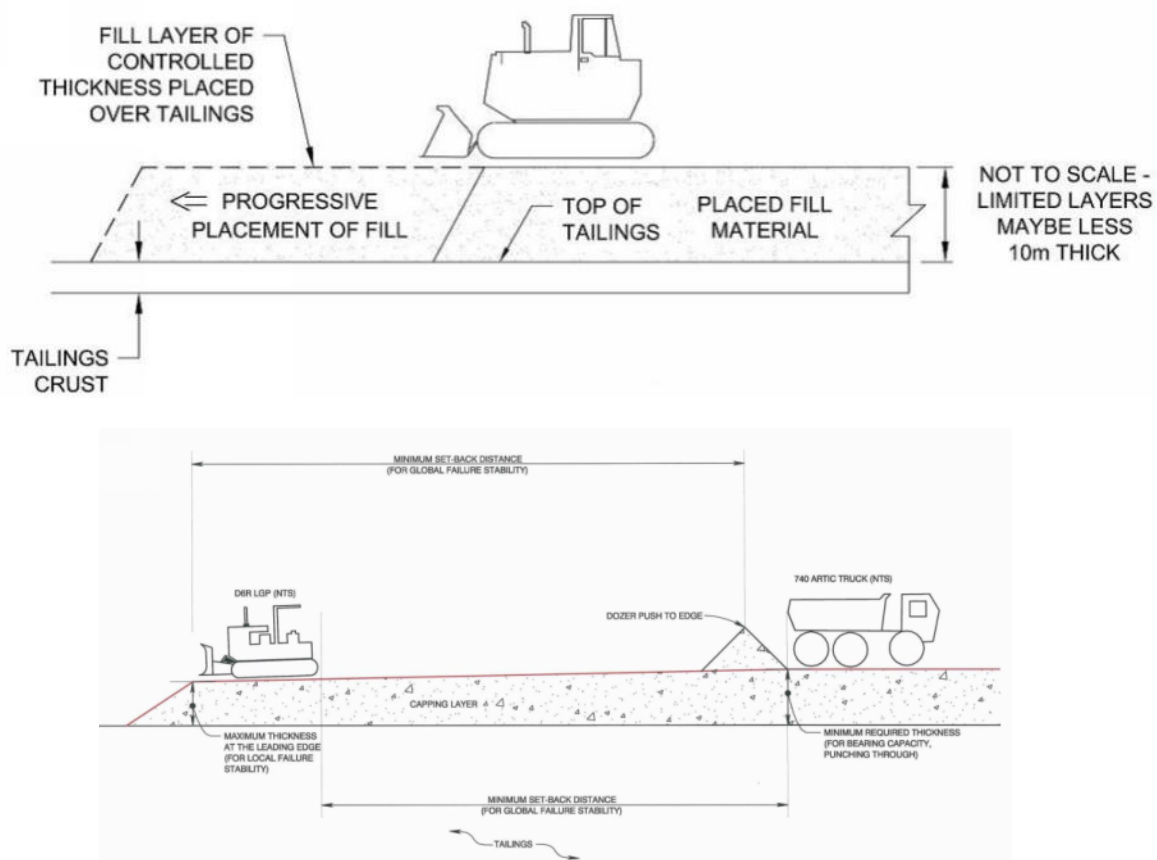
Figure 31 Conceptual Diagram for Placing Initial Capping Layers

Construction of the initial capping layer should proceed as above until the entire tailings surface is covered. Subsequent layer(s) of coarse reject (or other suitable fill material) may then proceed, however this will be subject to detailed design of equipment and layer thicknesses and placement methodologies. The concept is illustrated below in **Figure 31**.

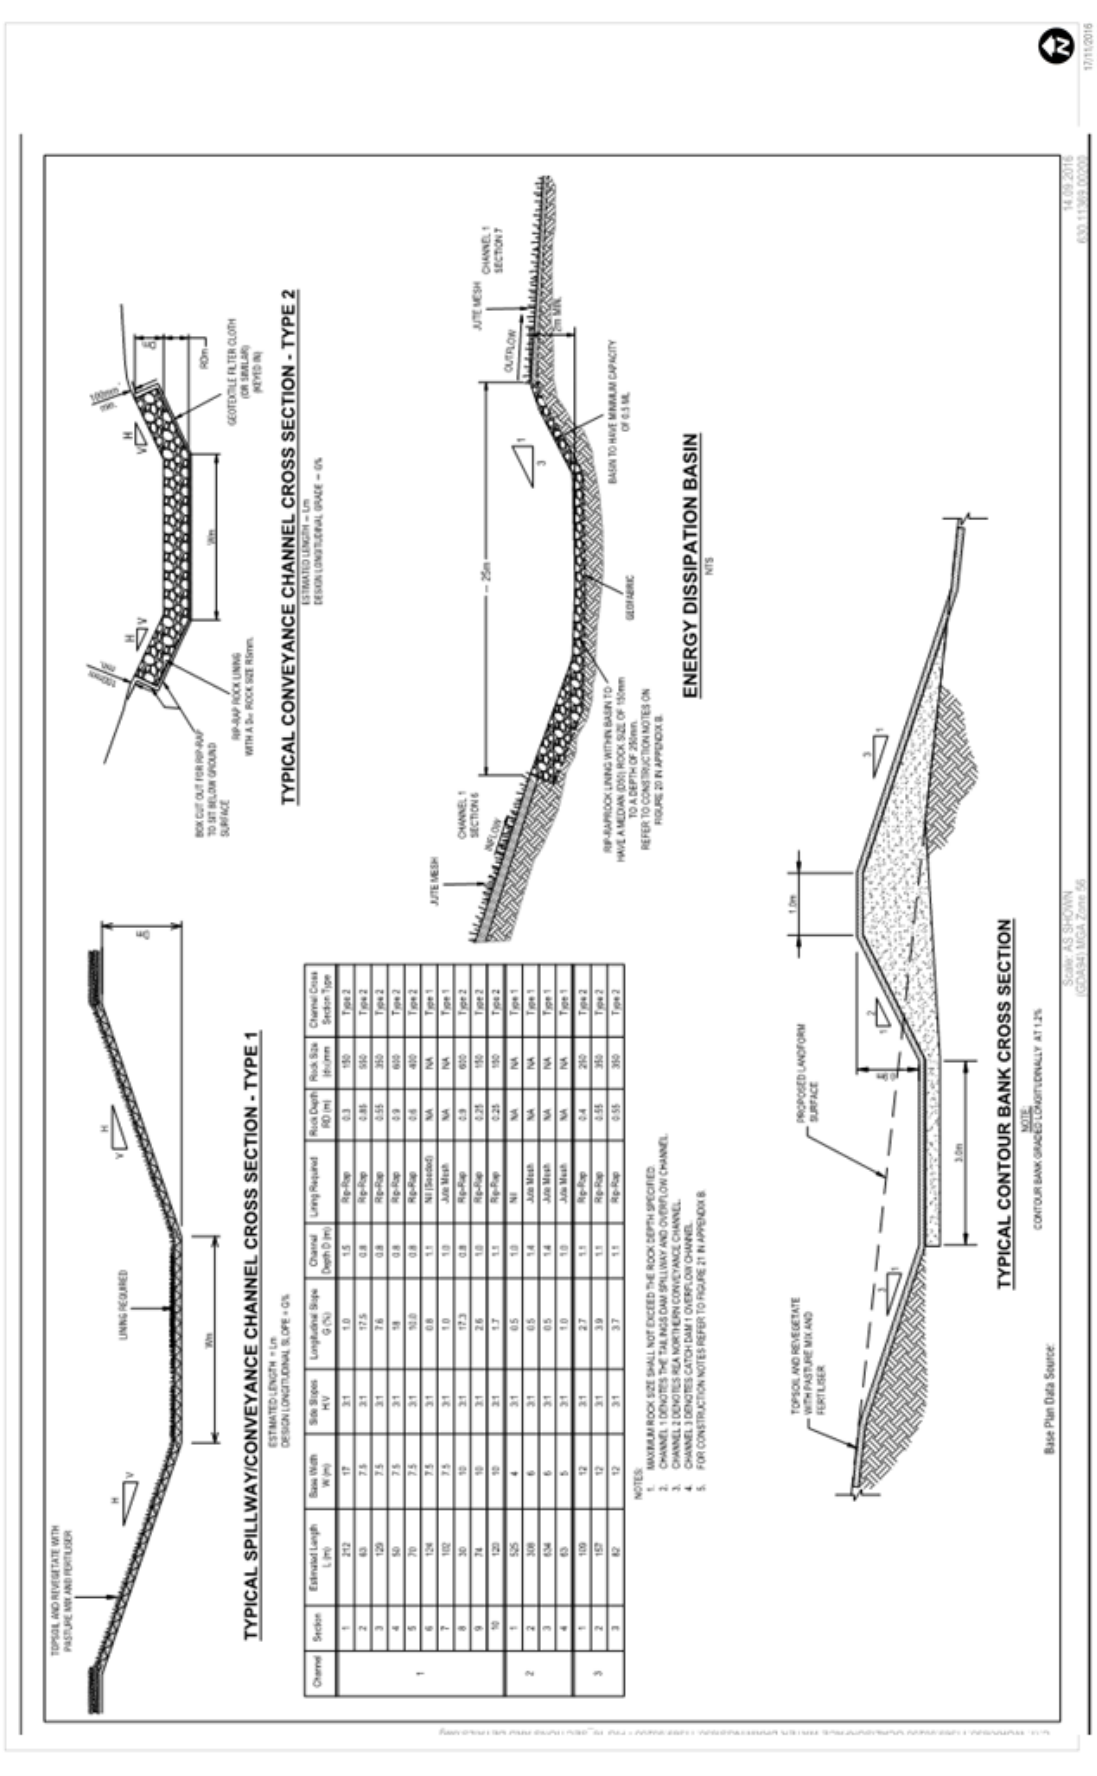
FIGURE 37

General arrangement of the Tailings Dam Spill and conveyance channel

The overall MCPP Final Landform Water Management General Arrangement is shown in **Figure 37**.

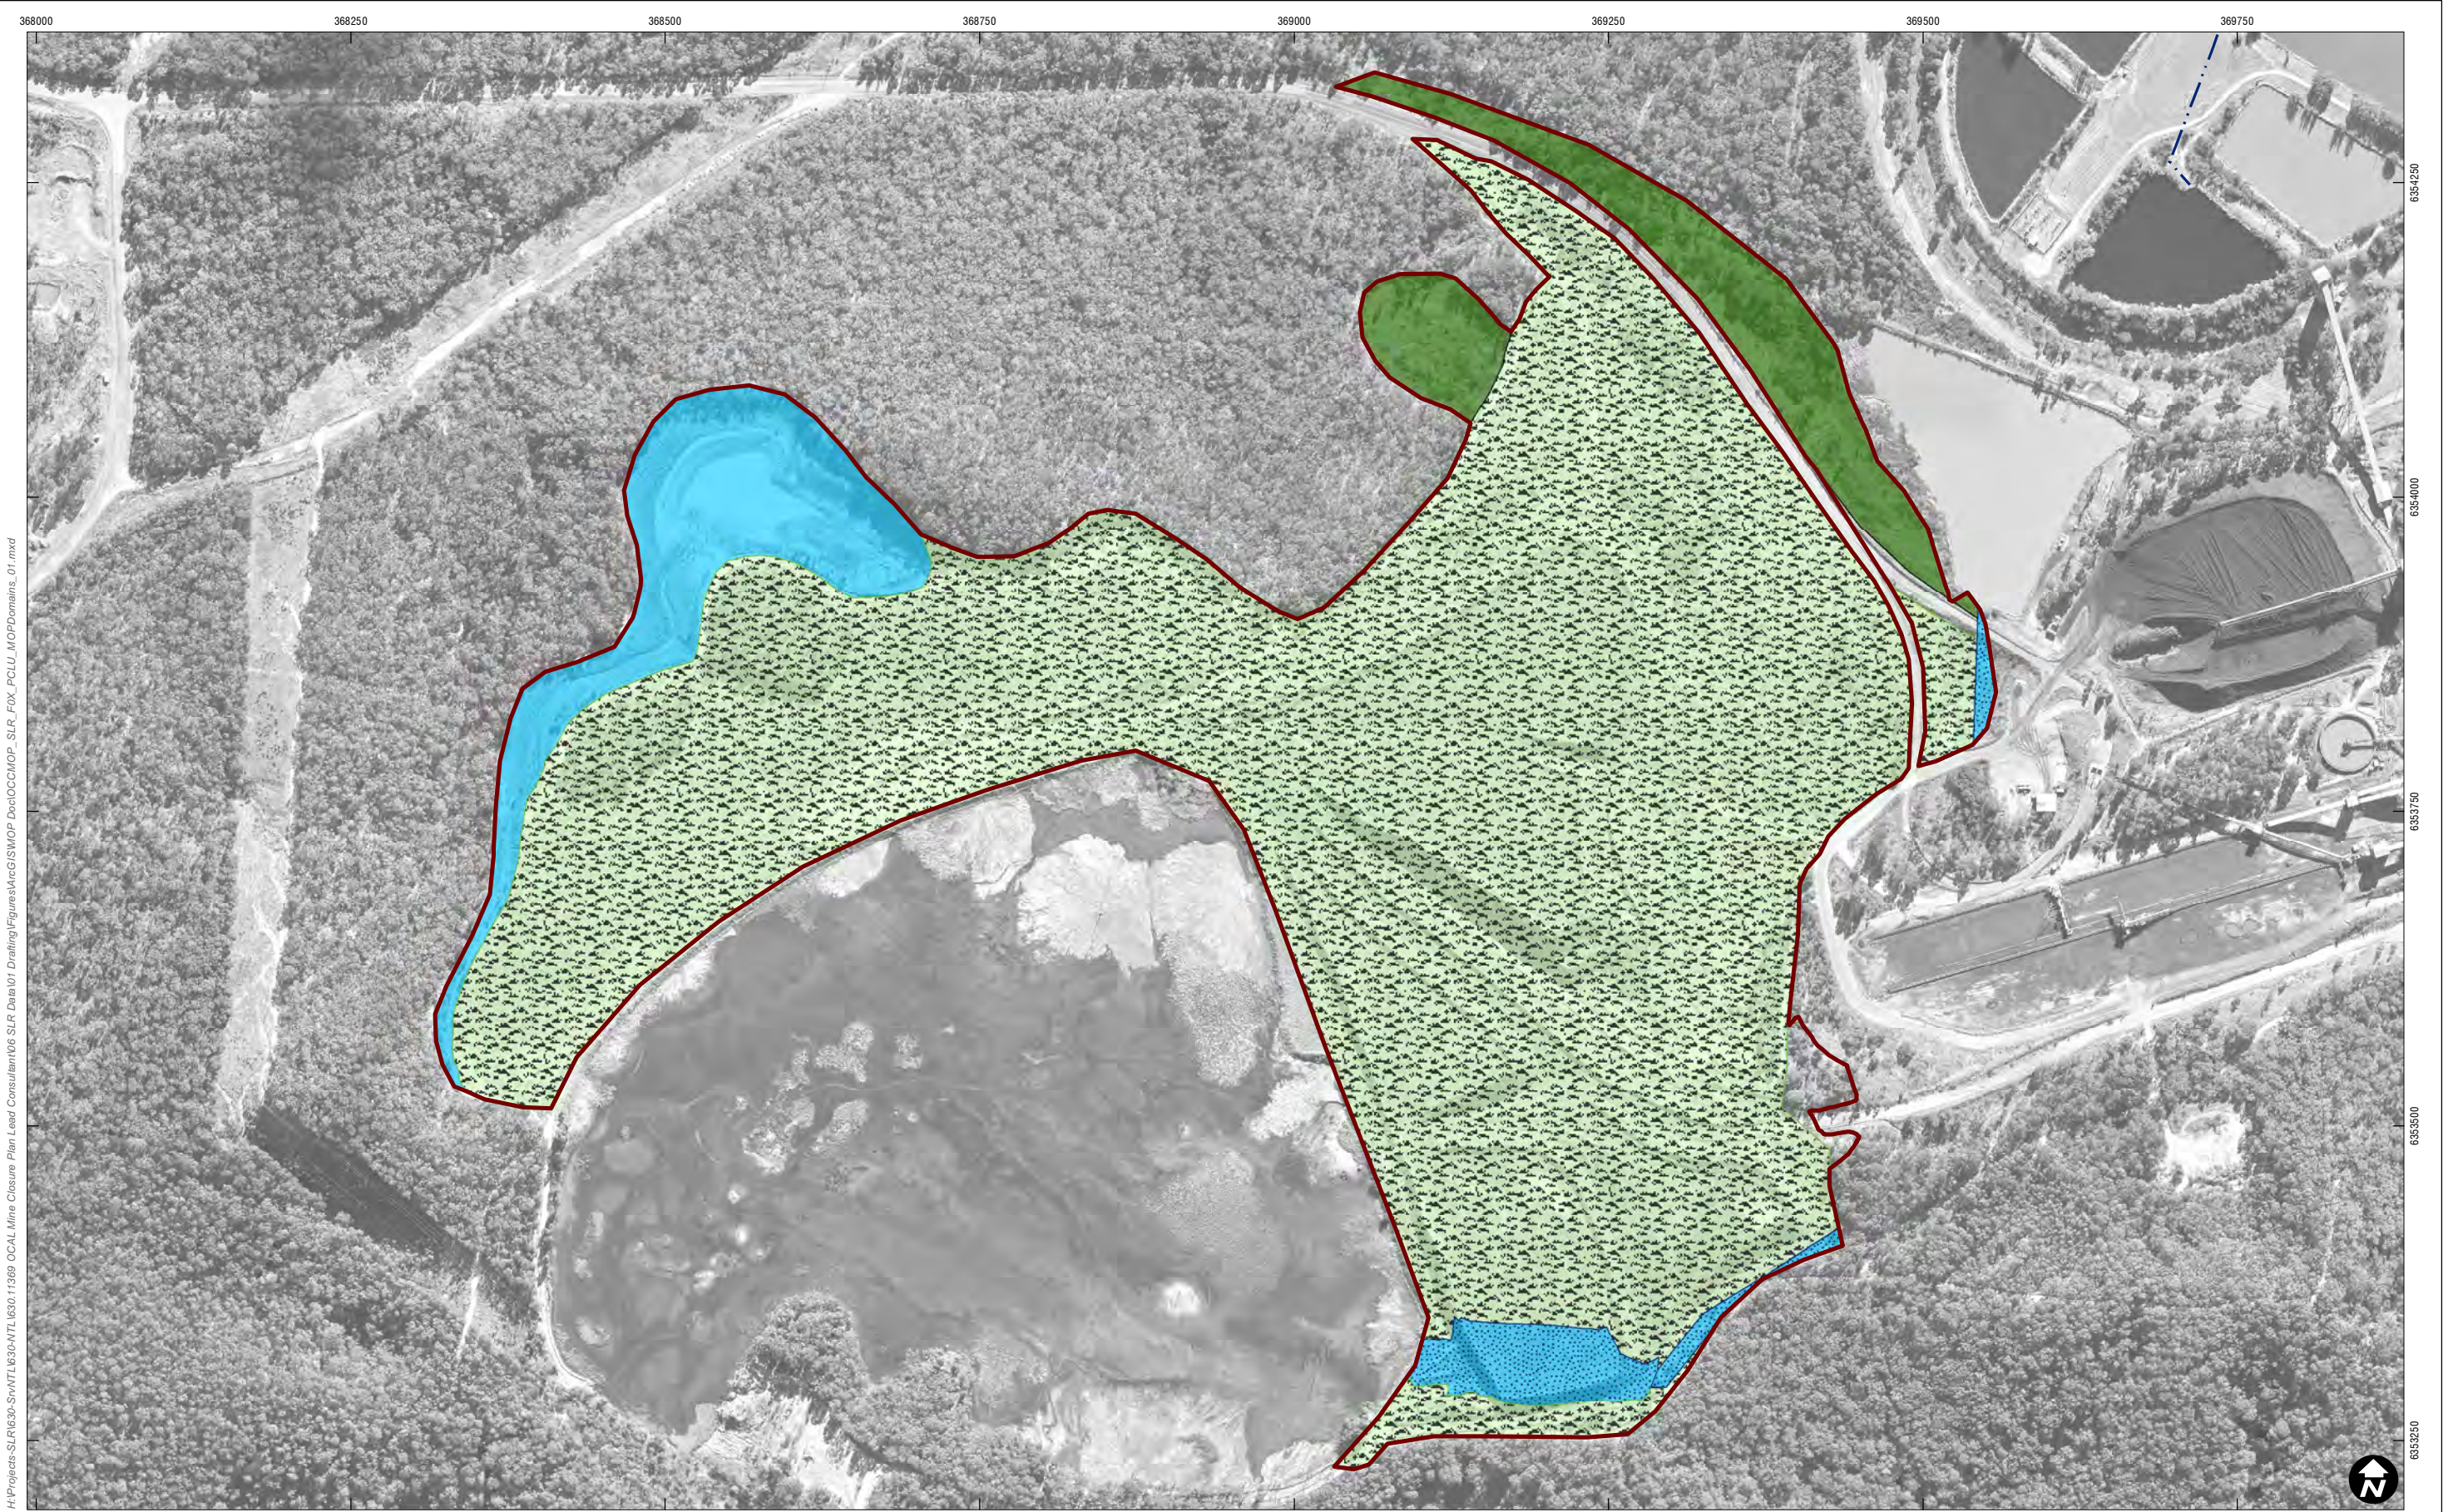
FIGURE 34

The final land use outcomes (shown in **Figure 34**) were adopted based on land use options from the work above; this is outlined as:

- A total of 5.85 ha of remnant/undisturbed bushland retained;
- 50.61 ha of pasture established on the REA, tailings embankments and hardstands;
- 1.56 ha of the REA Dam retained after construction of the buttress; and
- The spillway from the TSF to Catch Dam 1.

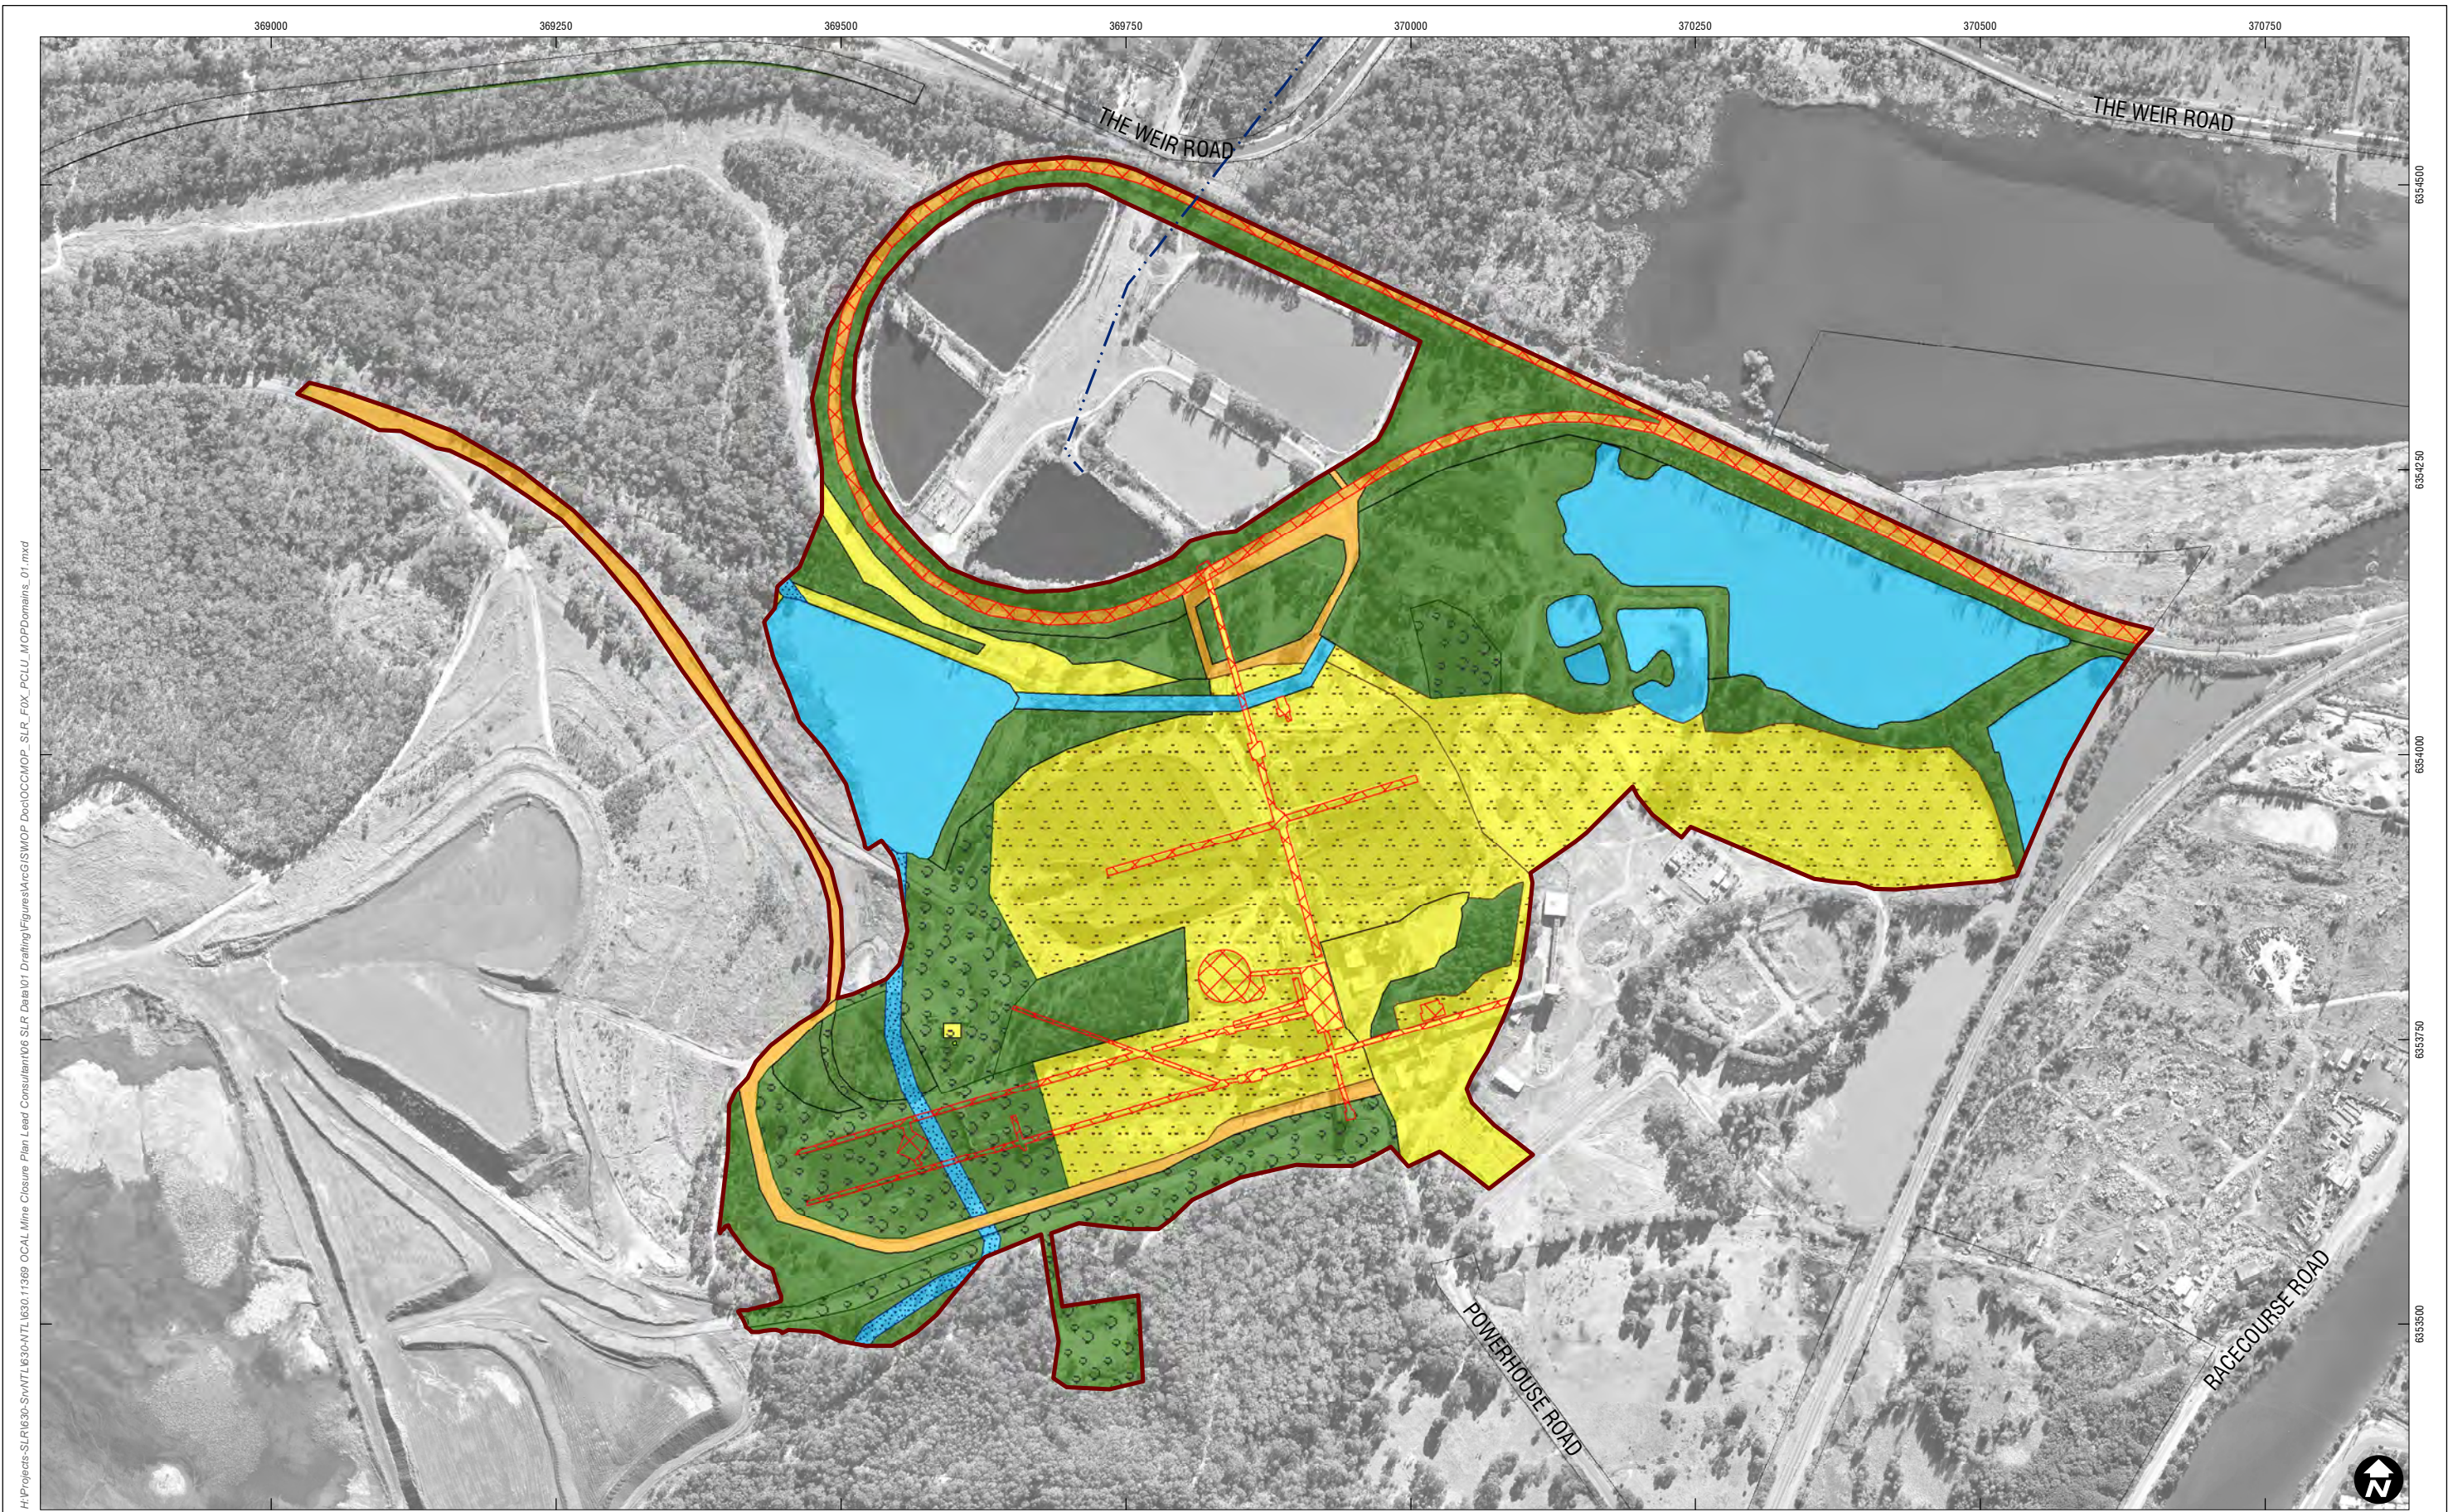
FIGURE 39

The final land use outcomes (shown in **Figure 39**) were adopted based on land use options from the work above; this is outlined as:

- Existing rehabilitation will be retained as bushland; and
- Additional areas of hardstand areas will be created.
