OCEANIC COAL AUSTRALIA LIMITED
Mining Operations Plan
Closure of the OCAL Complex

OCCP-SLR-DOM00-CM-RPT-001

Mining Operations Plan

Closure of the OCAL Complex

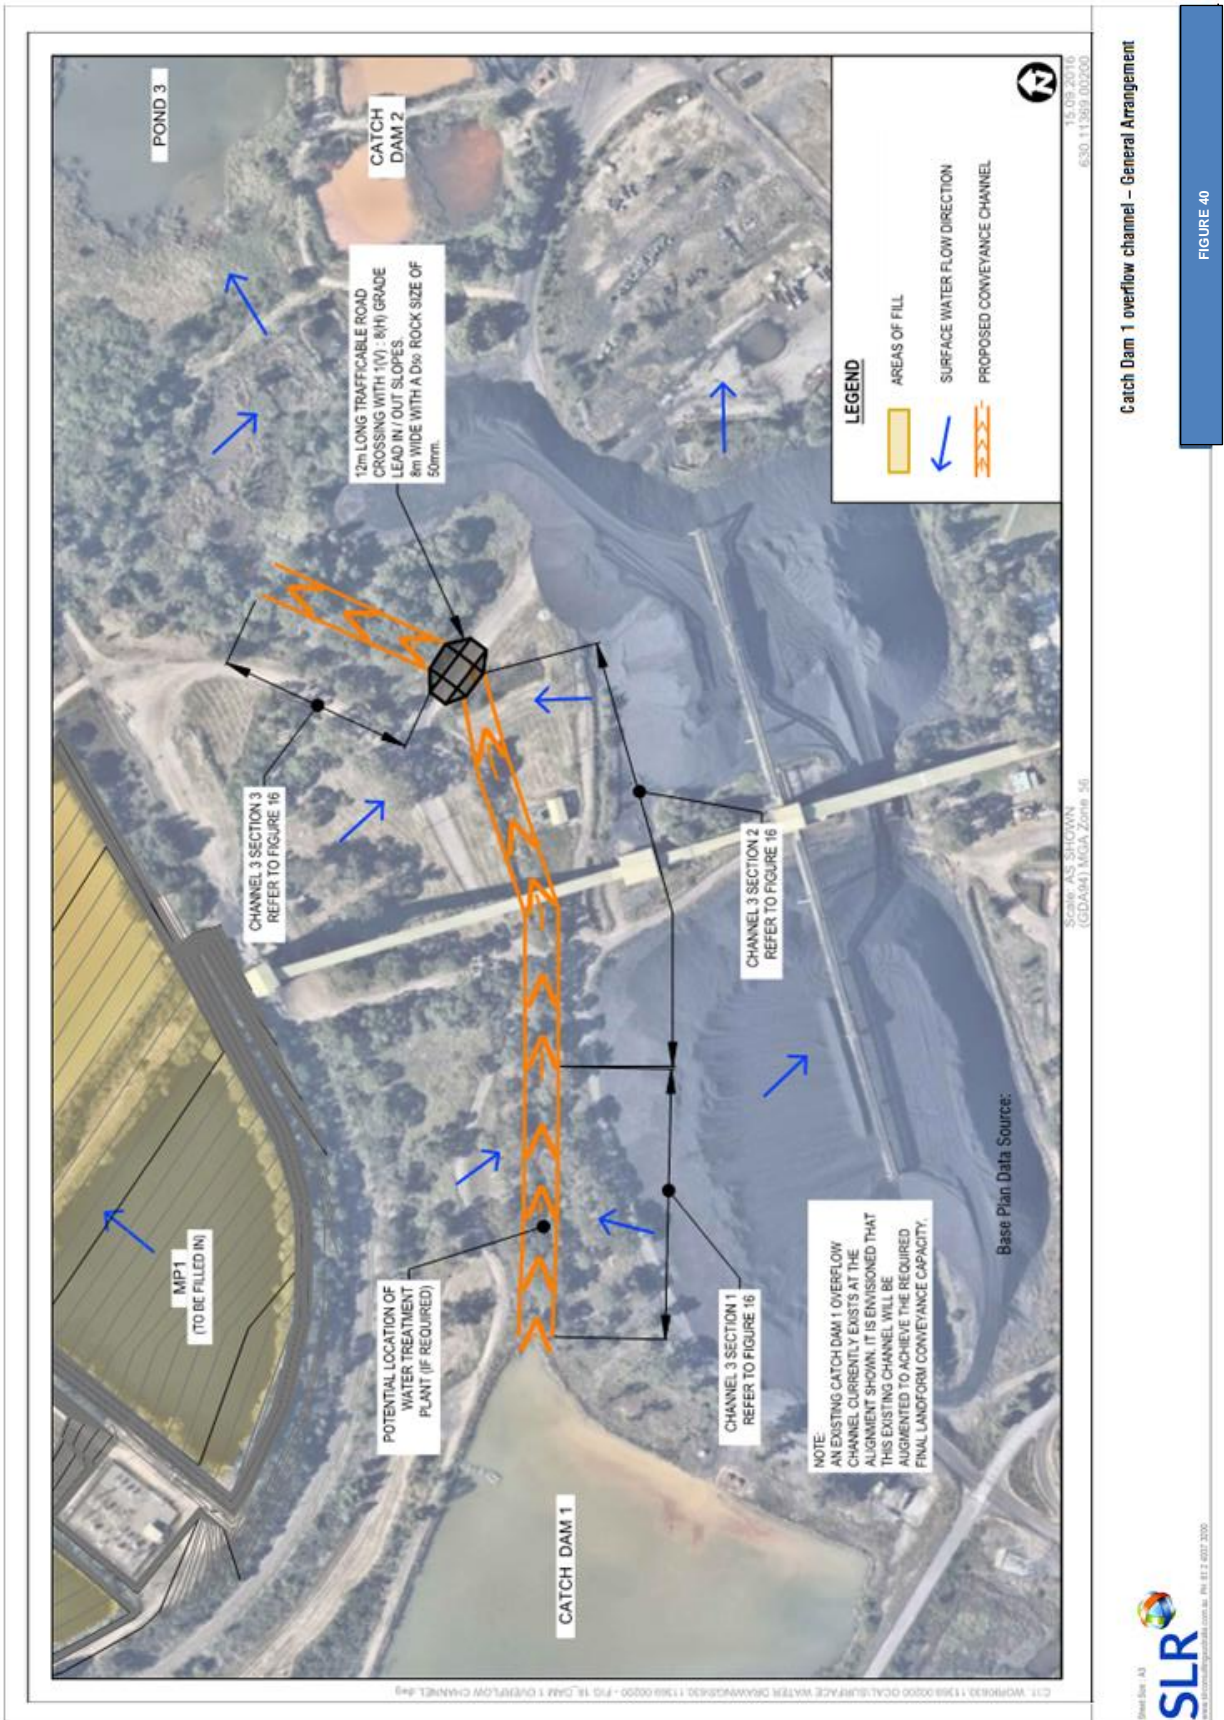
- Pumping water from Catch Dam 2 to catch Dam 3 to enable sediment removal; and
- Upgrading the Catch Dam 1 to Catch Pond 3 overflow channel: The lower sections of the TSF overflow channel will pass through this domain which will retain the majority of the existing hardstand areas (see **Figure 40**). The existing overflow channel is undersized to convey the predicted future peak flow rates and as such, the capacity of this channel will need to be increased as conceptually designed in XP-RAFTS to safely convey peak flow rates from a 100 year ARI rainfall event following capping of the TSF.

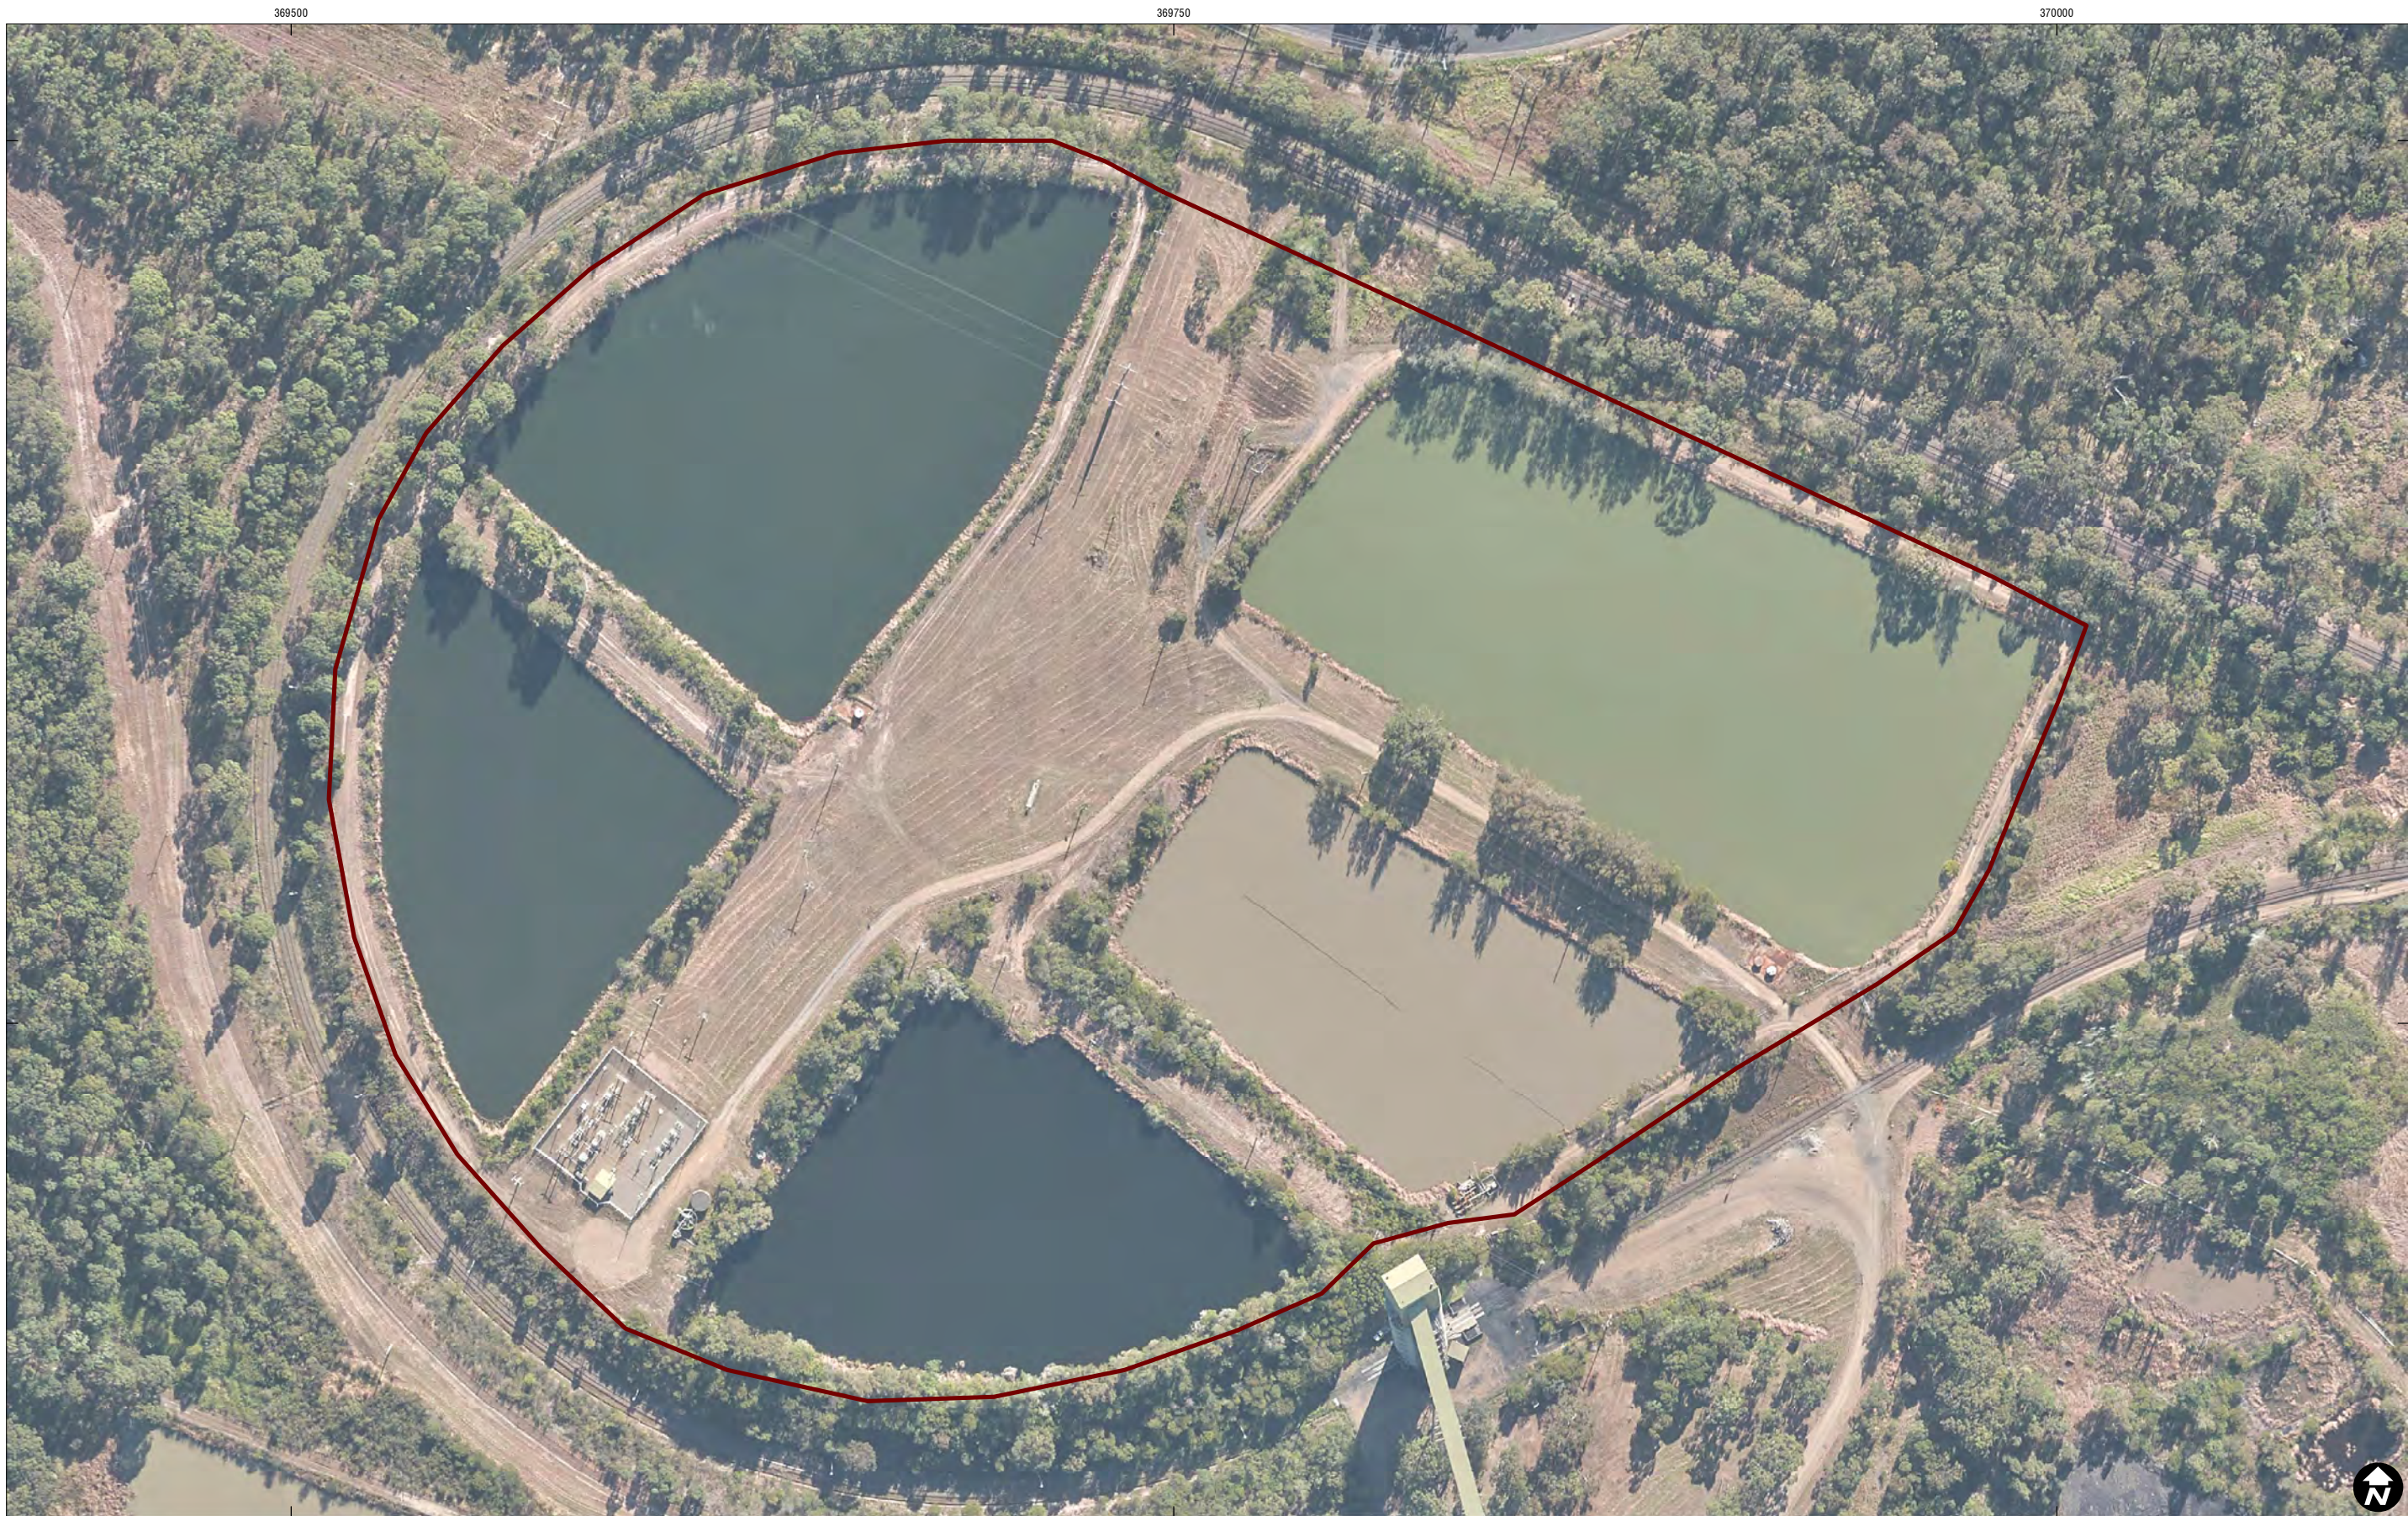
FIGURE 41

Figure 41 shows the existing arrangement of Domain 10 as at July 2016.

Maturation Ponds 1, 2 and 3 receive the majority of treated effluent from the Edgeworth Sewage Treatment Plant (ESTP) via a pipeline constructed predominantly on MCPP land (crossing Domain 14). The pipeline contains asbestos. The maturation Ponds 4 and 5 receive overflow from Maturation Ponds 1, 2 and 3, as well as the coal stockpiles and washery area (pumped across from Catch Dam 2 in Domain 9). Overflow from Maturation Ponds 4 and 5 reports to the catch pond system in Domain 9.

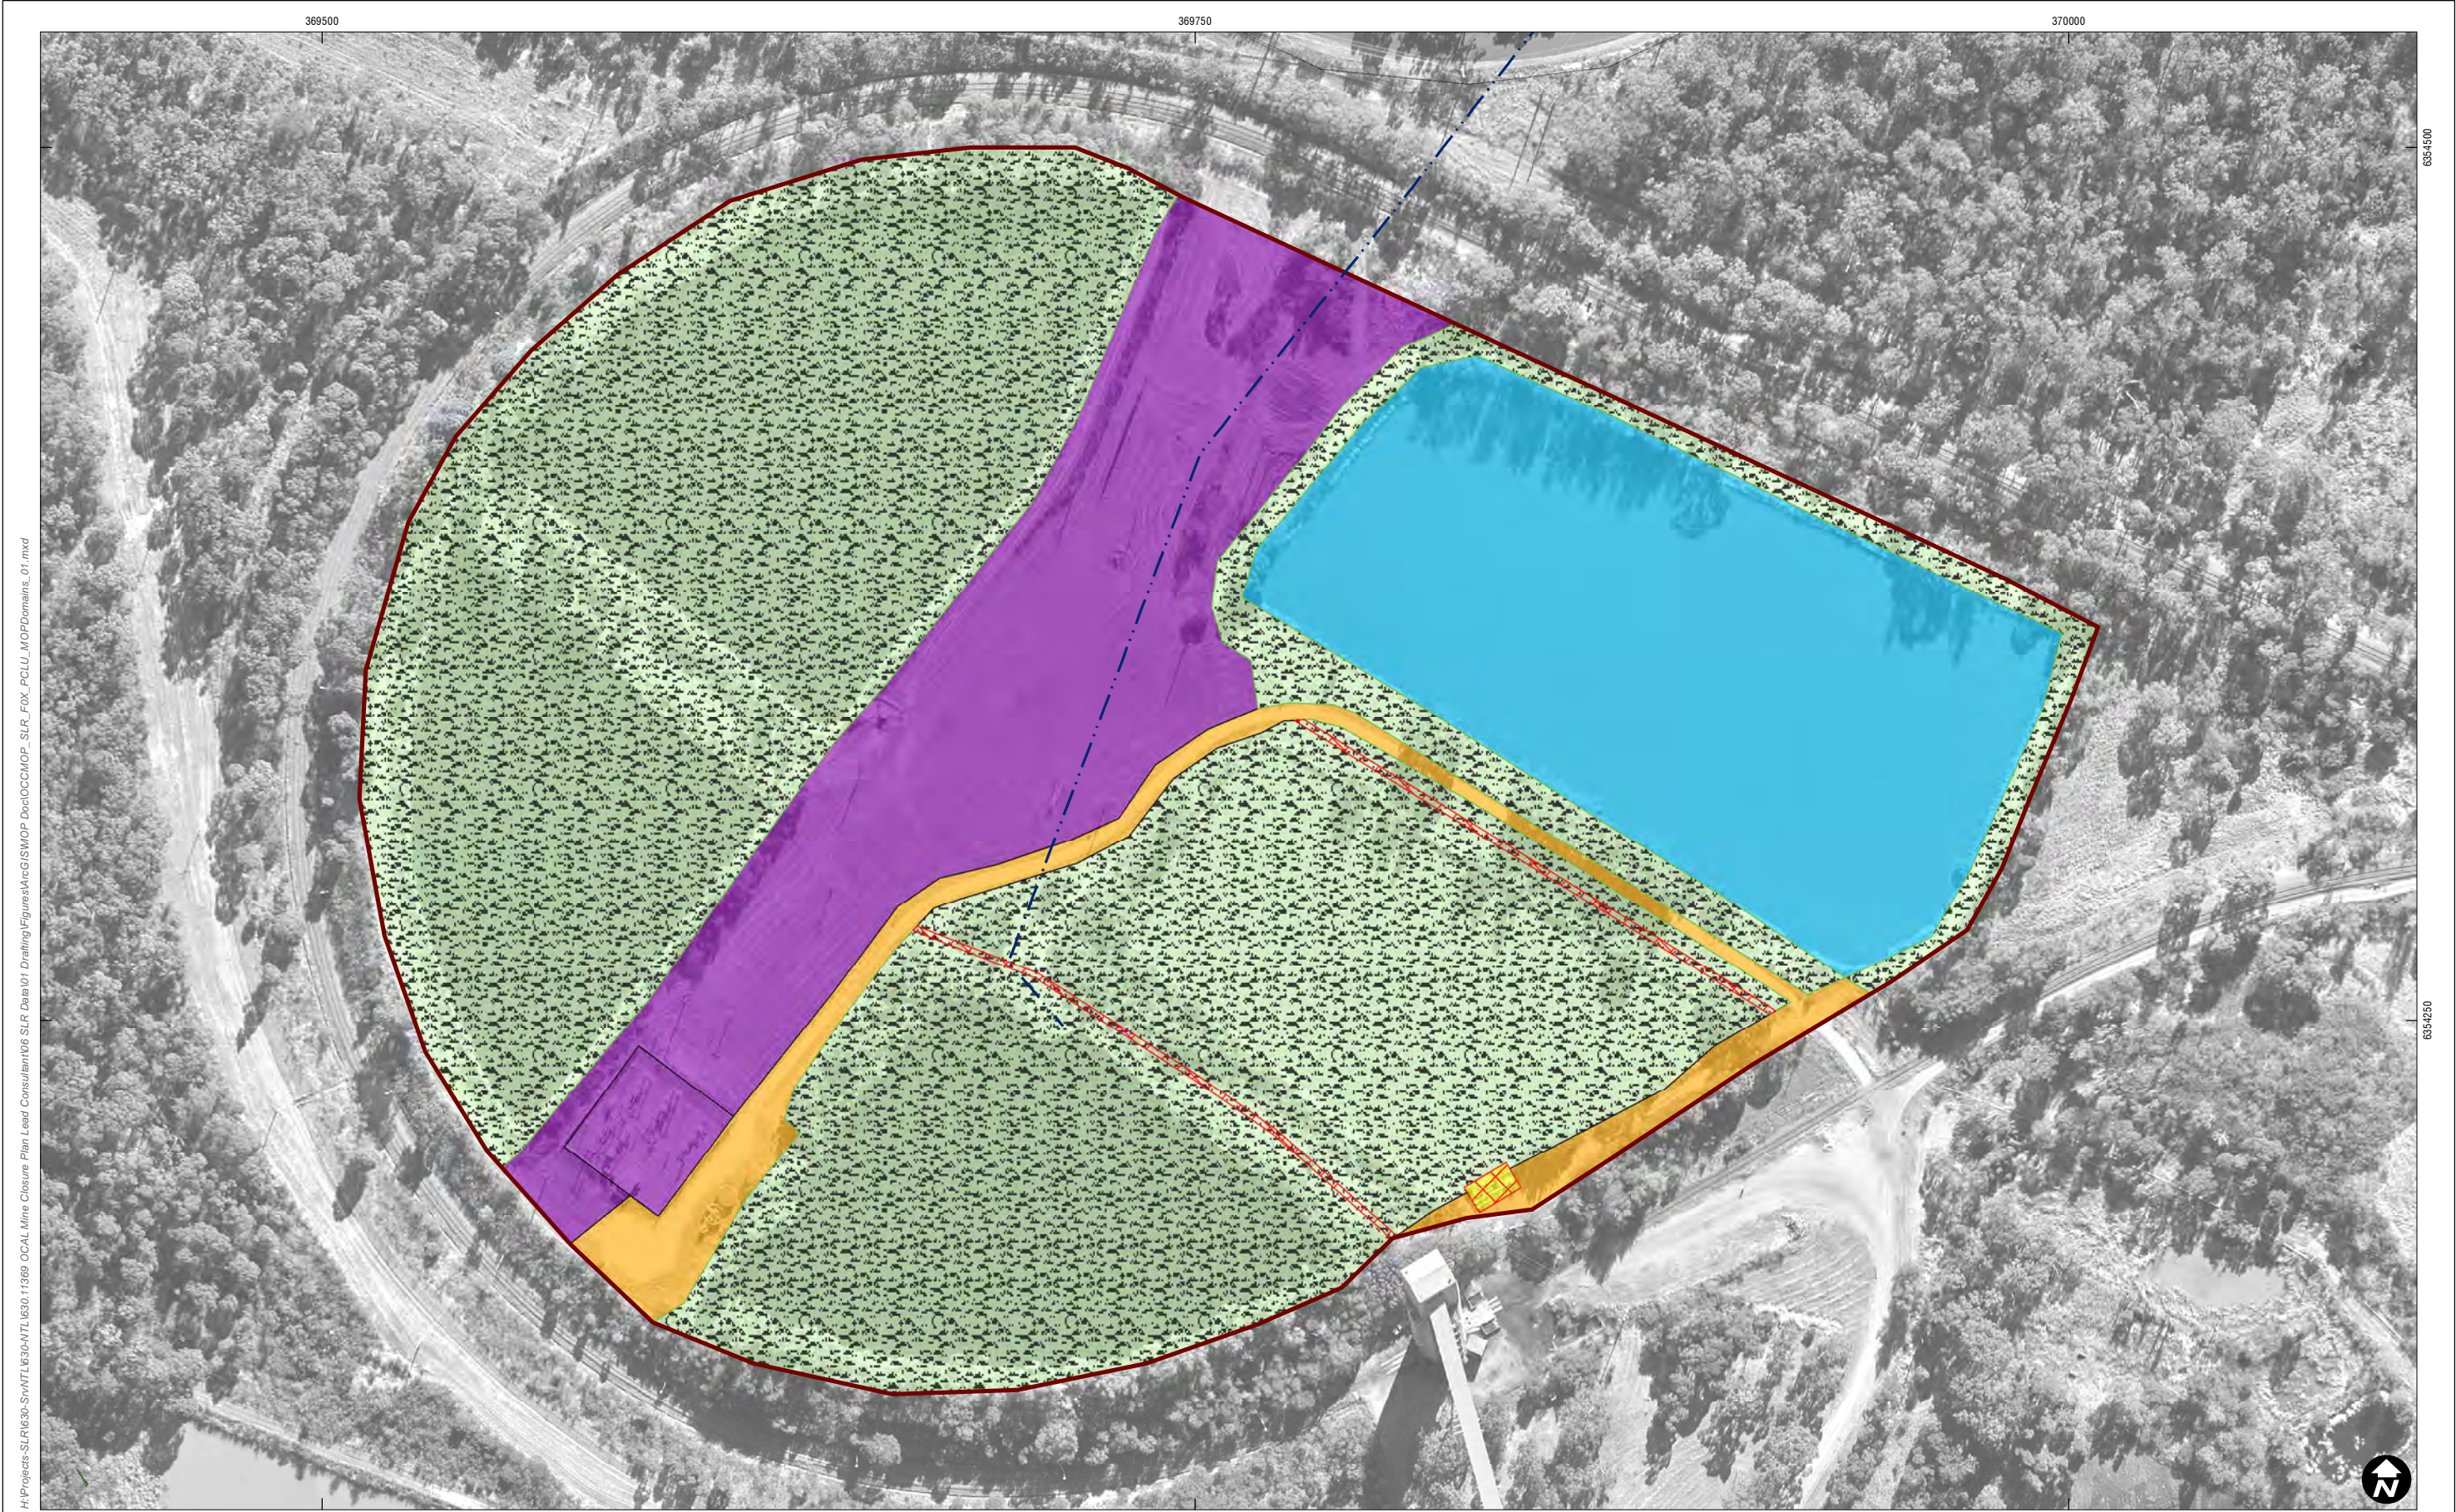
The final land use outcomes (shown in **Figure 42**) were adopted based on land use options from the work above; this is outlined as:

- A total of 7.51 ha of disturbance will be converted to pasture (surfaces of Maturation Ponds 1, 2, 3 and 5);
- 2.0 ha of non-OCAL infrastructure will be retained (substation);
- 0.5 ha of retained roadways and hardstand to access non-OCAL infrastructure; and
- 2.21 ha of Maturation Pond 4 will be retained as a sediment dam and retention basin based on the final proposed landform.

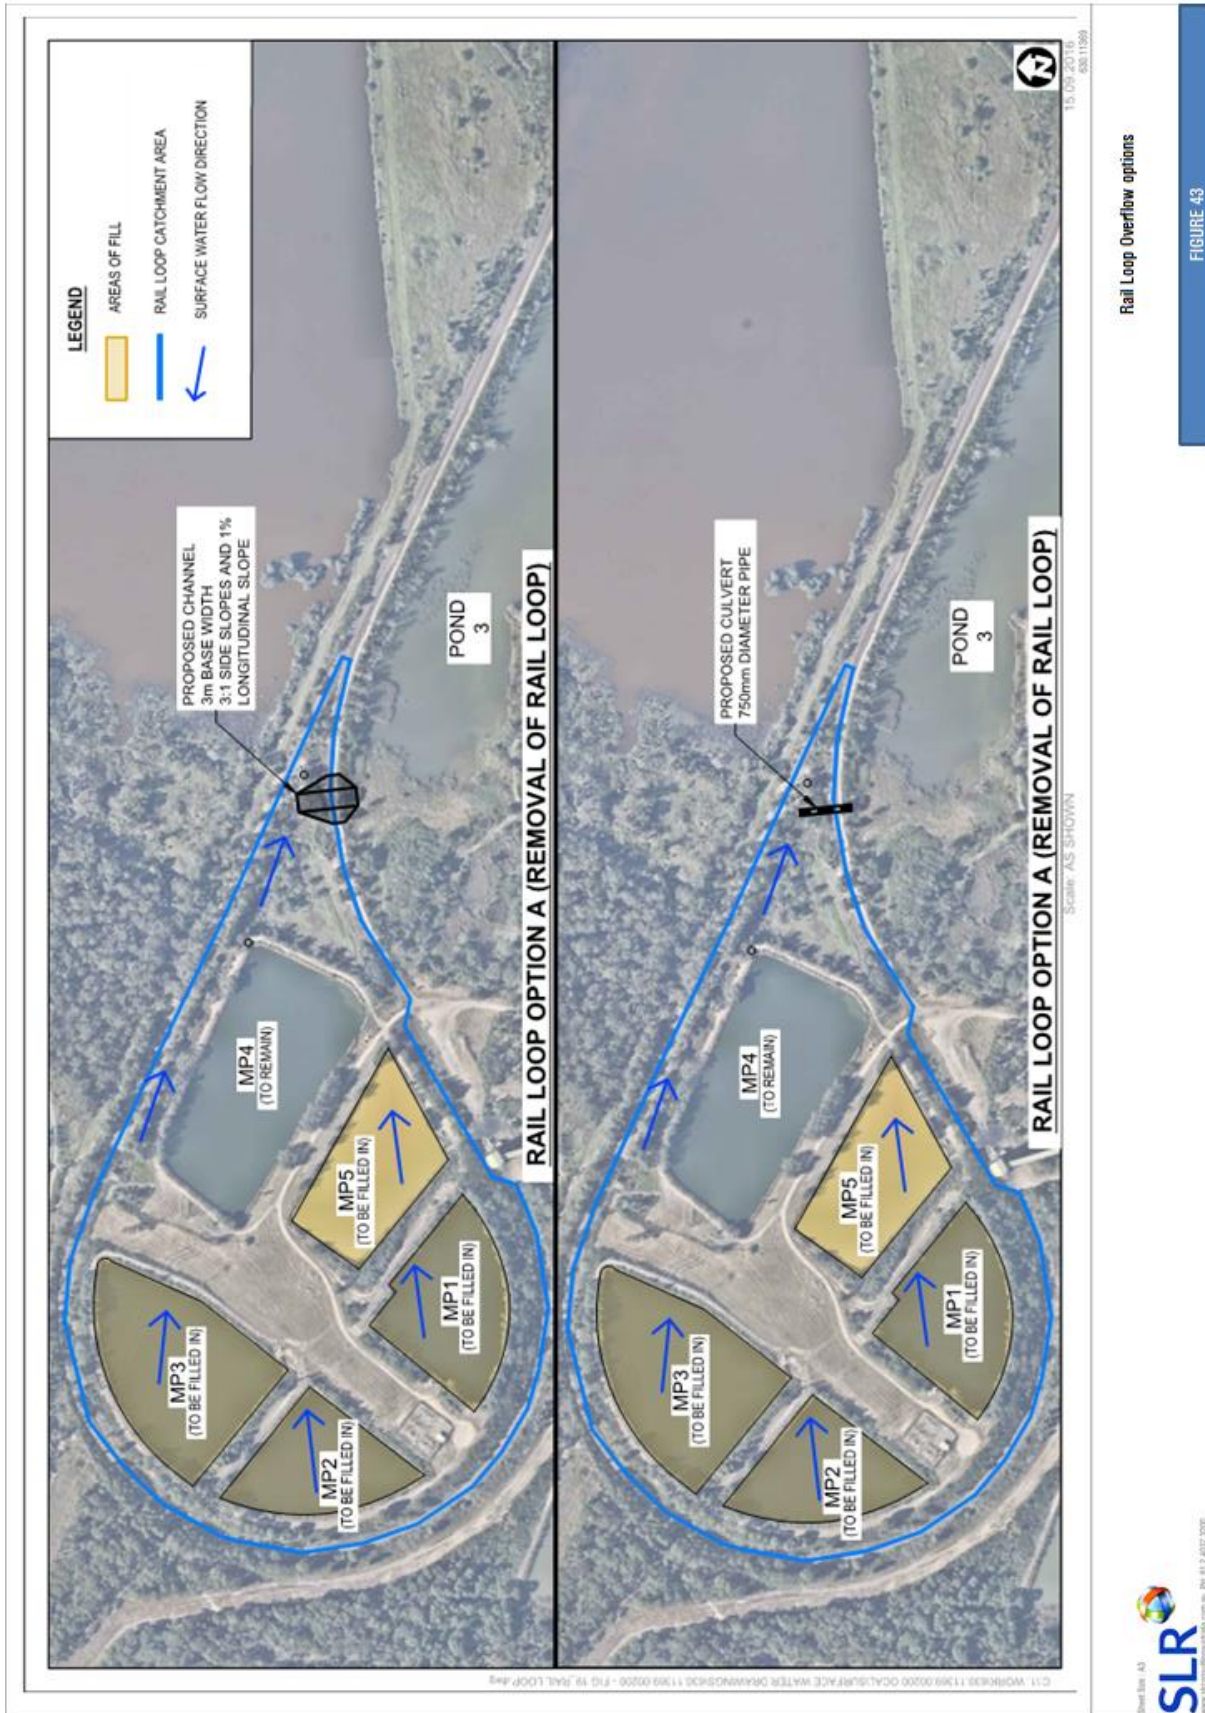
FIGURE 43

If a post mining land user for the rail loop is not determined, this infrastructure will be decommissioned and a channel constructed through the existing rail loop embankment so that the overflows from Maturation Pond 4 will be conveyed into Pond 3. If a post mining land user is identified, a culvert with rip rap scour protection at the outlet and headwalls/wingwalls will need to be constructed through the rail loop embankment necessitating an existing low point area adjacent to the rail line on the northern side of the rail loop be bunded to ensure that any overflows report to Pond 3. Both these options are shown in **Figure 43**.

Rail Loop Overflow options

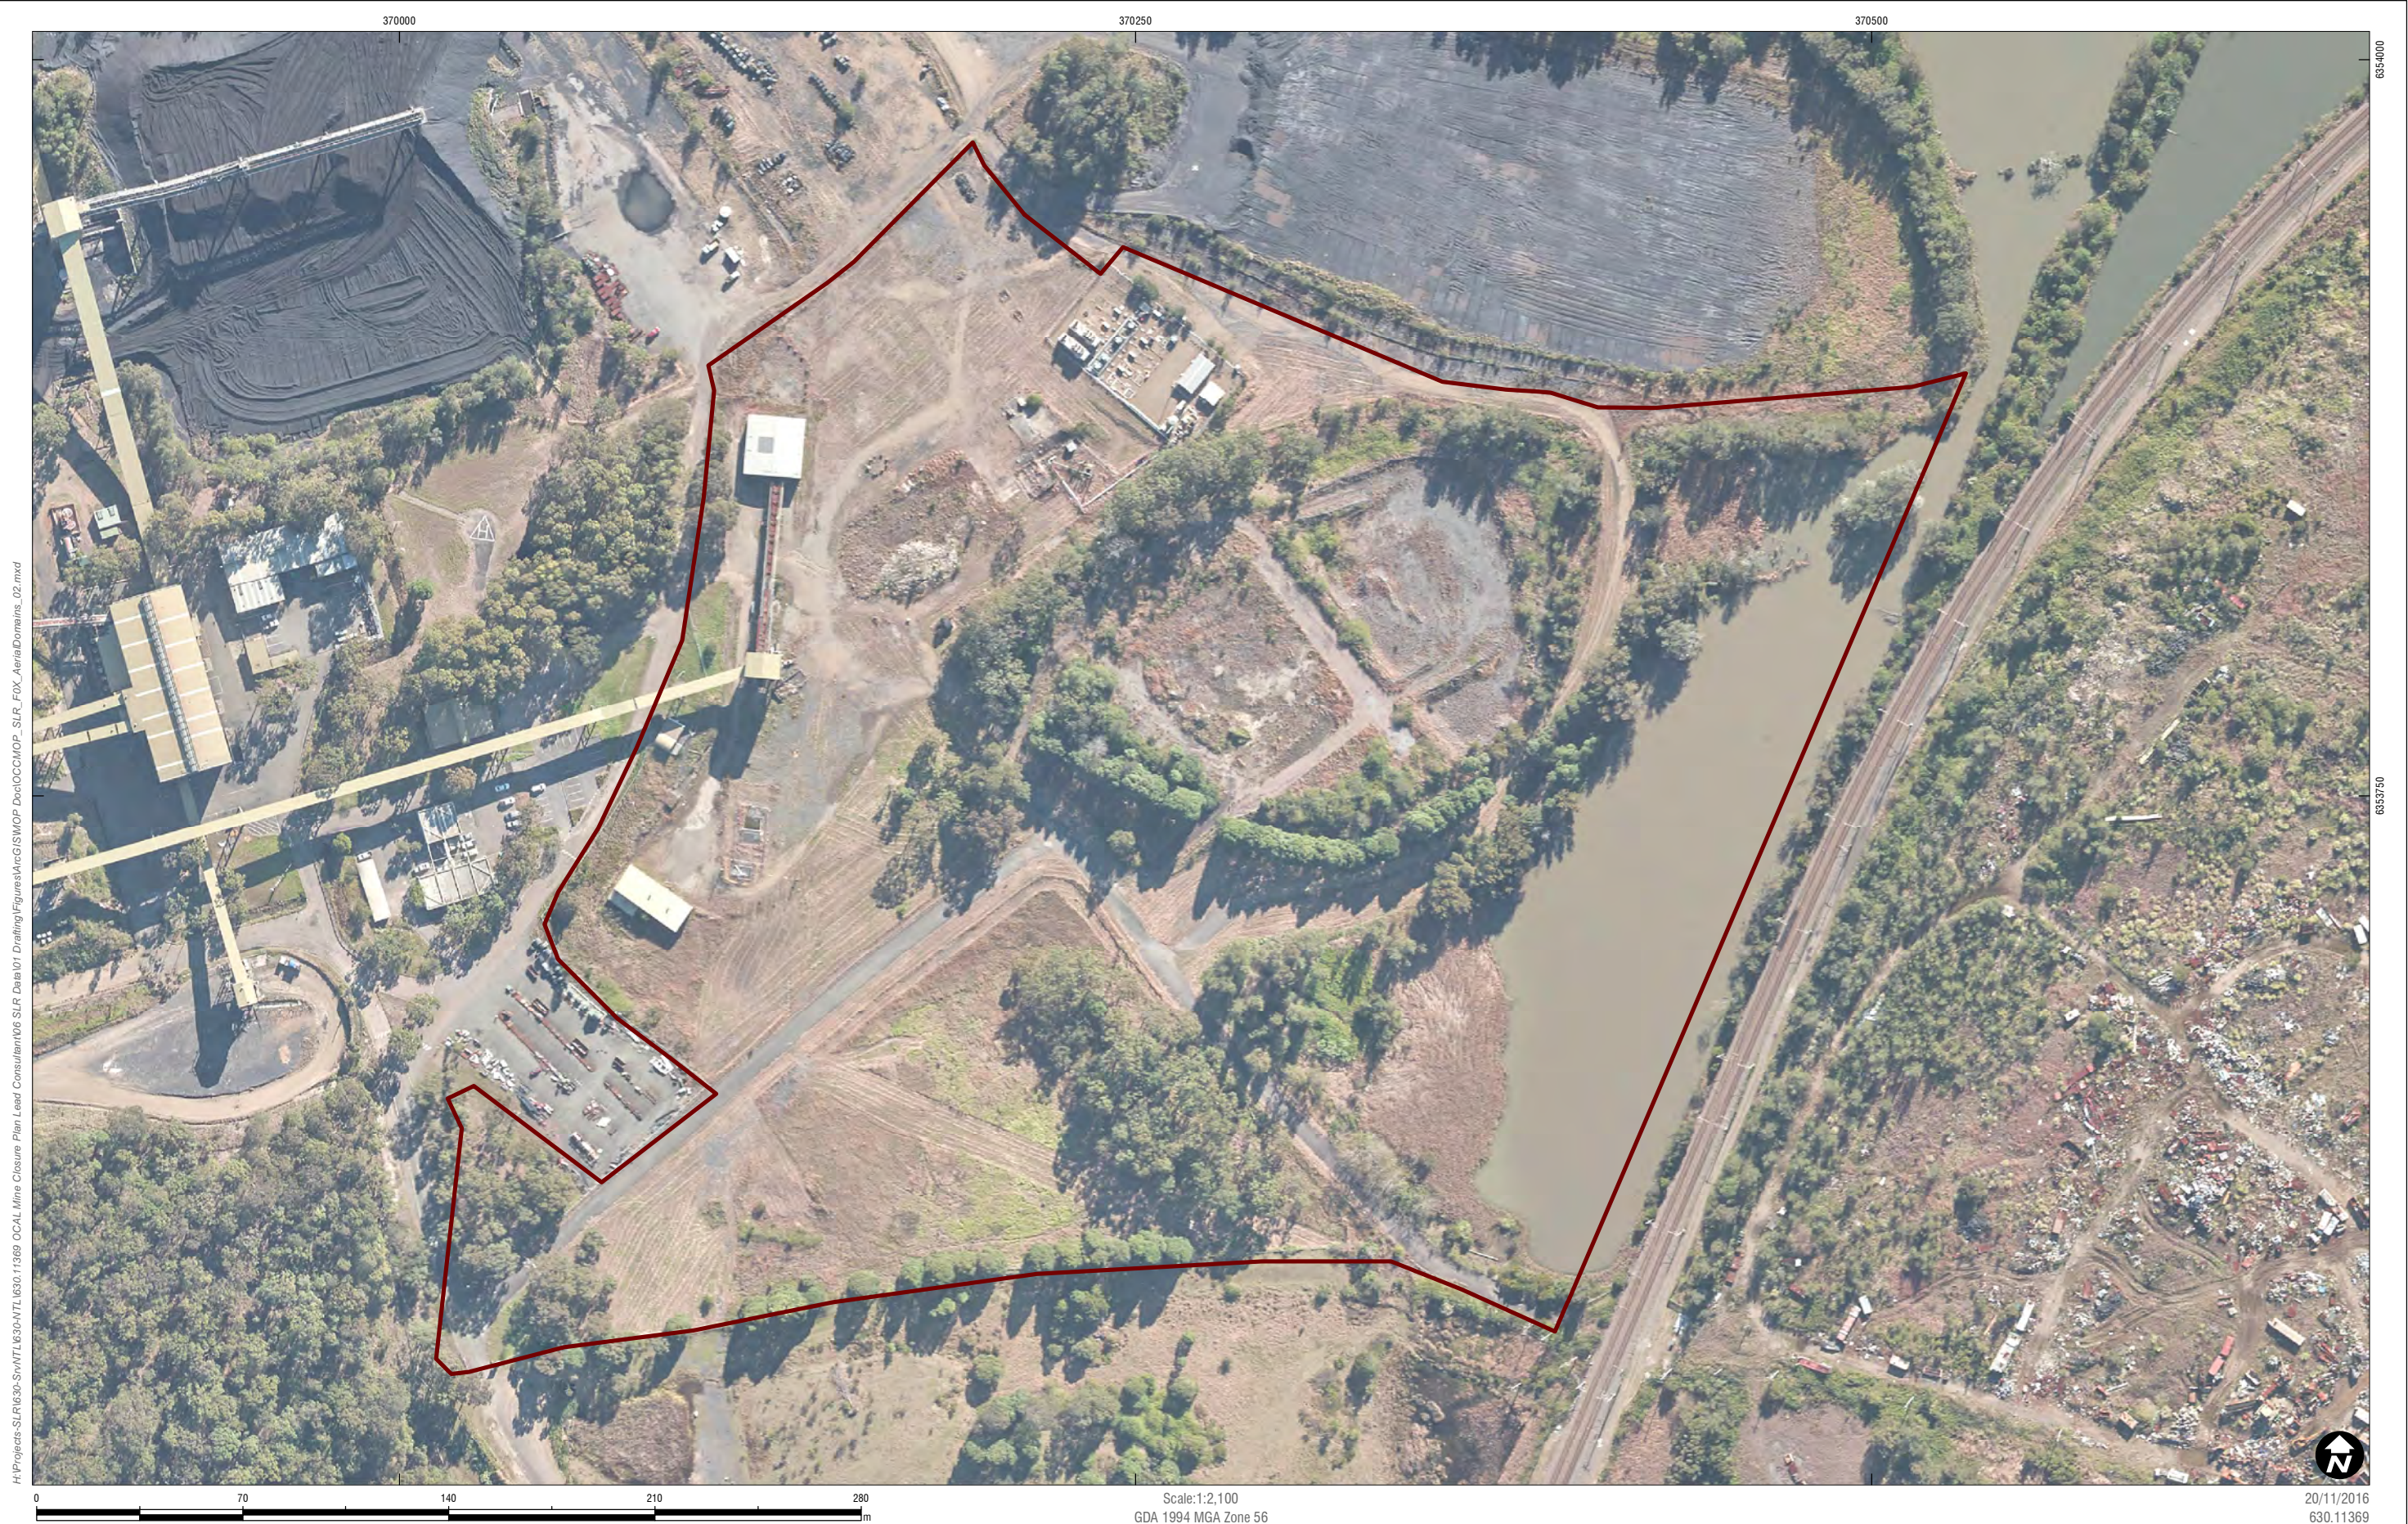
Figure 44 shows the existing arrangement of Domain 11 as at July 2016.

A small disturbance area exist associated with Teralba Northgate infrastructure including the Great Northern Seam Heading, the Fassifern Seam and Australasian Seam Drifts and the Teralba Southgate de-watering bore

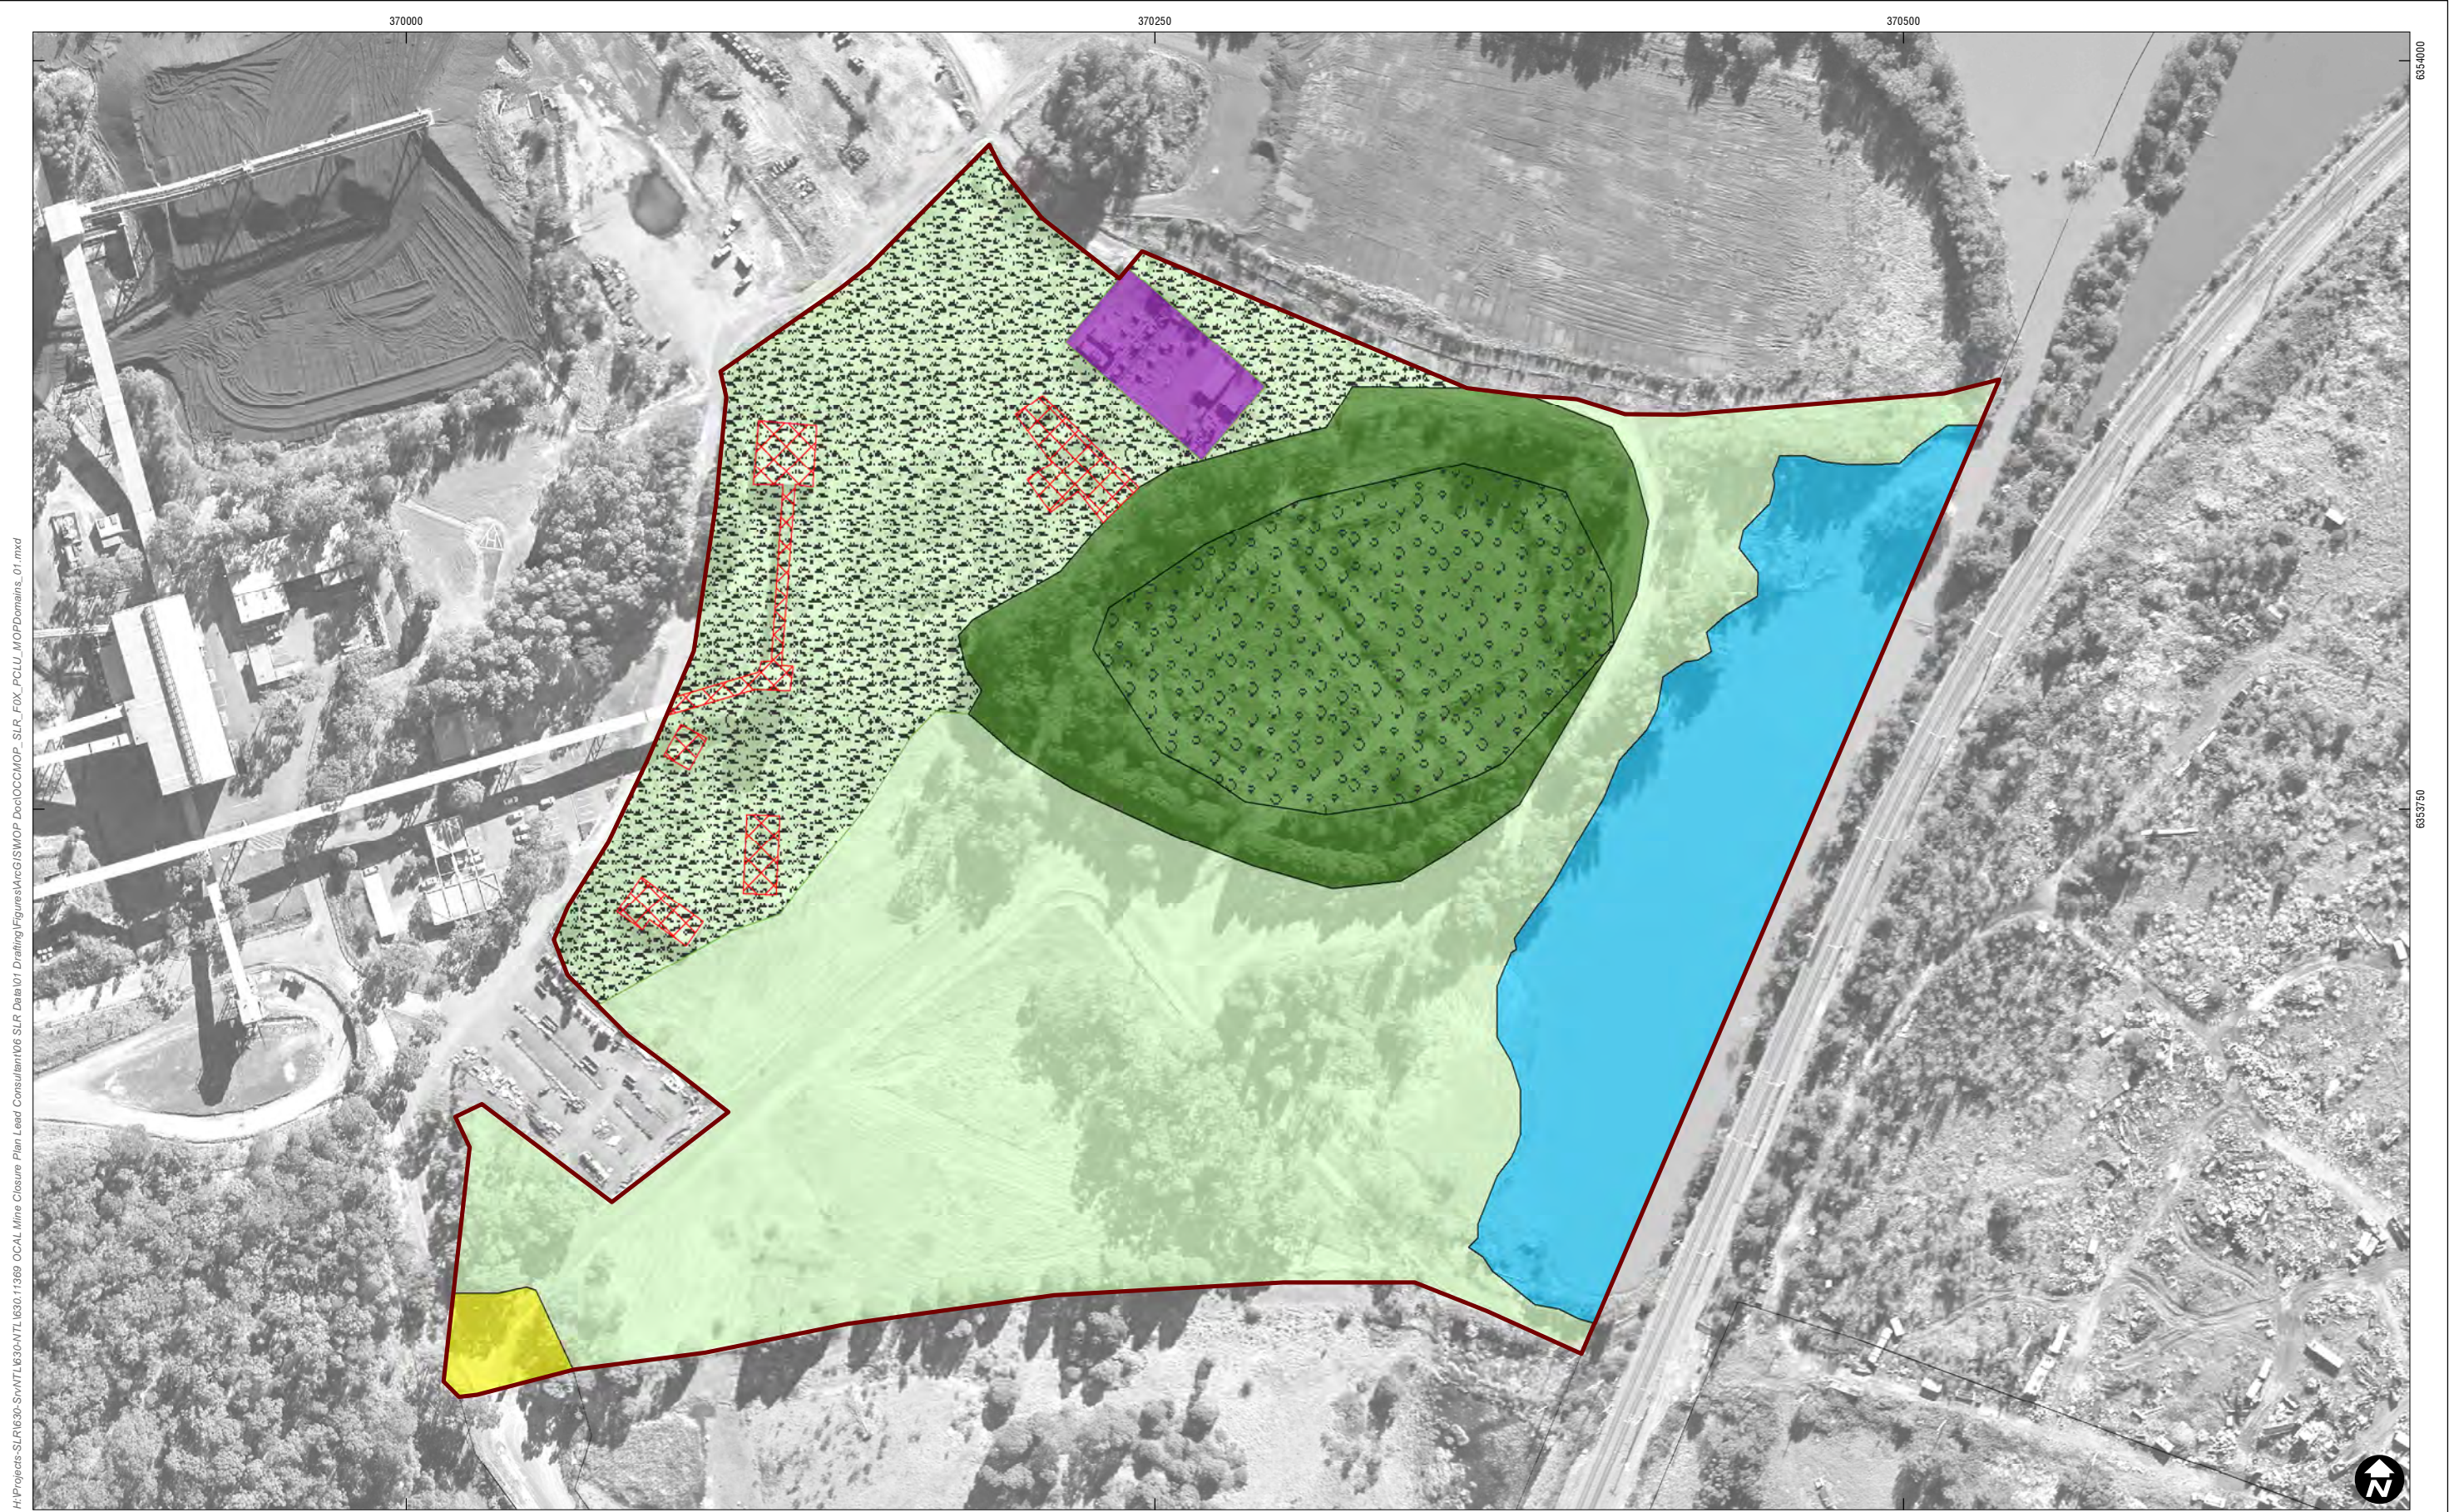
The final land use outcomes (shown in **Figure 45**) were adopted based on land use options from the work above; this is outlined as:

- A total of 2.63 ha of existing and planned rehabilitation will be retained as bushland including a central, currently un-rehabilitated disturbed area;
- 0.20 ha of infrastructure in a fenced area to be retained for a post mining land user;
- 0.11 ha of retained roadway at the south of the domain forming part of the access to the south east entrance to MCPP (Domain 9);
