2022 Annual Review
Ulan Coal Mine

Name of operation	Ulan Coal Mine
Name of operator	Ulan Coal Mines Pty Limited
Development consent / project approval #	PA 08_0184
Name of holder of development consent / project approval	Ulan Coal Mines Pty Limited
Mining lease #	CCL 741, MPL 315, ML 1341, ML1365, ML 1366, ML 1467, ML 1468, ML 1511, ML 1554, ML 1656, ML1754, ML1796, ML1798, ML1799, ML1813, EL 5573, EL 7542, EL 8687, EL9363 & EL9419.
Name of holder of mining lease	Ulan Coal Mines Pty Limited
Water licence #	WAL41492, WAL19047, WAL37192, WAL41817, WAL41906, WAL42900 & WAL34921 (only allocation Licences listed).
Name of holder of water licence	Ulan Coal Mines Pty Limited
Annual Review start date	01/01/2022
Annual Review end date	31/12/2022
<p>I, Lucy Stuart, certify that this audit report is a true and accurate record of the compliance status of Ulan Coal Mines Pty Limited for the period of 01 January 2022 to the 31 December 2022 and that I am authorised to make this statement on behalf of Ulan Coal Mines Pty Limited.</p> <p>Note.</p> <p>a) <i>The Annual Review is an ‘environmental audit’ for the purposes of section 122B (2) of the Environmental Planning and Assessment Act 1979. Sect

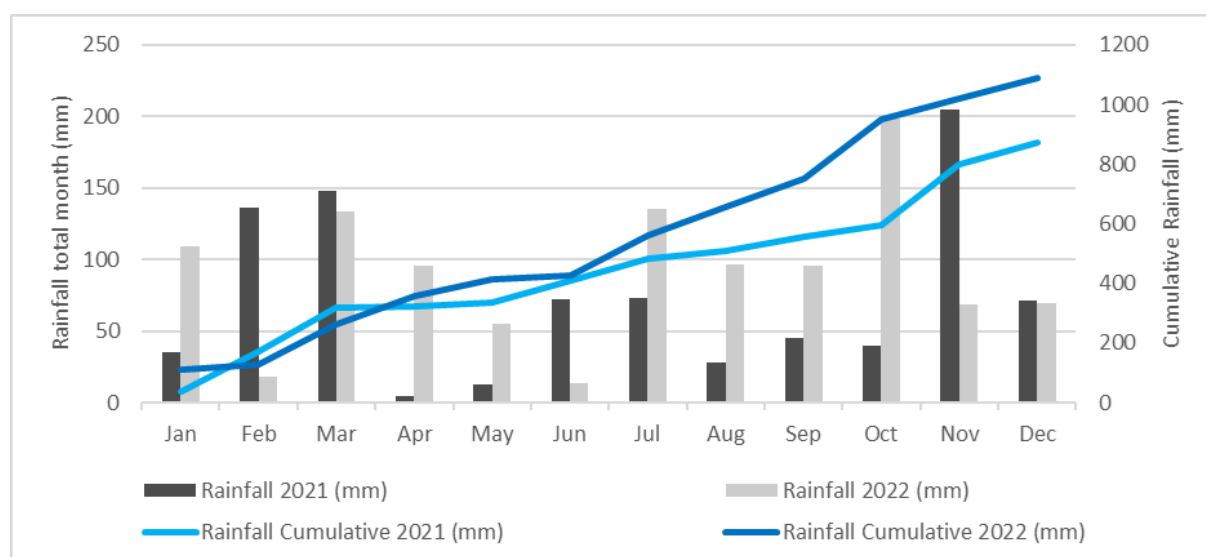
Figure 6-1 - Rainfall Comparison to Previous Reporting Period

The rainfall recorded at WS1 for the Reporting Period (**Table 6-2**) was 1090.3mm, 217.8mm more rainfall than 2021 (**Figure 6-1**) and 418.3mm above the long term average of 672mm for the region (2009 EA). The majority of rain received was during the last two quarters of 2022 approximately 61% of the annual amount. The wettest month was October with 198.7mm of rainfall recorded. The driest month was June with 13.4mm of rainfall recorded.

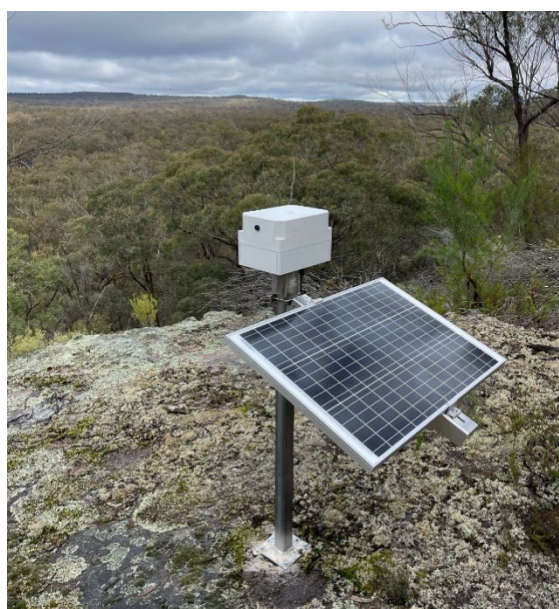
Photo 1 GNSS Unit within the BCA (August 2022)

During the 2022 Reporting Period, UCMPL installed three Global Navigation Satellite Systems (GNSS) units to monitor UW subsidence effects within the Brokenback Conservation Area (BCA). The GNSS units provide real time continuous three-dimensional (3D) ground movement data with trigger alarms as described in the Extraction Plan. No triggers alarms have been received during the Reporting Period.

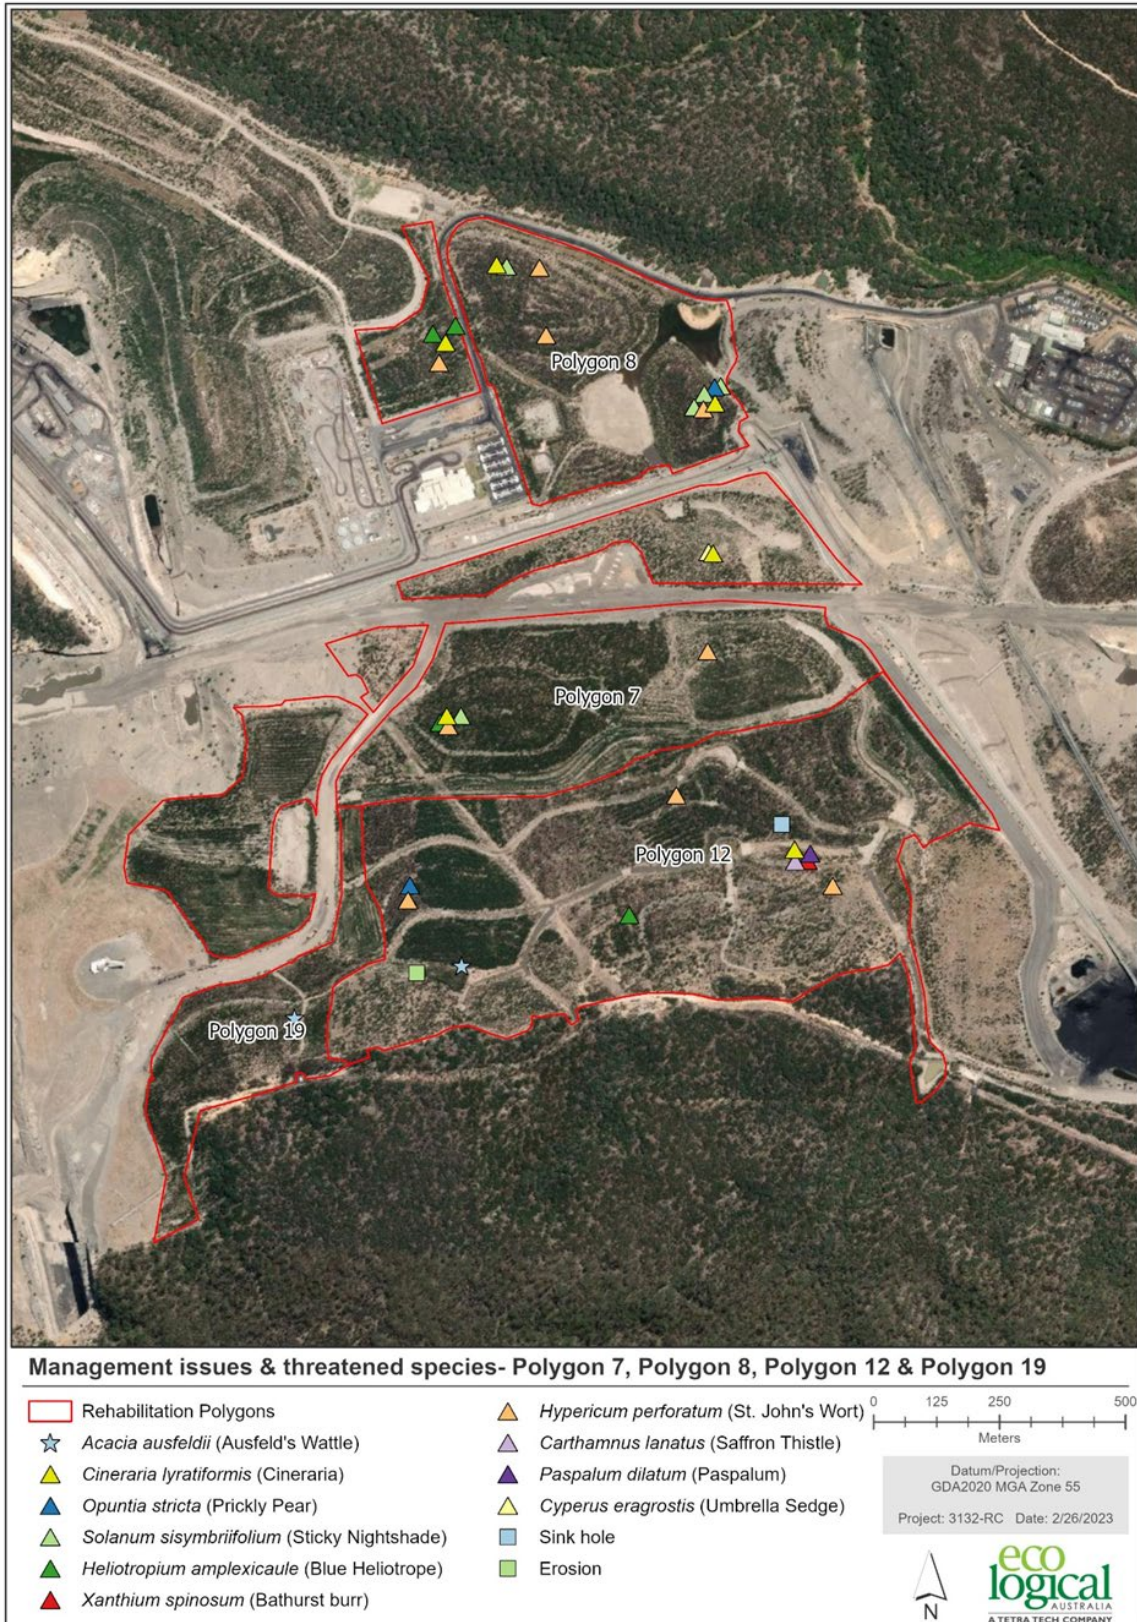
Figure 8-4 – Open Cut Rehabilitation Report Card Results

Three (3) of the six (6) rehabilitation polygons that were monitored in 2022 attained an overall Performance Category of 'Maintenance', whilst the other three (3) have been categorised as 'Monitor'. The RRC results from spring 2022 monitoring are shown in **Figure 8-3** and **Figure 8-4**.
