# MANGOOLA OPEN CUT

## Translocation of Threatened Flora Species Management Plan

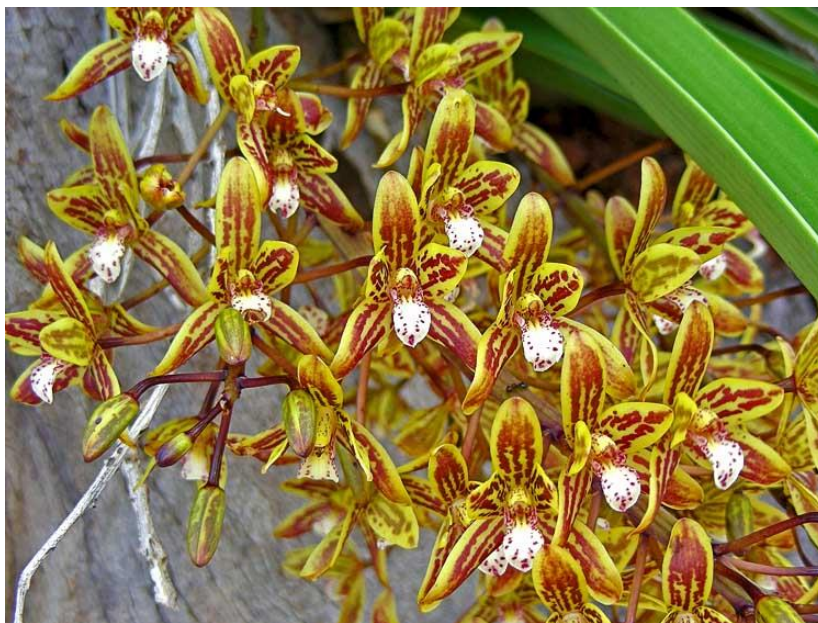
Figure 2.1 – *Cymbidium canaliculatum*

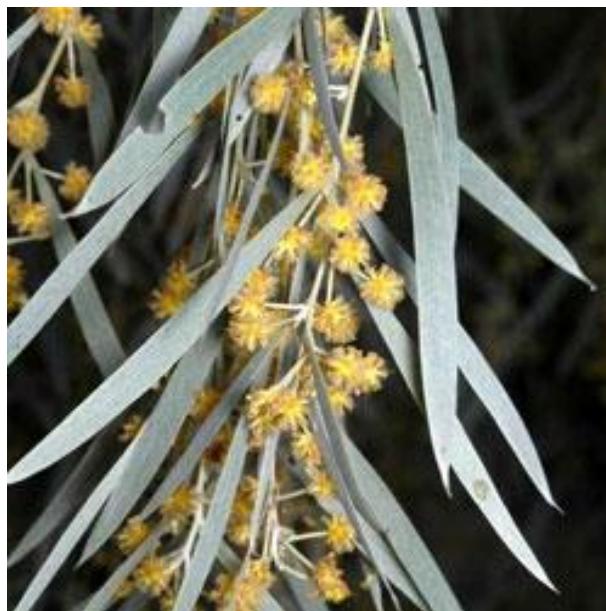
Figure 2.4 – *Acacia pendula*

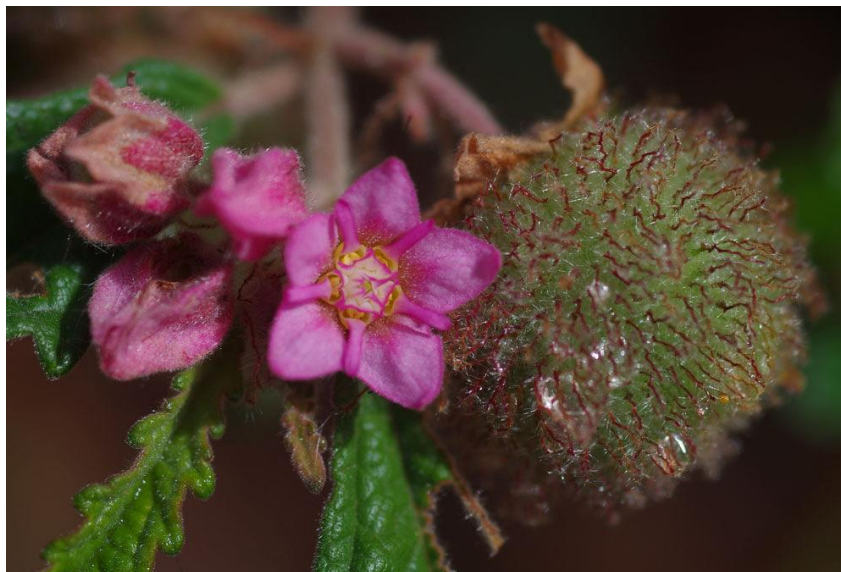
Figure 2.5 – *Commersonia rosea*

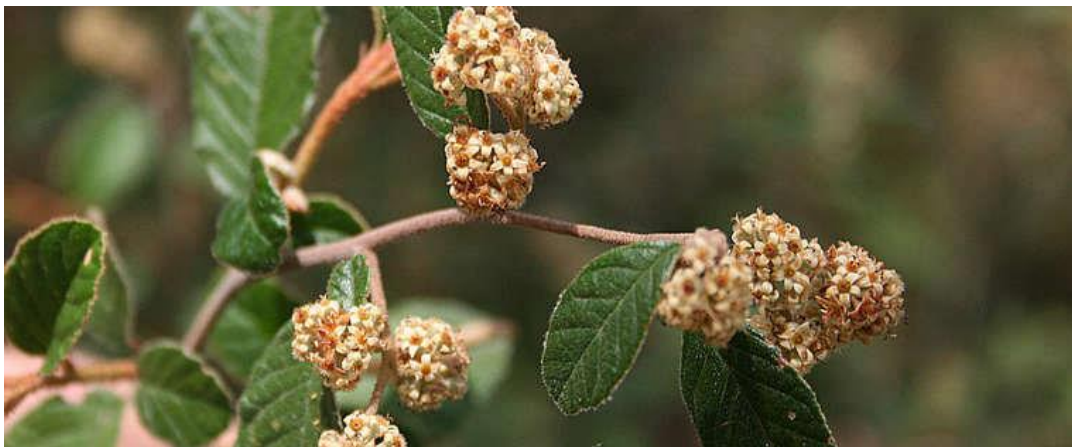
Figure 2.6 – *Pomaderris queenslandica*

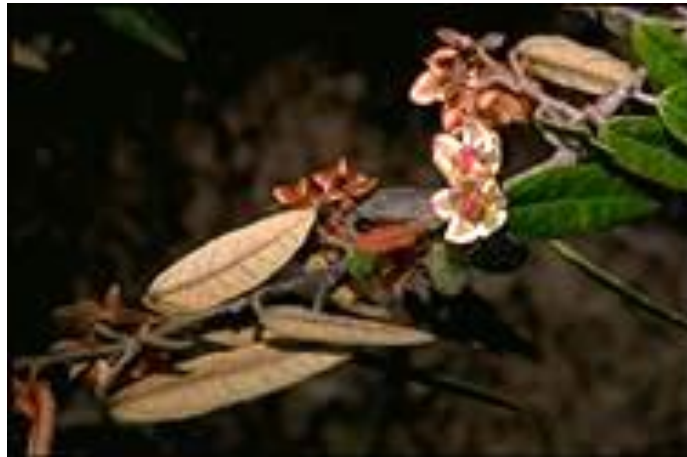
Figure 2.8 – *Lasiopetalum longistamineum*

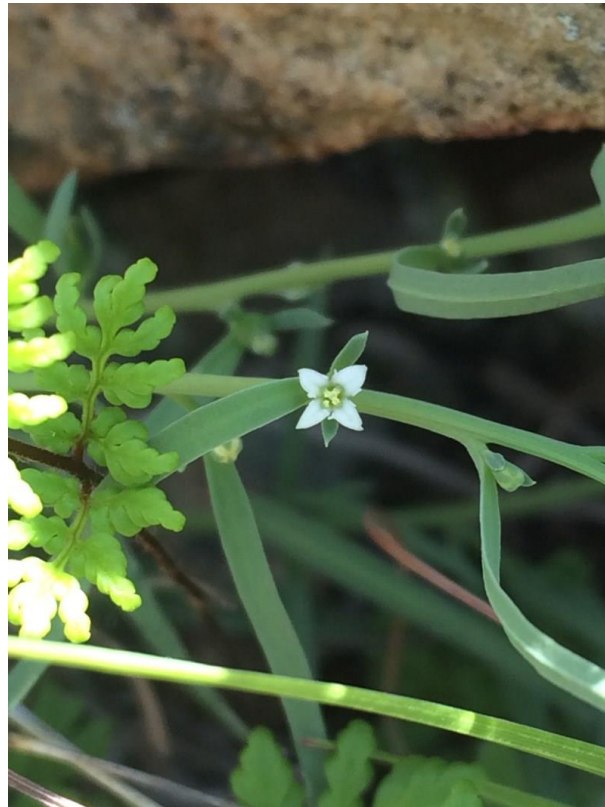
Figure 2.11 – *Thesium australe*

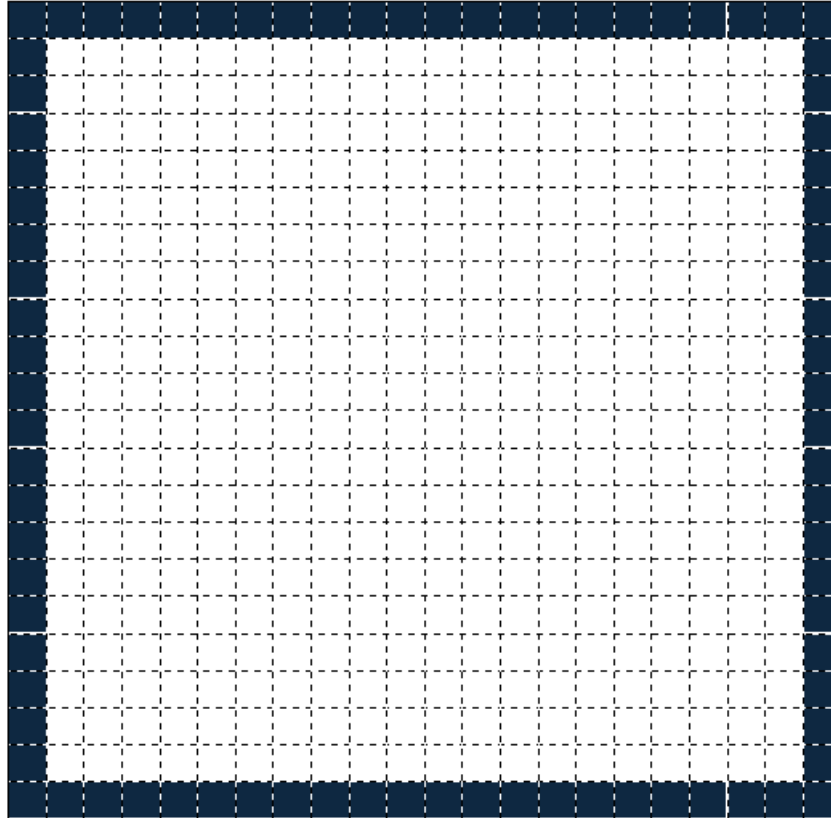
- prior to planting out, grass should be brush-cut to 5-10 cm high, and the cut grass completely removed.
- extraction of orchids is best done with a spade, cutting the four sides down to about 25 cm depth and approximately 10 cm away from the orchid stem on each side (to avoid tuber damage). Extraction of soil in situ around the orchid (i.e. as a soil core) is needed to also translocate the mycorrhizal fungi.
